F/CMVSS Noncompliance Recall

18315 Rear Seatbelt Automatic Locking Retractor (ALR) Function

Reference Number: N182180720

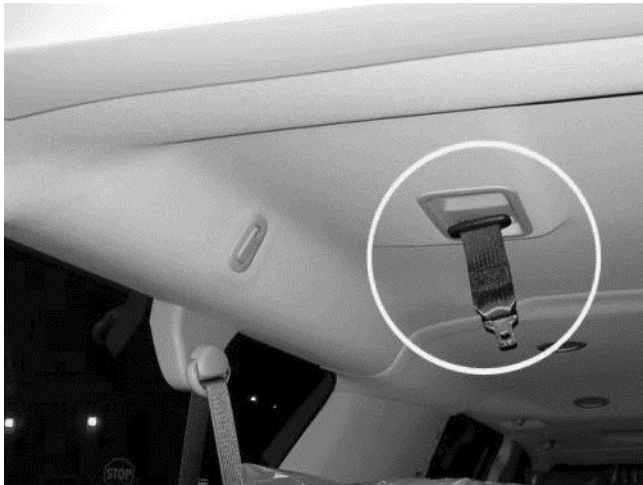
1. Remove the middle third row seatbelt buckle from the headliner seatbelt bezel.

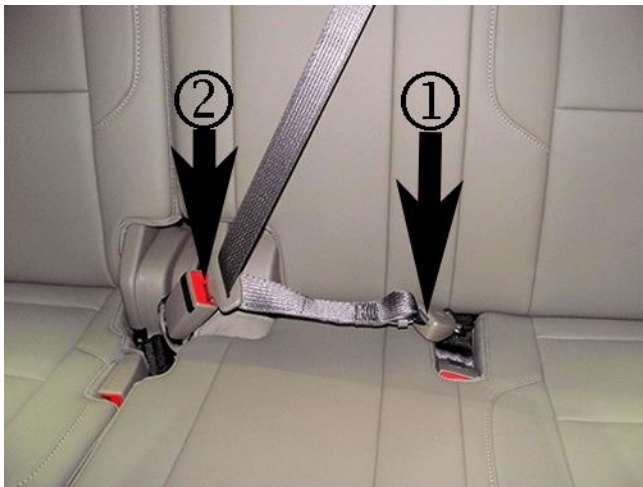
2. Pull the seatbelt out of the retractor and install the small latch plate into the detachable anchor (1). Install the large latch plate into the buckle as if buckled over an occupant (2).

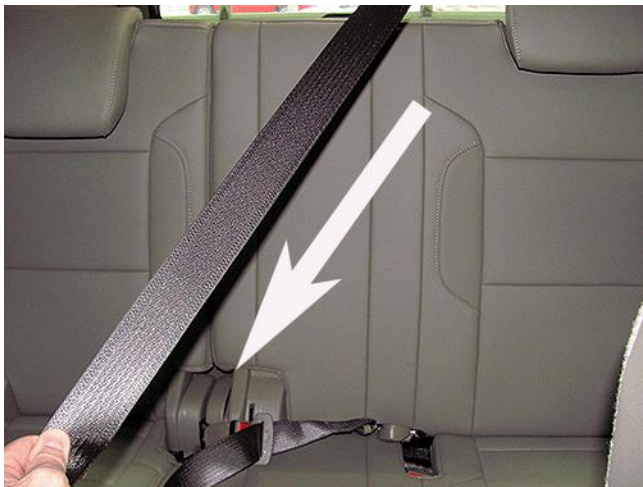
3. Pull the complete length of the seatbelt out until it reaches a hard stop.

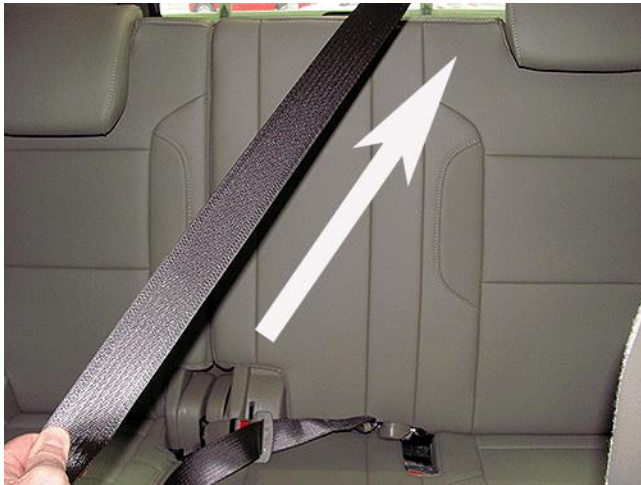
5149697

4. Allow approximately 12 inches (30 cm) of the belt to slowly retract back into the retractor (you will hear a ratcheting sound).
5. Firmly tug on the belt and verify that it locks and cannot be pulled out of the retractor.

6. Allow another 12 inches (30 cm) to retract into the retractor, firmly tug on the belt and verify that it locks and cannot be pulled out of the retractor.

7. Allow another 12 inches (30 cm) to retract into the retractor, firmly tug on the belt and verify that it locks and cannot be pulled out of the retractor.

- **If the seatbelt retractor locks without releasing six times in succession, no further action is required, the belt system is performing as designed.**

- **If the seatbelt fails to lock at any time during the six cycles, the seatbelt retractor assembly requires replacement.** Refer to *3rd Row Center Seat Belt Retractor Replacement (Long Wheelbase)* in SI.

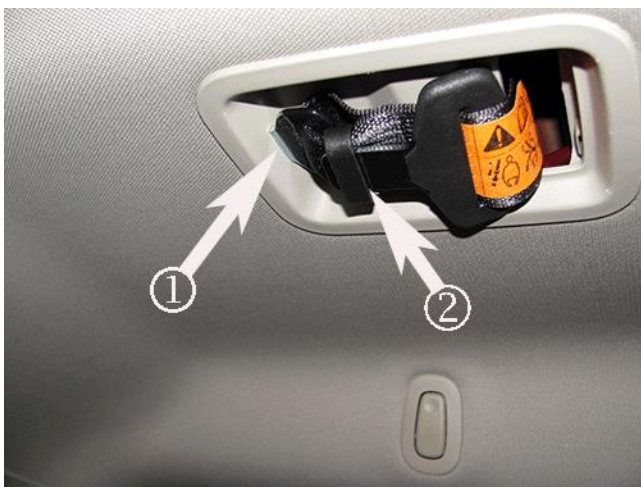
5149700

11. Disconnect both latch plates and reinstall the seatbelt buckle into the bezel (1) and ensure it is secured in the anti-rattle receiver (2).

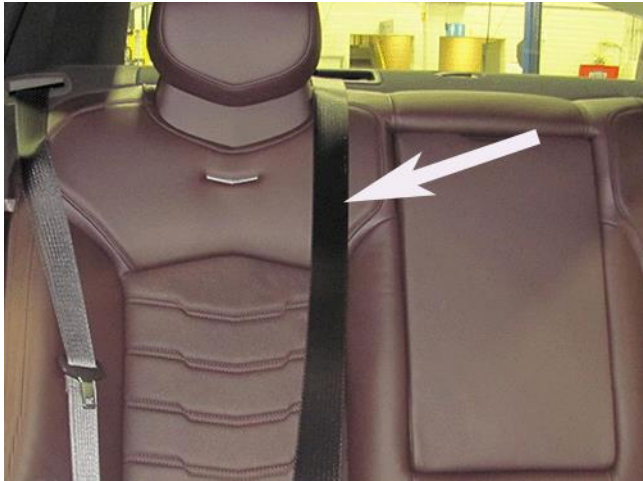
5149702

1. Locate the middle rear seatbelt.
2. Pull the seatbelt out of the retractor and insert the latch plate into the buckle.

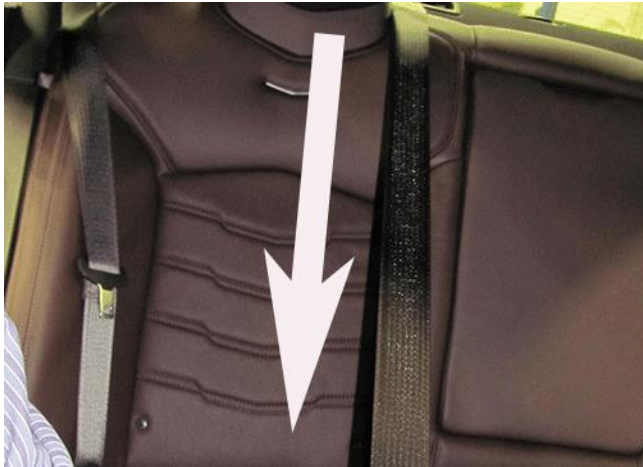
5149703

3. Pull the complete length of the seatbelt out until it reaches a hard stop.

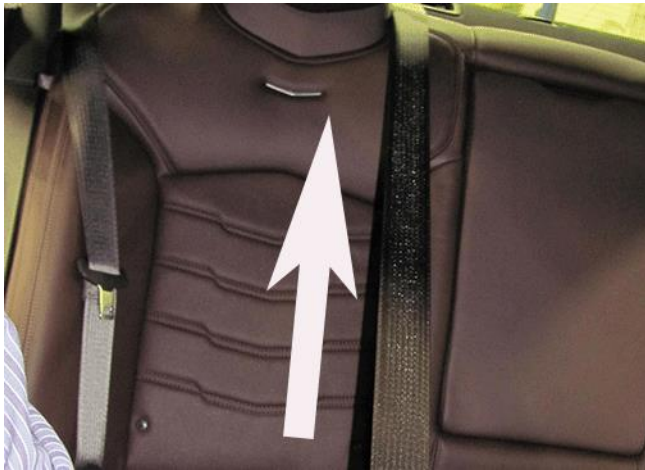
5149704

4. Allow approximately 12 inches (30 cm) of the belt to slowly retract back into the retractor (you will hear a ratcheting sound).
5. Firmly tug on the belt and verify that it locks and cannot be pulled out of the retractor.

6. Allow another 12 inches (30 cm) to retract into the retractor, firmly tug on the belt and verify that it locks and cannot be pulled out of the retractor.

7. Allow another 12 inches (30 cm) to retract into the retractor, firmly tug on the belt and verify that it locks and cannot be pulled out of the retractor.

8. Disconnect the latch plate and allow the seatbelt to fully retract.
9. Repeat steps 2-8 six times.
 - **If the seatbelt retractor locks without releasing six times in succession, no further action is required,** the belt system is performing as designed.

- **If the seatbelt fails to lock at any time during the six cycles, the seatbelt retractor assembly requires replacement.** Refer to *Rear Center Seat Belt Retractor Replacement* in SI.

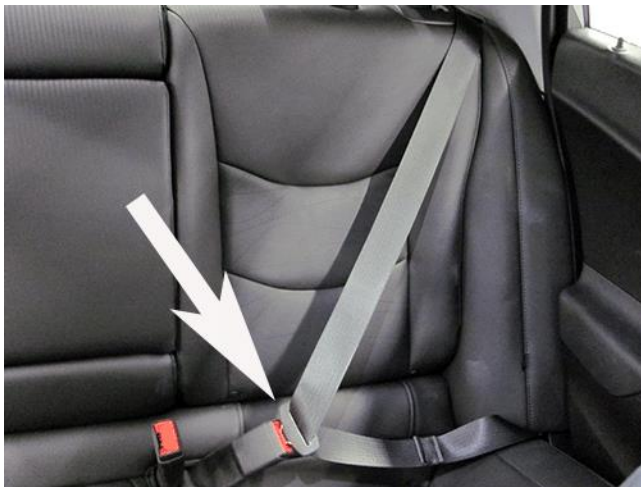
5149707

2. Pull the seatbelt out of the retractor and insert the latch plate into the buckle.

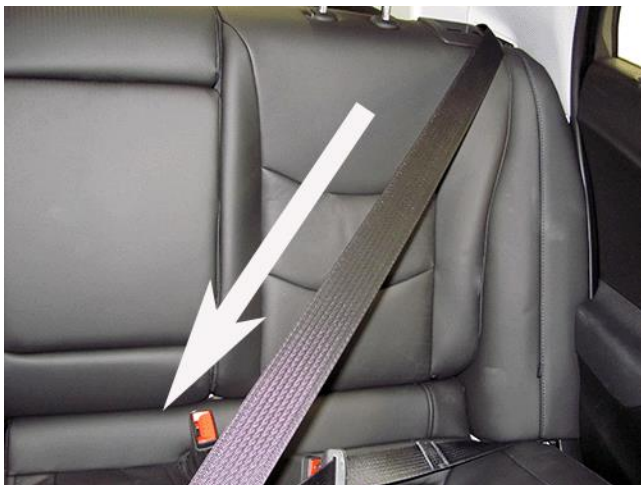
5149708

3. Pull the complete length of the seatbelt out until it reaches a hard stop.

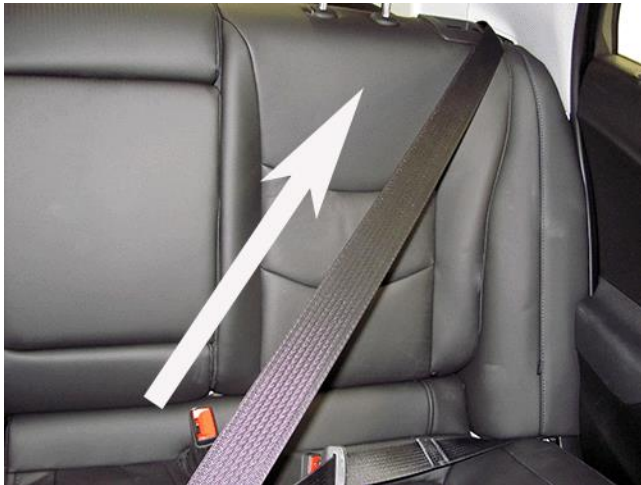
5149709

4. Allow approximately 12 inches (30 cm) of the belt to slowly retract back into the retractor (you will hear a ratcheting sound).
5. Firmly tug on the belt and verify that it locks and cannot be pulled out of the retractor.

6. Allow another 12 inches (30 cm) to retract into the retractor, firmly tug on the belt and verify that it locks and cannot be pulled out of the retractor.

7. Allow another 12 inches (30 cm) to retract into the retractor, firmly tug on the belt and verify that it locks and cannot be pulled out of the retractor.

- **If the seatbelt retractor locks without releasing six times in succession, no further action is required**, the belt system is performing as designed.

- **If the seatbelt fails to lock at any time during the six cycles, the seatbelt retractor assembly requires replacement.** Refer to *Rear Seat Belt Retractor Replacement* in SI.
