# Product Safety Recall

## N182204040 Seat Belt Buckle Rivet

**Release Date:** January 2019

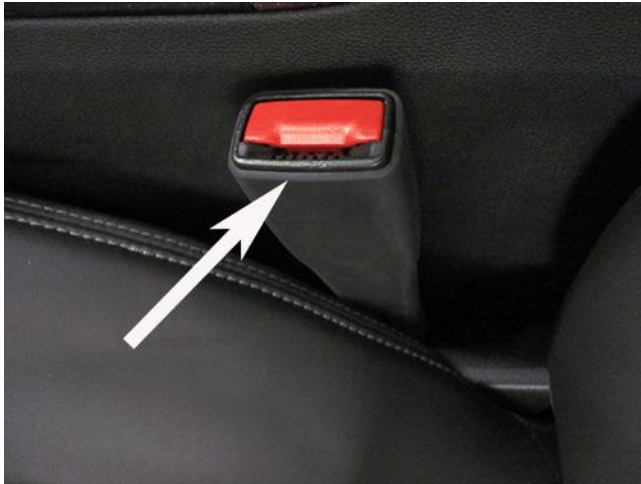
5199904

#### Buckle Retained in Sleeve

- If the buckle does not move out of the sleeve, no further action is required. Unlatch the buckle and return the belt to its original position.

1. Pull the driver side front seat belt out of the retractor. Insert the latch plate into the buckle until a “click” sound is heard. Position the belt as if buckled over an occupant.
2. Grasp the belt webbing at the buckle area, being careful to not grab the buckle itself, and pull straight away from the buckle with a firm tug (pull).
3. After applying the pull to the belt webbing, inspect the buckle for movement out of the buckle sleeve.

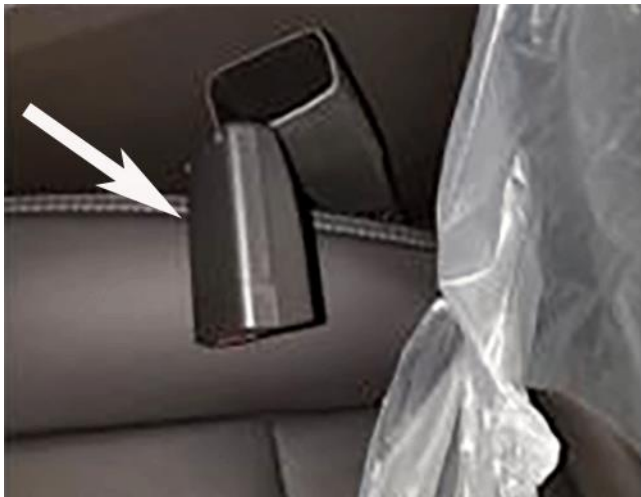
5199903

#### Buckle Pulled Out of Housing

- If the buckle pulls out of the sleeve, **replace the front seat belt buckle**. Refer to *Front Seat Belt Buckle Replacement* in SI.
