Product Safety Recall

N182204040 Seat Belt Buckle Rivet

Release Date: December 2018

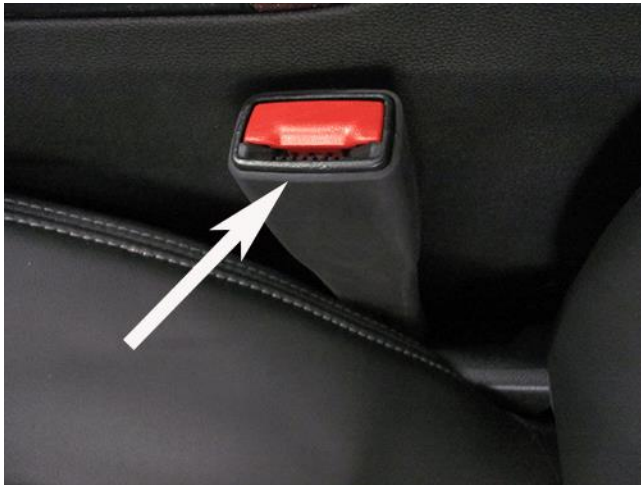
5199904

Buckle Retained in Sleeve

- If the buckle does not move out of the sleeve, no further action is required. Unlatch the buckle and return the belt to its original position.

1. Pull the driver side front seatbelt out of the retractor. Insert the latch plate into the buckle until a “click” sound is heard. Position the belt as if buckled over an occupant.
2. Grasp the belt webbing at the buckle area, being careful to not grab the buckle itself, and pull straight away from the buckle with a firm tug (pull).
3. After applying the pull to the belt webbing, inspect the buckle for movement out of the buckle sleeve.

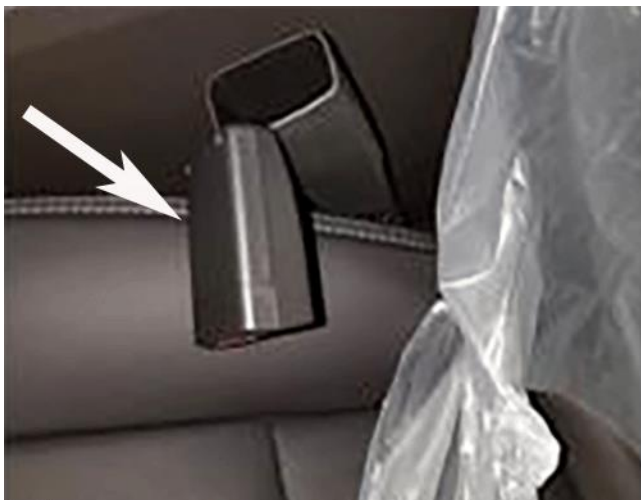
5199903

Buckle Pulled Out of Housing

- **If the buckle fails to remain locked in the sleeve, or pulls out of the sleeve in any way, the front seat belt buckle requires replacement.** Revised service parts are currently NOT available. This bulletin will be updated once revised service parts are available.
