SOP01734

Recall Repair of QAAR 9146: Unity DS Front Trans-mount Leveling Jack Bracket Realignment

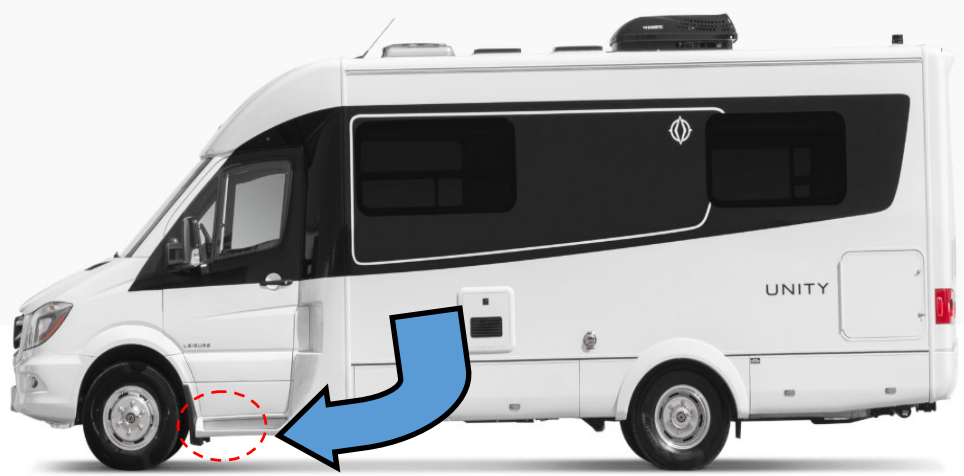
1

Locate the D.S front leveling jack trans-mount bracket under the coach.

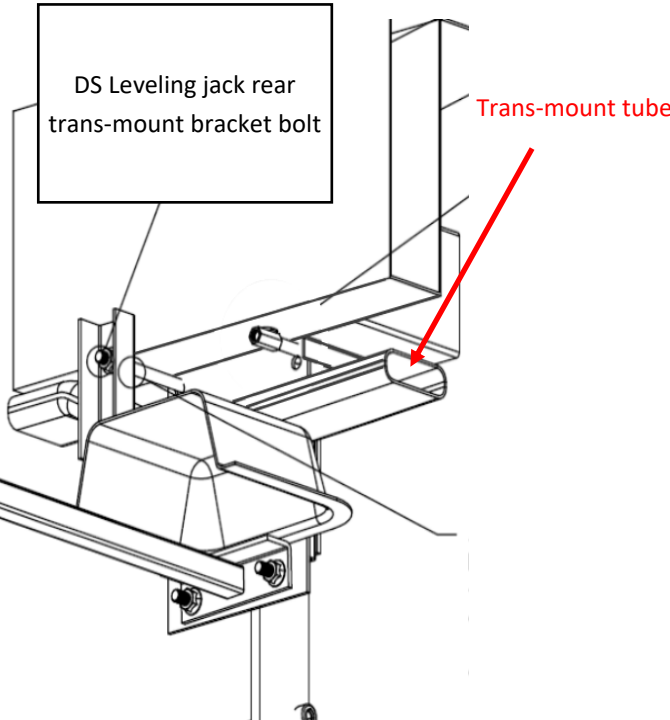
2

Look for the rear trans-mount tube jack bracket on the inner edge of the chassis frame.

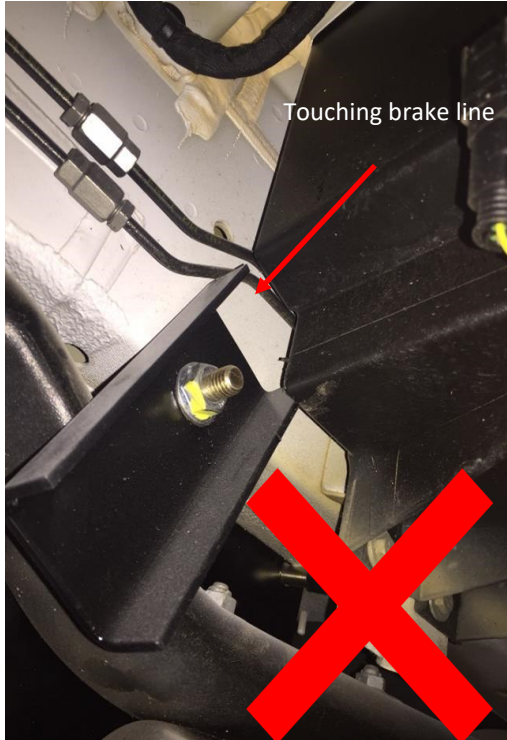
3

Inspect the brake line running along the inner chassis frame to verify that the bracket is not touching one of the lines. If bracket is clear of brake line no further action required.

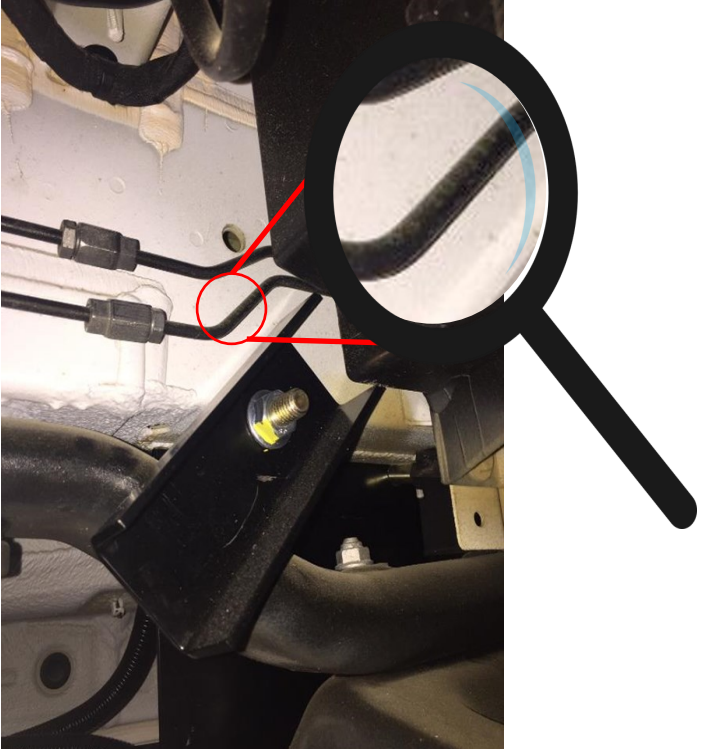
6

Inspect brake line for damage. If damage is found, contact Triple E at 1-877-992-9906 for further instructions.
