David J. Johnson
 Director
 Service Engineering Operations
 Ford Customer Service Division

SUBJECT: **Safety Recall 19S01 – Supplement #3**
 Certain 2005-2014 Mustang, 2005-2006 GT, 2007-2011 Ranger, 2006-2012 Fusion and MKZ/Zephyr, 2006-2011 Milan, and 2007-2010 Edge and MKX Vehicles
 Passenger Airbag Inflator Replacement

REF: **Safety Recall 16S26** - Passenger Airbag Inflator Replacement
Safety Recall 17S01 - Passenger Airbag Inflator Replacement
Safety Recall 18S01 - Passenger Airbag Inflator Replacement

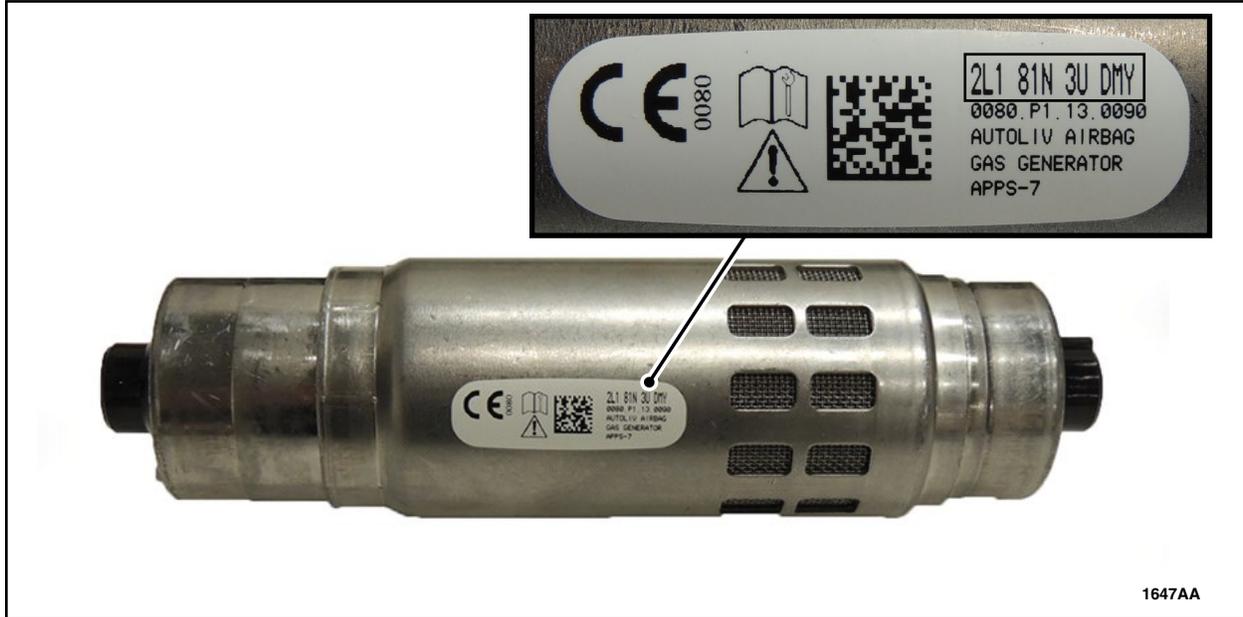
FIGURE 7

9. Record the 11 character serial number of the *new* airbag inflator on the repair order. See Figure 7.

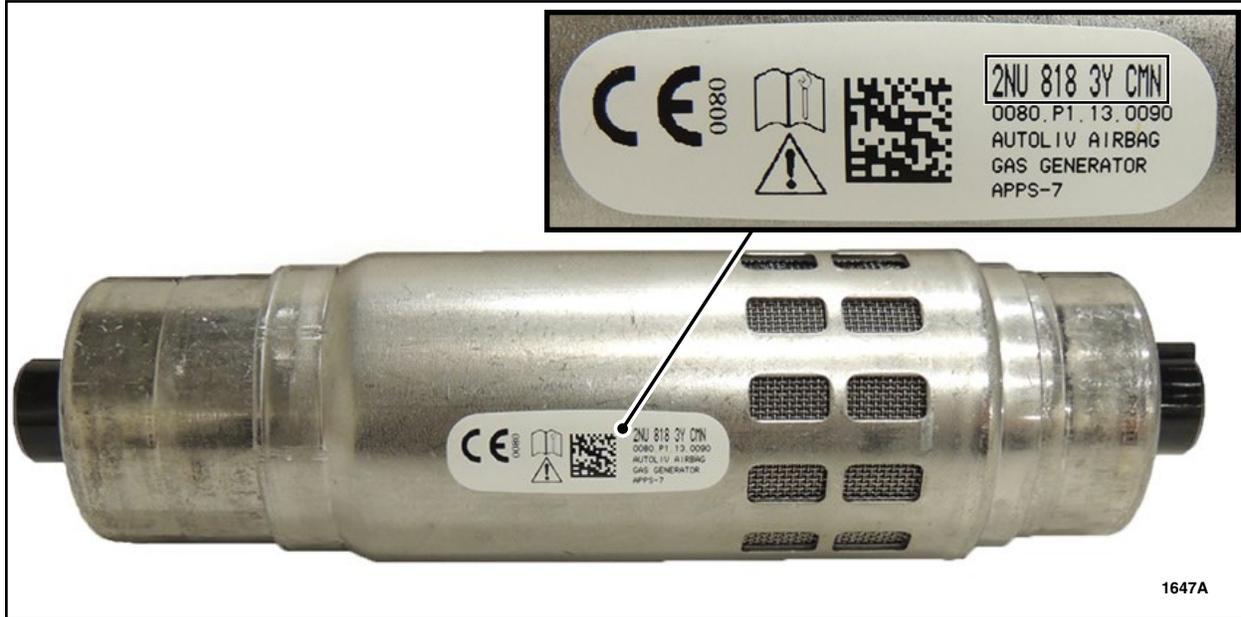
FIGURE 7

9. Record the 11 character serial number of the *new* airbag inflator on the repair order. See Figure 7.

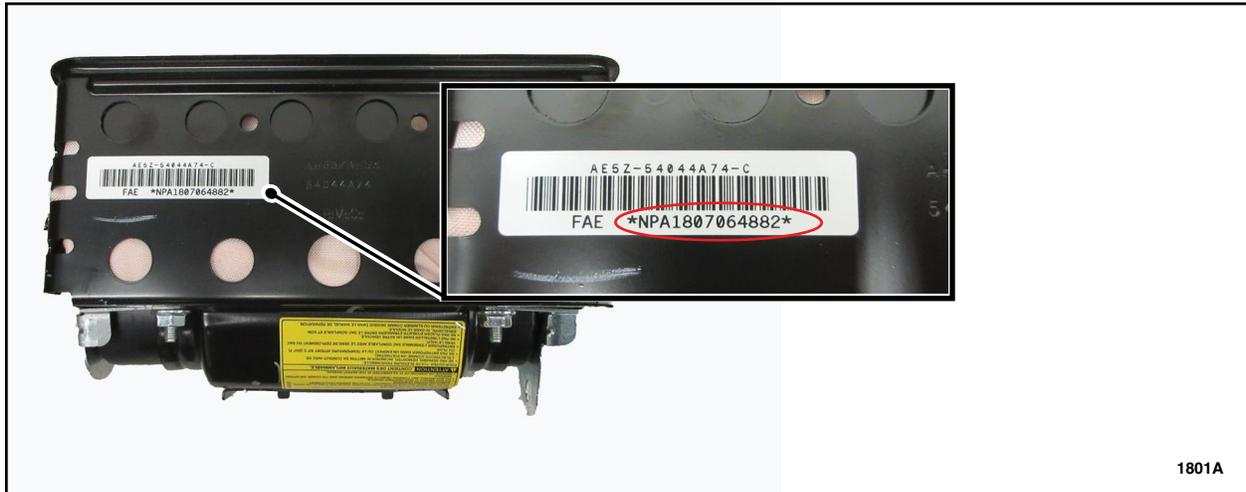
FIGURE 1

1. Record the 13 character serial number of the new airbag module on the repair order. See Figure 1.
