Recall Campaign Launch Notification			October 15, 2019
Campaign No. :	NHTSA ID	Campaign Desc. :	Replace Battery Mounting Bracket
2019090010	19V586	19P5490029	
<p>This is to notify you of a Recall Campaign Launch to update the battery mounting bracket on 26,584 Model Year (“MY”) 2018-2019 C-Class (205 platform) vehicles. The recall campaign will be visible on the www.safercar.gov website and may generate questions from customers. Affected VINs will be flagged in VMI as “OPEN” on October 15, 2019.</p>			
Background			
Issue	<p>Daimler AG (“DAG”), the manufacturer of Mercedes-Benz vehicles, has determined that on certain Model Year (“MY”) 2018-2019 C-Class vehicles (205 platform), the mounting bracket for the 12V starter battery might not have been manufactured according to current production specification. If the battery is not properly secured, it could shift and disconnect the terminals in the event of a crash. If this were to occur, the vehicle’s power supply would be interrupted, impairing different post-crash functionalities. Furthermore, if the battery detaches from the vehicle in a crash, it could become a road hazard. Either of these scenarios can increase the risk of injury.

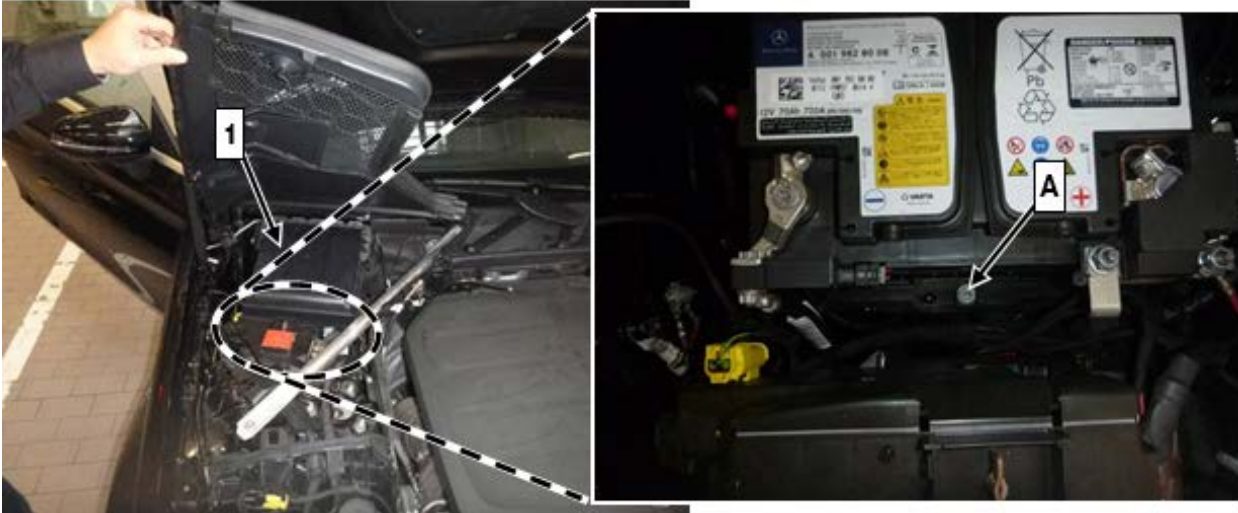
Figure 1

Daimler AG ("DAG"), the manufacturer of Mercedes-Benz vehicles, has determined that on certain Model Year ("MY") 2018-2019 C-Class vehicles (205 platform), the mounting bracket for the 12V starter battery might not have been manufactured according to current production specification. If the battery is not properly secured, it could shift and disconnect the terminals in the event of a crash. If this were to occur, the vehicle's power supply would be interrupted, impairing different post-crash functionalities. Furthermore, if the battery detaches from the vehicle in a crash, it could become a road hazard. Either of these scenarios can increase the risk of injury. An authorized Mercedes-Benz dealer will replace the battery mounting bracket on the affected vehicles.

1. Open hood and remove battery cover (1, figure 1).

2. Replace holder at battery frame (**Nm** 23 Nm A, figure 1).
i For basic data, see AR54.10-P-0005LW.
3. Assemble in reverse order.
