Wheel Nuts Safety Campaign

ROADSTER 2020-1 Wheel Nut May Crack_137073

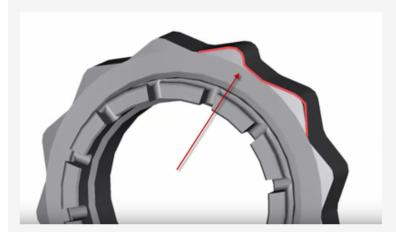
The new wheel nuts are designed with a new shape and look in order to define the difference between the new and previous nut * See below image.

The new nut 705402730 is now available, though it will be limited quantity for the coming weeks, we will be operating under a selective release system until we have enough parts available to ensure all dealers receiving a fair quantity of the wheel nuts, we will be putting priority for the first batch of wheel nut towards the southern states of the USA due to the fact that the first released units were shipped in these areas. Parts are already on his way to the international distribution center.

It is also important to know that the wheel nut tool and torque spec will be unchanged and that you will need to follow the shop manual and safety bulletin procedure along with this below is a quick video that can help with the procedure.
