***** IMPORTANT SAFETY RECALL 19E-069 *****
(RECORDATARIO IMPORTANTE PROGRAMA DE SEGURIDAD)

Recall Number and Description: 19E-069 – VOM74MM Mirror Monitor Field Repair

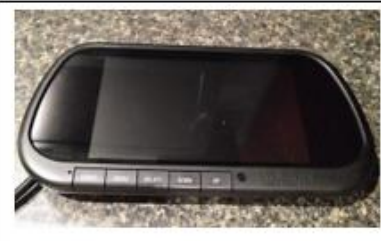
This recall condition relates to vehicles that have a **Relay/Capacitor Harness Module (PVOM74MMFFK)** installed under the seat in 2019 Sprinters and has a VOM74MM Mirror Monitor that has a serial number starting with "A", "B", "C", or "D".

This Relay/Capacitor Harness Module (13" long) was installed under the Driver's Seat (Sprinters)	VOM74MM Voyager Monitor: Relay/Capacitor Harness Module powers this Voyager Monitor	VOM74MM serial numbers that start with A, B, C, or D can be affected.

What is the issue? On your vehicle, it may be possible for the VOM74MM mirror monitor to not turn on or be intermittent. The driver may not have the ability to see behind the vehicle to avoid an object or person **increasing the risk of a crash**. Please utilize the side mirrors if the mirror monitor is not working until the repair is implemented. **This repair will be done free of charge.**

What are we asking you To Do? Please contact 1-877-384-4400 to arrange a VOM74MM Mirror Monitor replacement to Rev E (or F) and the removal of the Relay/Capacitor Harness Module free of all charges. ASA Electronics will be happy to work with your local dealer service center or fleet maintenance shop to schedule a successful repair. The VIN number and VOM74MM serial number will be required for ASA to supply the replacement monitor and supply the instruction to inspect/remove the Relay/Capacitor Harness Module.
