IMPORTANT SAFETY RECALL

Subject: NHTSA Campaign Number 19E-072

Models Affected: Hendrickson CONNEX ST trailer steerable suspension and axle systems with

PRODUCT BULLETIN – IDENTIFYING MOUNTING WASHER

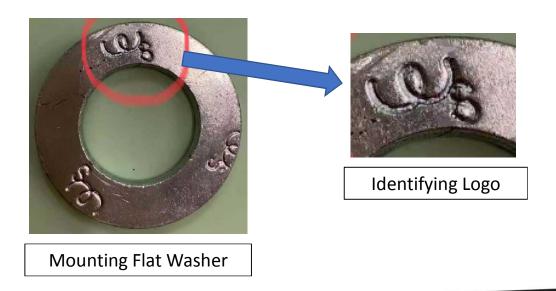
- This bulletin covers how to identify washers that may not conform to TSE's hardware specifications.
 - 1. Mounting Flat Washer with stamped logos (as pictured) may have compromised material properties. TSE recommends replacing the washer. Washers can be obtained from TSE free of charge.
 - 2. Washers without logos are not affected and can be used normally.
 - 3. Please reference TSE Brakes TSB#2019-001 for the proper procedure to replace washers.

- 1. Always block vehicle wheels when working on brake actuators to prevent vehicle rollaway.
- 2. Prior to removing or installing washers, insure the spring brake is caged.
- 3. Remove nut and washer from top side of bracket only.
- 4. Replace nut and washer on top side with new nut and washer supplied.
- 5. Torque nut to 133-155 ft-lbs. (180-210 Nm).
- 6. Remove nut and washer from bottom side of bracket only.
- 7. Replace nut and washer on bottom side with new nut and washer supplied.
- 8. Torque nut to 133-155 ft-lbs. (180-210 Nm).
