***** IMPORTANT SAFETY RECALL 19E-009 *****
(RECORDATARIO IMPORTANTE PROGRAMA DE SEGURIDAD)

Recall Number and Description: 19E-009 – VOM74MM Mirror Monitor Field Repair

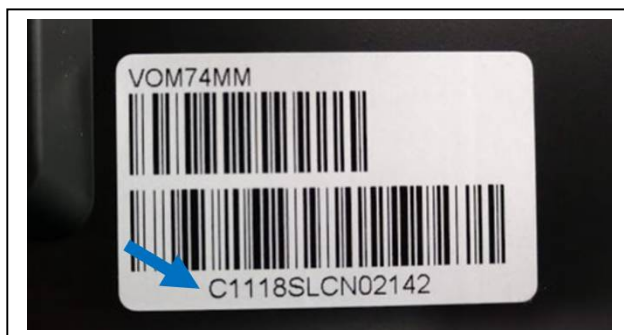
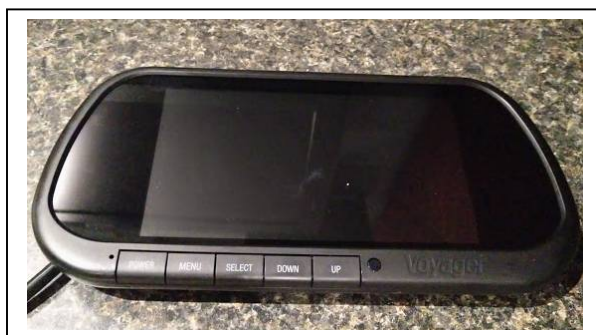
This recall condition only relates to vehicles that have the VOM74MM Mirror Monitor that has a serial number starting with “A”, “B”, or “C”.

What is the issue? On your vehicle, it may be possible for the VOM74MM mirror monitor (if the serial number starts with A, B or C) to power ON with an image that is reversed from what is expected. The driver may inadvertently turn the wrong direction to avoid an object behind the vehicle **increasing the risk of a crash**. Please utilize your side mirrors until the repair is implemented.

What are we asking you To Do? Please contact 1-877-384-4400 to arrange the repair of the VOM74MM monitor which includes adding a harness/relay/capacitor module free of all charges. ASA Electronics will be happy to work with your local dealer service center or fleet maintenance shop to schedule a successful installation. The VIN number, VOM74MM serial number, and Chassis Type will be required for ASA to supply the best repair kit and instruction.

Labor Time: Installation of the harness/relay/capacitor module may take up to 30 minutes. However, due to service scheduling times, your service provider may need your vehicle for a longer period.
