IMPORTANT SAFETY RECALL NOTICE

Subject: Can-Am® Ryker - Wheel nut may crack

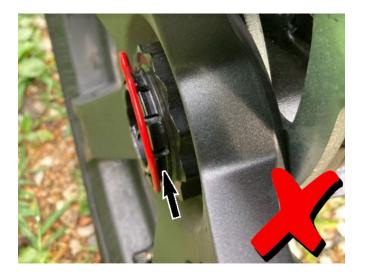
The wheel nuts may crack resulting in a reduced clamping force. This could affect the integrity of the wheel assembly and the vehicle's handling and control. This may increase the risk of a crash.

A properly installed red locking clip is sitting well into the groove all around the nut. If you see an installation like the picture below - red locking clip NOT installed properly, contact your dealer to organise transportation of your vehicle to the dealership.

RED LOCKING CLIP OUT OF THE GROOVE

BRP will repair your vehicle free of charge. The corrective action involves replacing the three wheel nuts. After the repair, your dealer will give you a copy of the MANDATORY CERTIFICATION FORM. This service should take less than one hour.

If the red locking clip is NOT well installed, do not drive your vehicle as you may lose a wheel while driving.
