Revision (8) October 2023

Dealer Service Instructions for:

Safety Recall V06 / NHTSA 19V-021 Drag Link

2014-2018	(DJ) RAM 2500 Pickup
2013-2018	(D2) RAM 3500 Pickup
2014-2018	(DD) RAM 3500 Cab Chassis
2016-2018	(DF) RAM 3500 10K LB. Cab Chassis

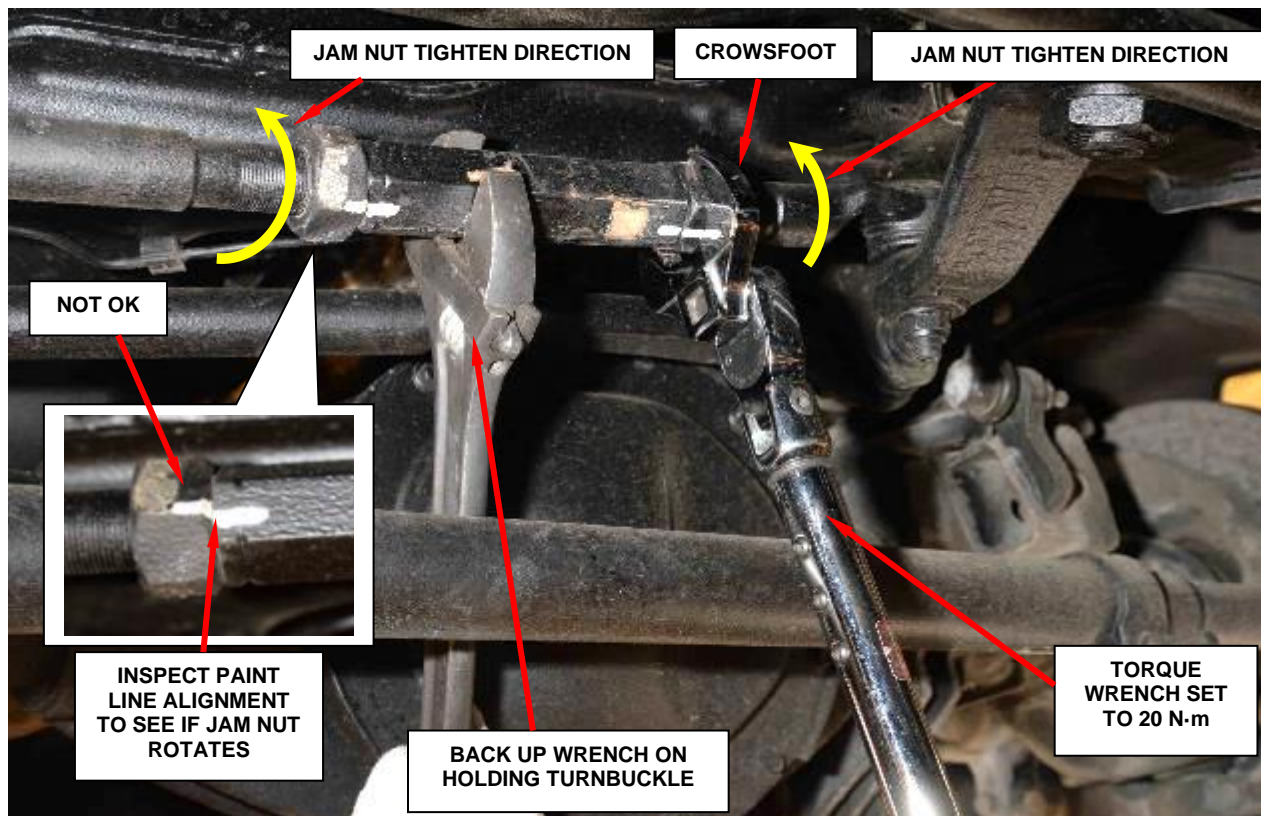
Figure 2 – Inspect for Jam Nut Movement

NOTE: If using a digital torque wrench during the inspection, observe the torque wrench digital reading to determine if minimum torque of 20 N·m (15 ft. lbs.) is achieved.

NOTE: Some jam nut movement may occur when tightening from 20 N·m (15 ft. lbs.) to 148 N·m (109 ft. lbs.). **DO NOT** replace the drag link if initial 20 N·m (15 ft. lbs.) is achieved.

6. Rotate each jam nut **in direction as shown** (tightening direction) until wrench clicks or 20 N·m (15 ft. lbs.) is achieved (Figure 2).
 - If paint lines **do not** show nut rotation, continue to section **C. Weld Turnbuckle Jam Nuts.**
 - If either paint line **shows** nut rotation, continue to section **B. Measure Drag Link Assembly Threads.**

10. Using a backer wrench and a 41 mm crowsfoot, such as Special Tool 2069400190 (Snap-on SCOM41) or equivalent, set a torque wrench to 105 N·m (77 ft. lbs.) and attempt to loosen each jam nut (ref: Figure 2 for set-up).
 - If both jam nuts **do not** rotate (breakaway), continue to step 11.
 - If **either jam nut rotates** (breakaway), **repeat Steps 5 through 10 on a different turnbuckle flat.**
11. Paint the area to prevent rust using MS-PF-1-25 black paint or equivalent.
12. Remove the supports and lower the vehicle.
13. Connect the negative battery cable and return the vehicle to the customer.

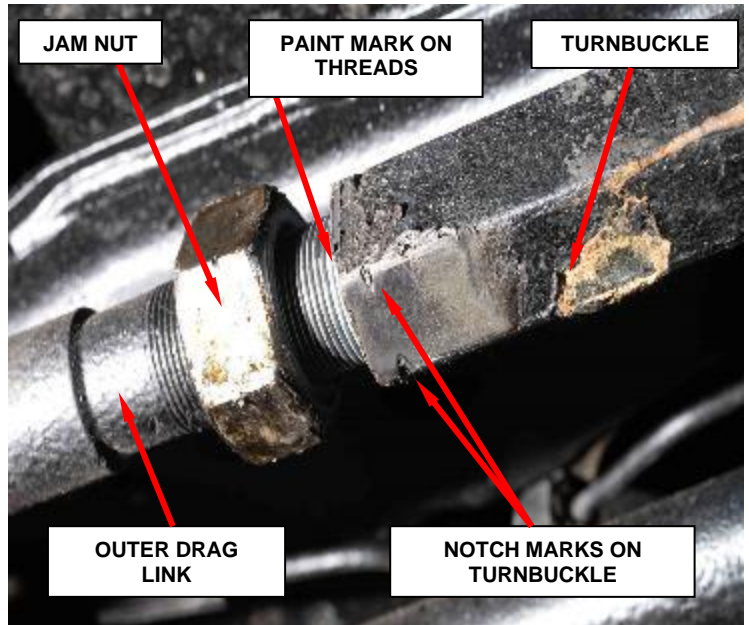
Figure 3 – Paint Mark on Threads

1. Back off both jam nuts enough to paint mark threads.
2. Paint mark threads of outer drag link at turnbuckle (Figure 3).

NOTE: Turnbuckle end with notch marks on hex goes toward the outer drag link.

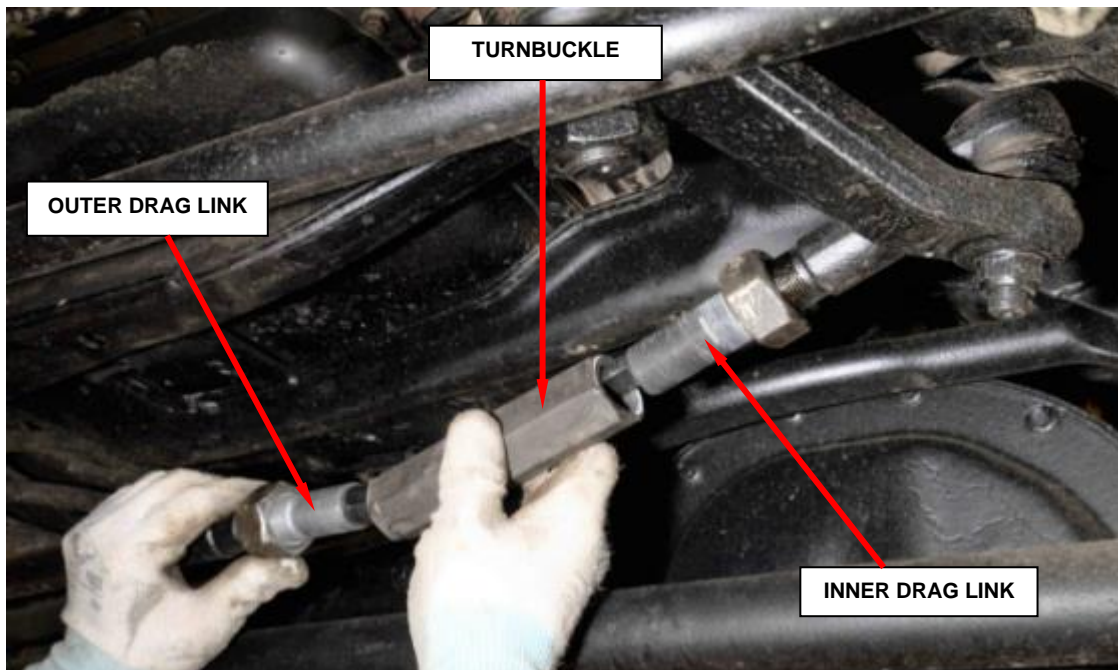
Figure 4 – Remove Turnbuckle

3. Remove the turnbuckle from the inner and outer drag links (Figure 4).

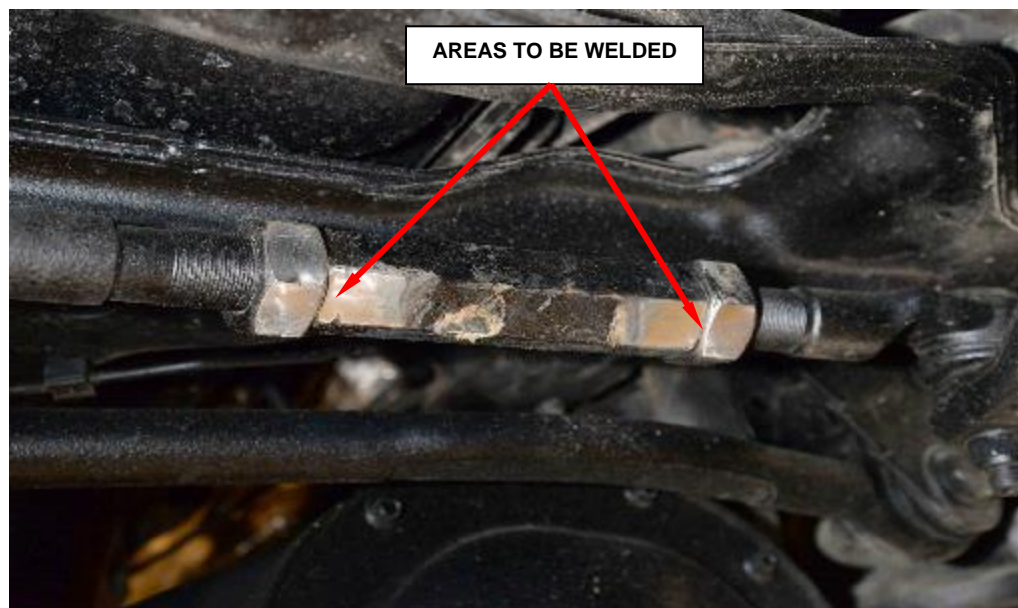
Figure 7 – Clean the Areas to be Welded

5. Clean the areas to be welded. Areas must be free of dirt, oil, water, salt, undercoating, moisture or any other contaminant that would affect the weld, then wire brush the area (Figure 7).

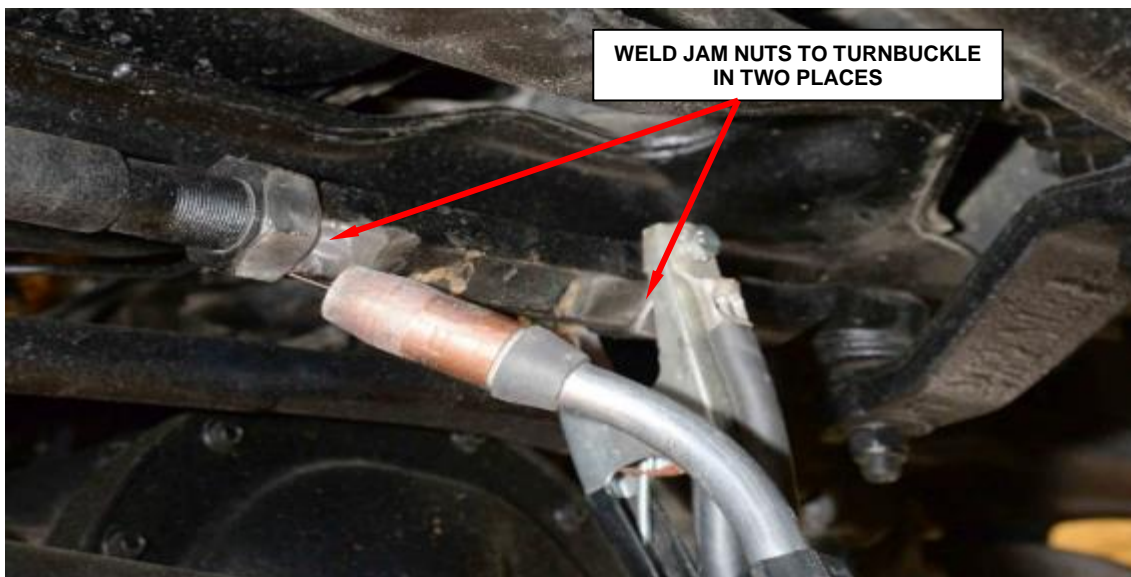
Figure 9 – Weld Both Jam Nuts to the Turnbuckle

7. Using a Lincoln Powerwave 350 Flux Cored Arc Weld (MIG) or equivalent GMAW (MIG) welding machine (140-150 amps), apply a **17mm long weld the length of one turnbuckle flat on each jam nut** (Figure 9).

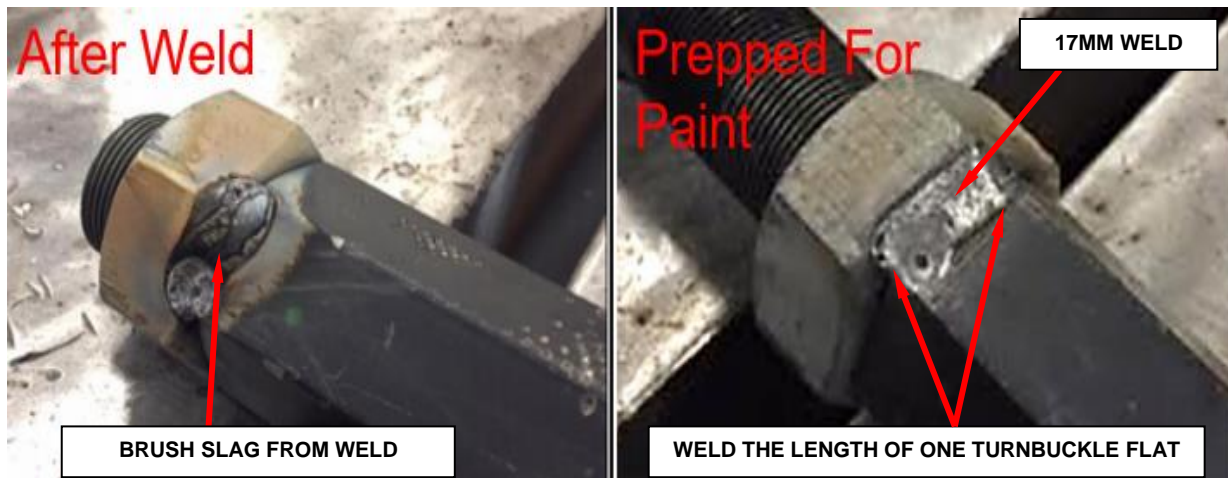
Figure 10 – Prepare areas for Paint

8. Wire brush the slag from the surface of the welds (Figure 10).
9. Allow to cool to room temperature.

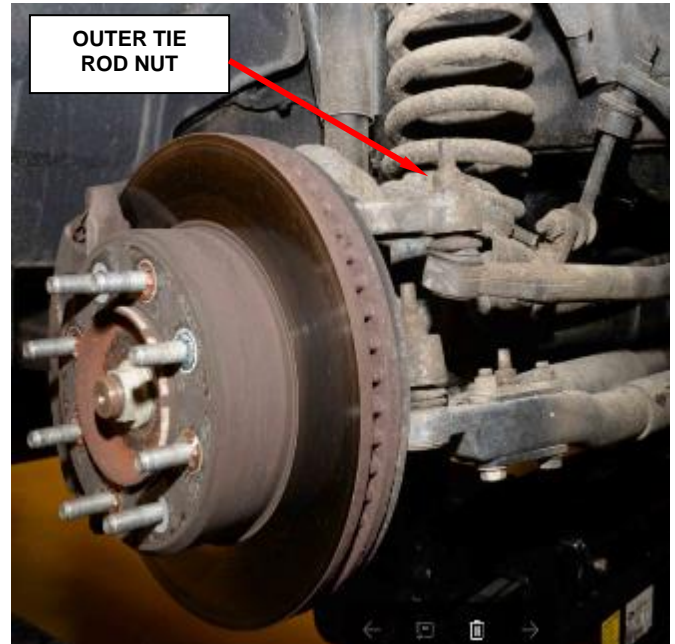
Figure 11 – Outer Tie Rod

1. Raise and support the vehicle.
2. Remove the right front tire and wheel assembly.
3. Remove and **DISCARD** the outer drag link to tie rod nut (Figure 11).
4. Remove the outer drag link tie rod from the knuckle using C-3894-A (puller shown in Figure 12).

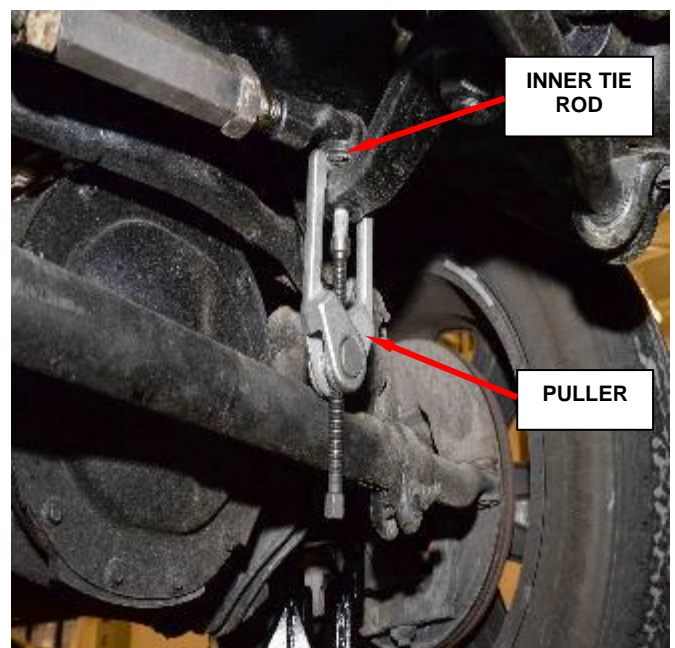
Figure 12 – Inner Tie Rod

5. Remove and **DISCARD** the inner drag link to pitman arm nut (Figure 12).
6. Remove the inner tie rod end from the pitman arm using special tool C-3894-A (Figure 12).
7. Remove and **DISCARD** the drag link assembly.

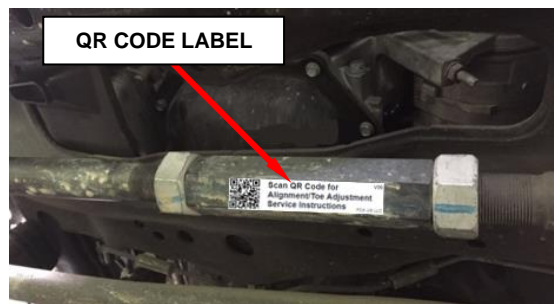
Figure 15 – QR Code Label Placement

Owners are receiving a pair of QR code labels that link to the service procedure. One label should be applied to the drag link adjuster sleeve (Figure 15) and the second can be saved, used as a replacement, applied to the owner's manual, door opening, or other location at owner's discretion.

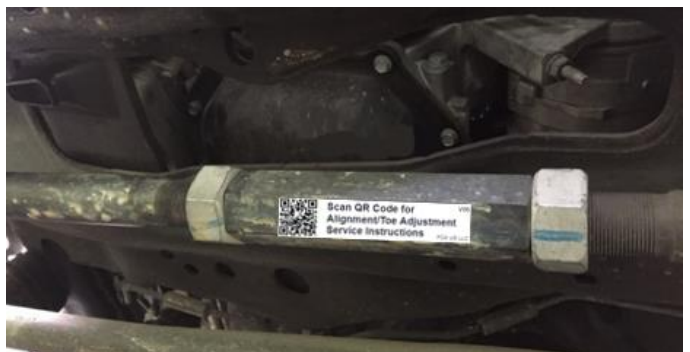
Apply provided label to drag link adjuster sleeve for reference during vehicle alignment. *(Prior to applying label, ensure surface has been cleaned and is fully dry.)*

Tie Rod: With the drag link nuts welded and the steering wheel/steering gear locked on center, the dealer will adjust the tie rod to align the wheels to the steering wheel.

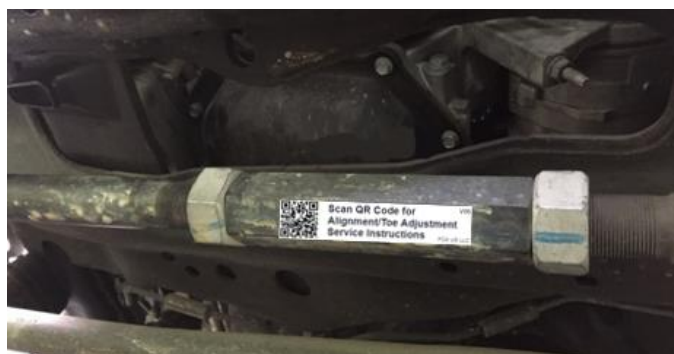
Apply provided label to drag link adjuster sleeve for reference during vehicle alignment. (Prior to applying label, ensure surface has been cleaned and is fully dry.)

Tie Rod: With the drag link nuts welded and the steering wheel/steering gear locked on center, the dealer will adjust the tie rod to align the wheels to the steering wheel.
