Revised (1) March 2019

Dealer Service Instructions for:

Safety Recall V06 / NHTSA 19V-021

Drag Link

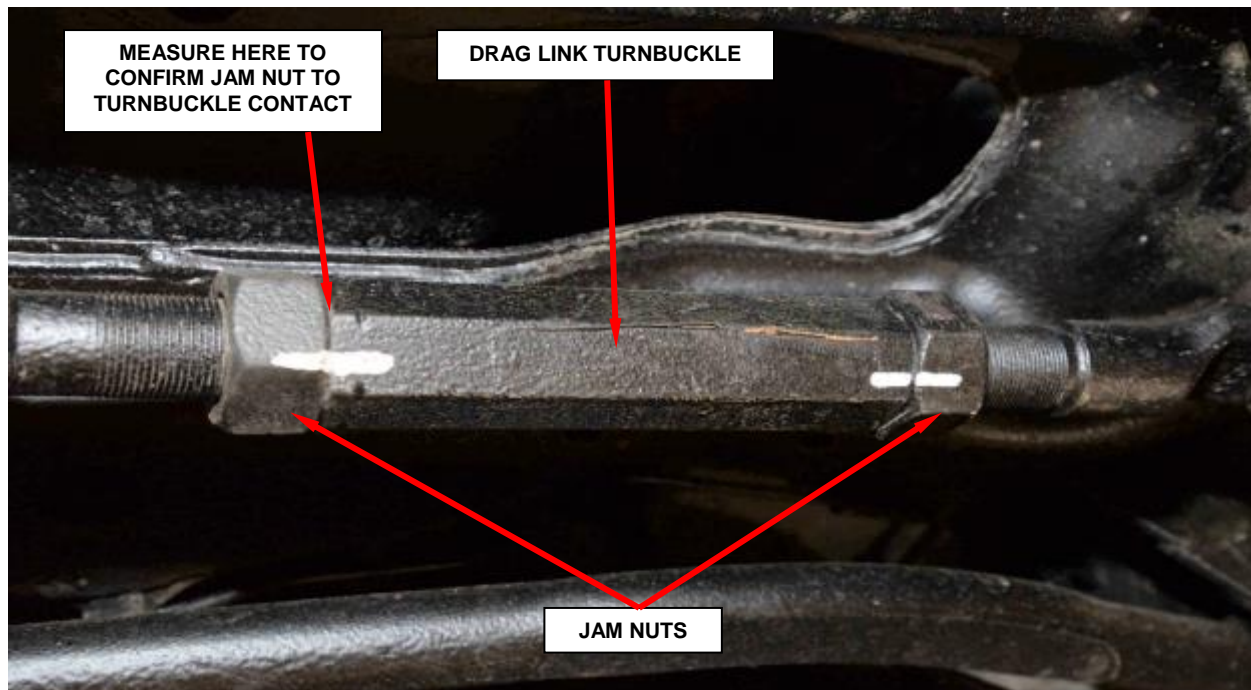
Figure 1 – Mark Jam Nuts and Turnbuckle

1. Inspect the drag link assembly for drag link to turnbuckle separation.
 - If no separation is observed, continue to Step 2.
 - If the vehicle was towed in and separation has occurred, continue to section **D. Replace Drag Link Assembly.**
2. Using a .020” feeler gauge, confirm jam nut contact to drag link turnbuckle. If no contact is noted, proceed to section **B. Measure Drag Link Assembly Threads** (Figure 1). **Jam nut to turnbuckle gap is not considered separation.**
3. Using a paint pen or equivalent, mark both jam nuts and turnbuckle with lines (Figure 1).
4. Hold the drag link turnbuckle with back-up wrench (Figure 2).
5. Using a 41 mm crow'sfoot, such as Special Tool 2069400190 (Snap-on SCOM41) or equivalent, set a torque wrench to 20 N·m (15 ft. lbs.) (Figure 2).

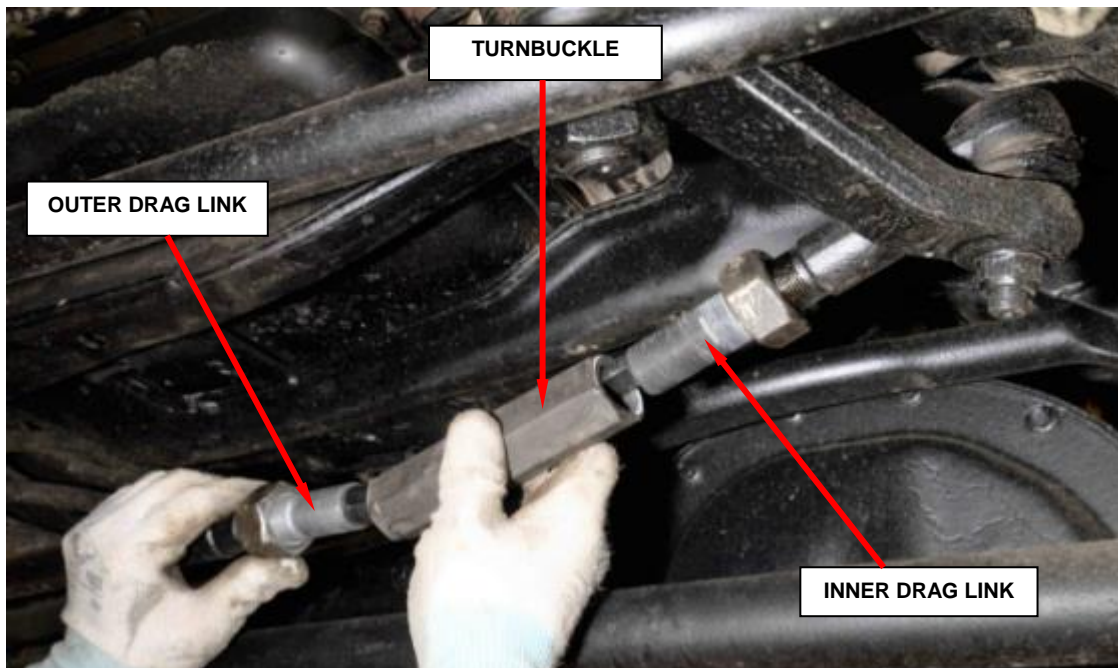
Figure 4 – Remove Turnbuckle

3. Remove the turnbuckle from the inner and outer drag links (Figure 4).

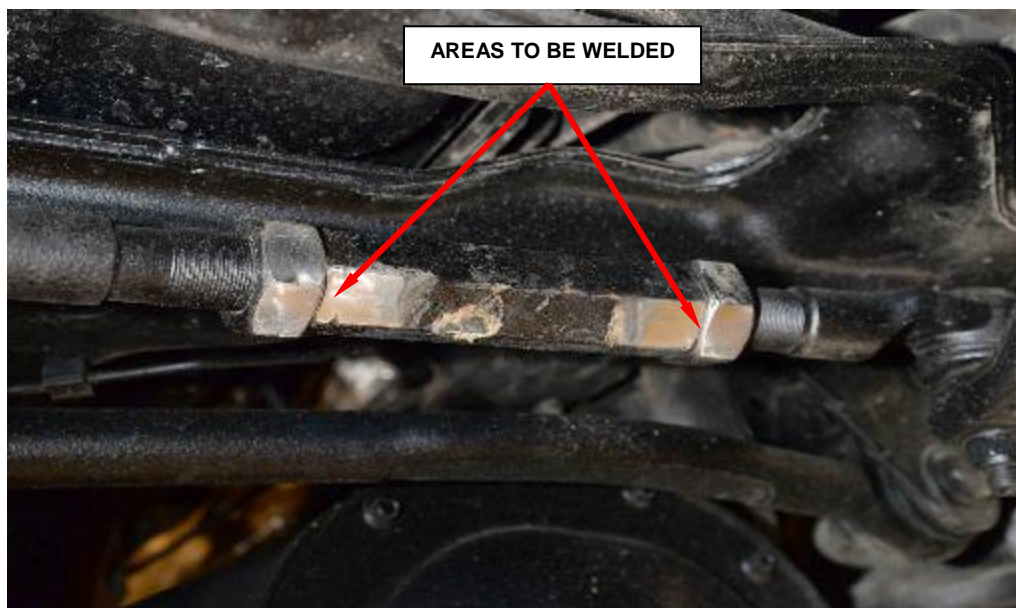
Figure 7 – Clean the Areas to be Welded

- Comply with all federal, state and local regulations to avoid any injuries due to shock, fires, fumes, sparks and liquids.
 - All flammable materials or liquid should be stored in tightly sealed and labeled containers, and used only in well ventilated areas.
 - No spark producing equipment should be permitted in any area where flammable materials are being handled or stored.
5. Clean the areas to be welded. Areas must be free of dirt, oil, water, salt, undercoating, moisture or any other contaminant that would affect the weld, then wire brush the area (Figure 7).

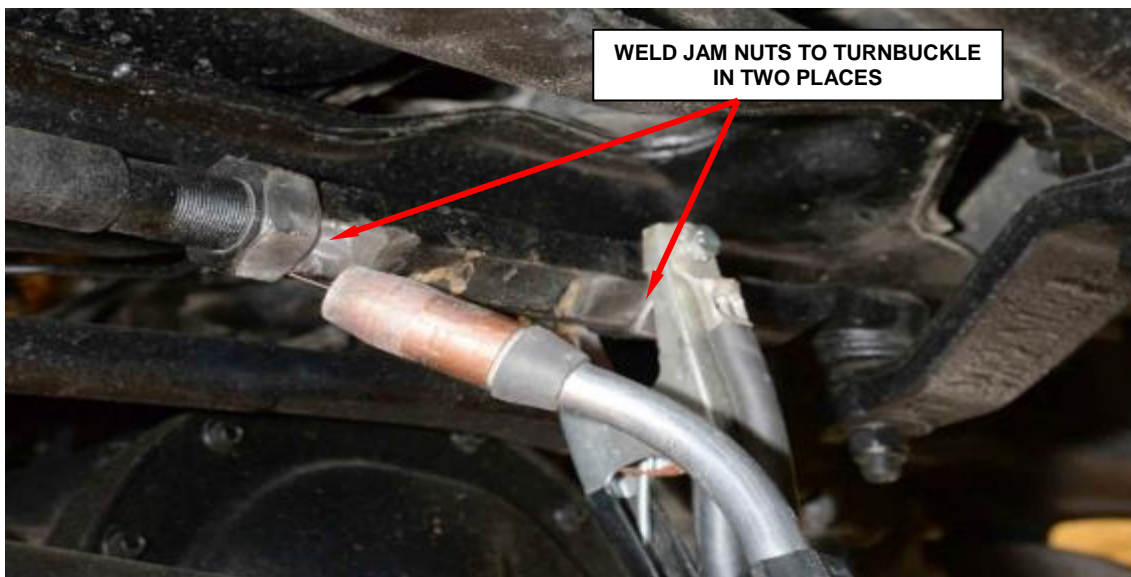
Figure 9 – Weld Both Jam Nuts to the Turnbuckle

7. Using a Lincoln Powerwave 350 Flux Cored Arc Weld (MIG) or equivalent GMAW (MIG) welding machine (140-150 amps), apply a 17mm long weld the length of one turnbuckle flat on each jam nut (Figure 9).

<p>Travel Angle 5 Degree Drag (+ 5 Degrees - 0 Degrees)</p> <p>Work Angle 45 Degrees from Turn Buckle</p>
Program:	Mode # 6 FCAW-S (Standard CV)	Electrode Type:	NR-211-MP (AWS E71T-11)	
Robot Description:	N/A	Electrode Diameter:	0.035"	
Electrical Stickout:	10 - 12 mm	Polarity:	DC Electrode Negative Part Positive	
Purge Time:	N/A	Shielding Gas Mixture:	N/A	
Hot Start:	N/A	Shielding gas flow:	N/A	
Travel Speed:	Manual 8 ipm approx.	Torch Type:	Tregaskies	
Voltage:	19 Volts	Nozzle Dia.:	N/A	
Wirefeed Speed:	200 ipm	Weave Data:	N/A -Stringer Only	
Amperage	140 -150 amps	Joint Design:	2F - 3F	
	N/A	Arc Transfer Type:	Constant Voltage (MIG)	
	N/A	Leg 1 Material Thickness:	N/A	
	N/A	Leg 2 Material Thickness:	N/A

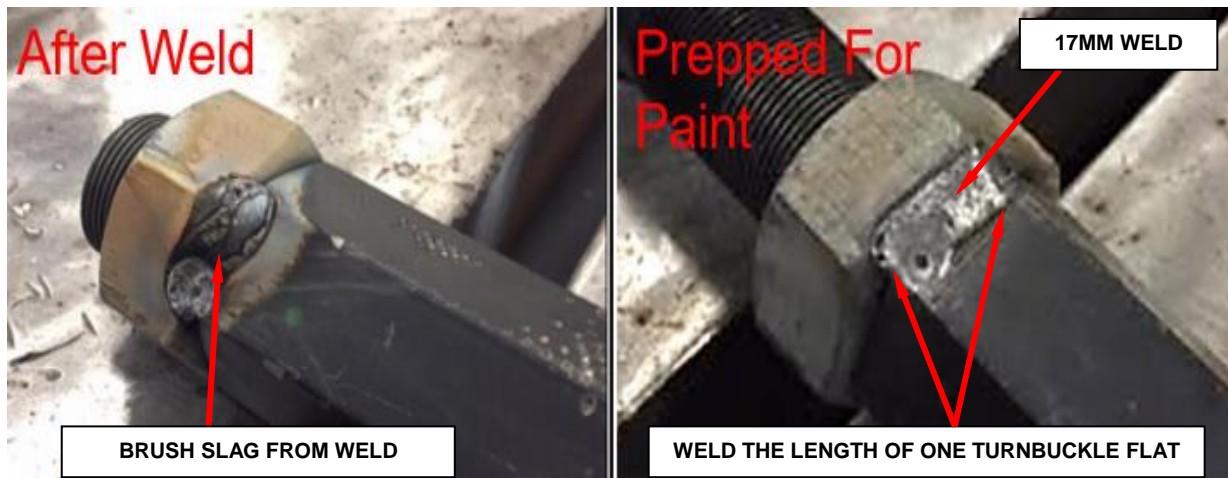
Figure 10 – Prepare areas for Paint

8. Wire brush the slag from the surface of the welds (Figure 10).
9. Allow to cool to room temperature.

NOTE: Each jam nut must hold a breakaway torque of 105 N·m (77 ft. lbs.).

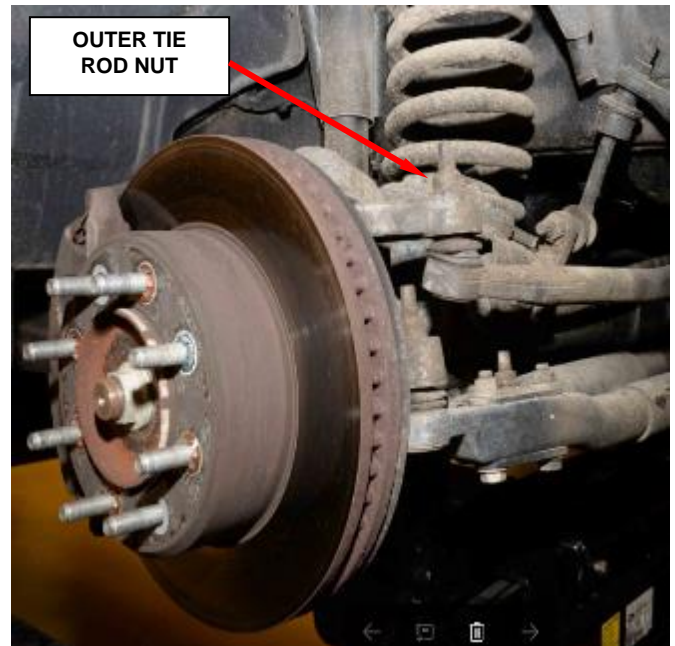
Figure 11 – Outer Tie Rod

1. Raise and support the vehicle.
2. Remove the right front tire and wheel assembly.
3. Remove and **DISCARD** the outer drag link to tie rod nut (Figure 11).
4. Remove the outer drag link tie rod from the knuckle using C-3894-A (puller shown in Figure 12).
