Dealer Service Instructions for:

Safety Recall V06 / NHTSA 19V-021 Drag Link

The drag link on about 795,000 of the above vehicles may have been built with an outboard steering linkage jam nut that could loosen allowing one end of the drag link to separate from the adjuster sleeve. A drag link separation can result in a loss of directional steering control, which can cause a vehicle crash without prior warning.

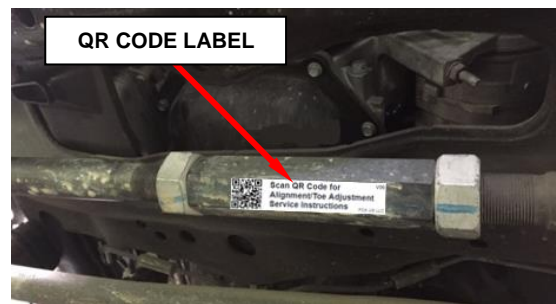
Figure 15 – QR Code Label Placement

Owners are receiving a pair of QR code labels that link to the service procedure. One label should be applied to the drag link adjuster sleeve (Figure 15) and the second can be saved, used as a replacement, applied to the owner's manual, door opening, or other location at owner's discretion.

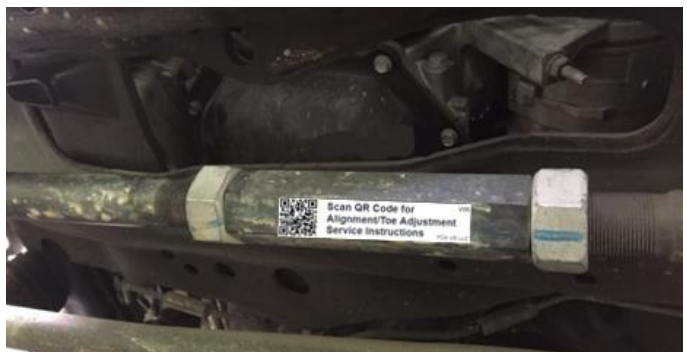
Apply provided label to drag link adjuster sleeve for reference during vehicle alignment. *(Prior to applying label, ensure surface has been cleaned and is fully dry.)*
