# Keystone RV Company

## SAFETY ADVISORY # 19-346

### Redwood MORryde Pin Box

## MORryde Rubber Pin Box

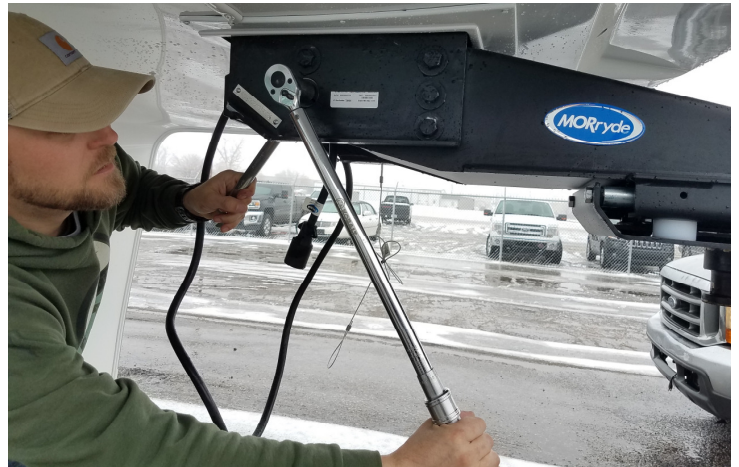
### Step 2:

Set the torque wrench to 135ft-lbs, use the 15/16" deep well socket and torque all 10 bolts that mount the pin box to the trailer frame. Keep the nuts from moving by using a 15/16" wrench.

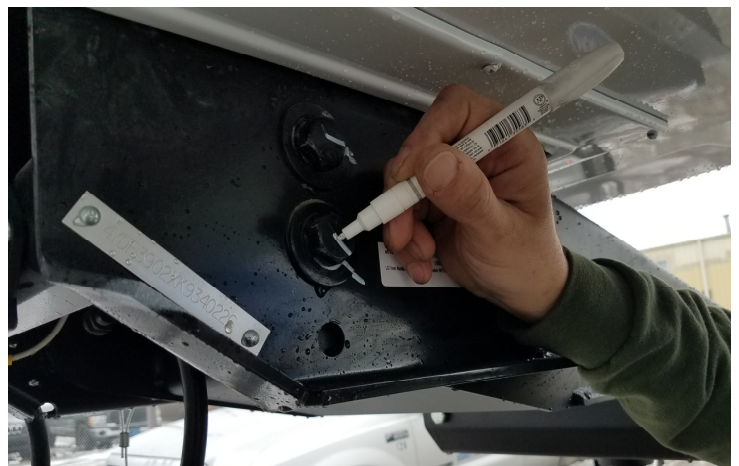
### Step 3:

Use a paint marker and torque mark all bolts.
