March 8, 2019

Version 2

Safety Recall: Driver's Airbag Replacement Inflator Can Be Over-Pressurized

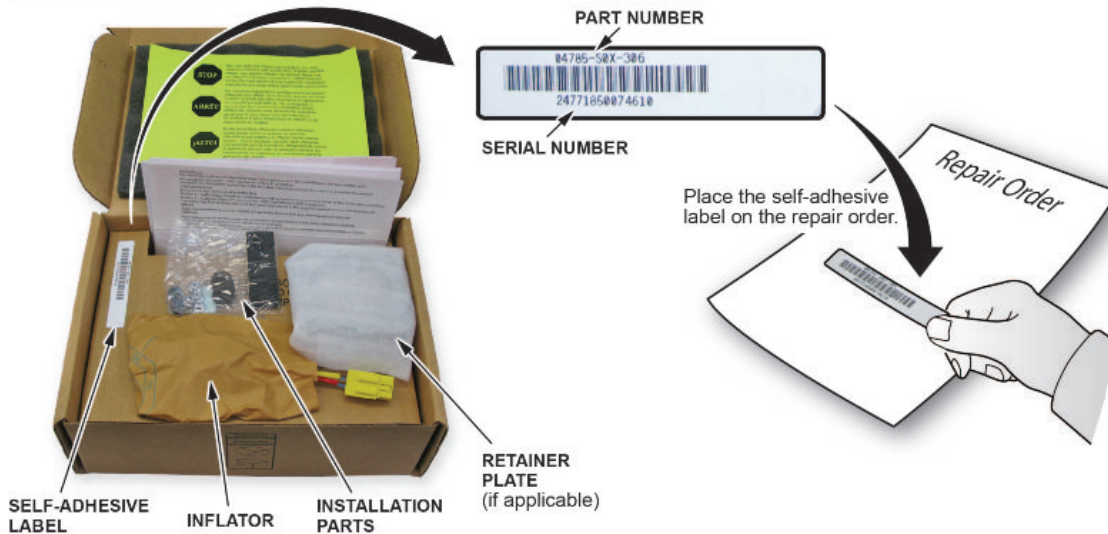
INFLATOR PARTS BOX

- The replacement part number is printed on the top part of the label and the serial number is printed on the bottom. **Make sure you attach the label to the RO and give it to the warranty clerk.**
- There may also be a colored sticker located in the kit, ignore it because it is not used.
- Not all inflator kits have a label included. In those cases, write the serial number and part number from the side of the inflator box on the RO. The part number always starts with 047.

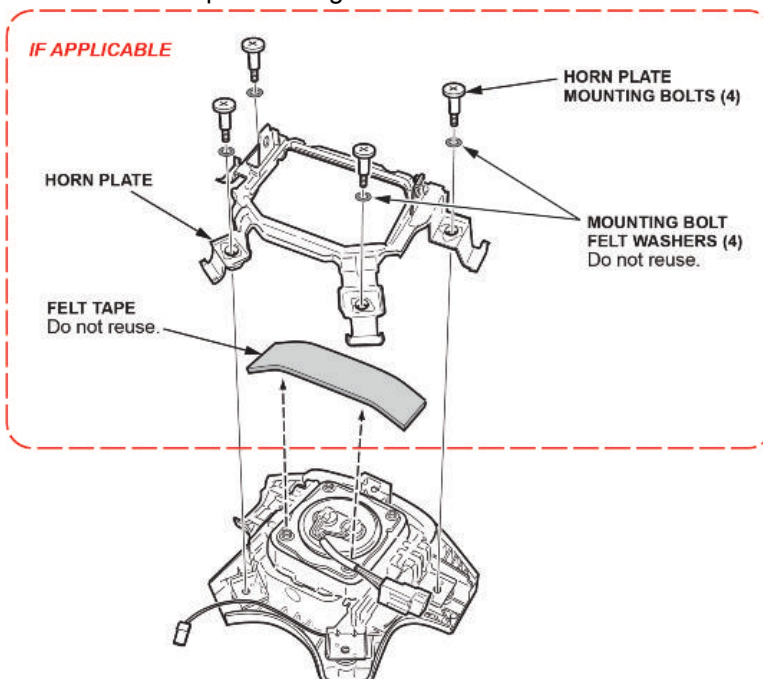
6.1. Type 1

- 6.1.1. Remove the four horn plate mounting bolts, the mounting bolt felt washers, the horn plate, and remove the felt tape covering the lower two inflator locknuts. The felt washers and felt tape will not be reused.

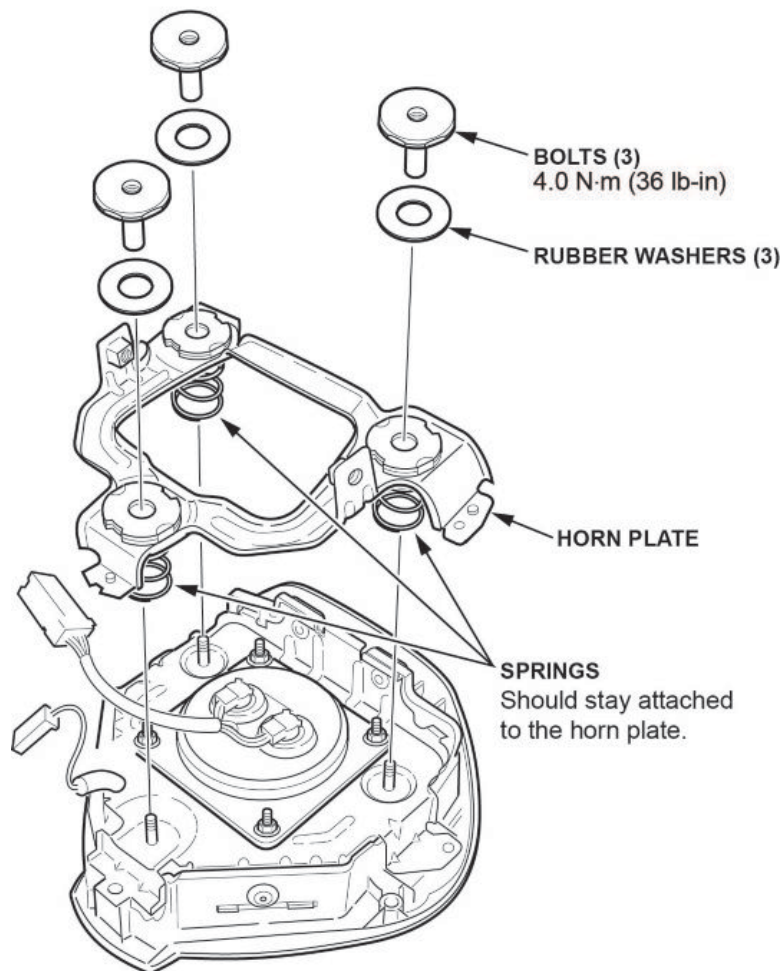
6.2. **Type 2 - 2013-16 ILX, 2013-14 ILX Hybrid, 2013-16 RDX**

6.2.2. Remove the 3 bolts. Make sure you do not drop or lose the 3 black rubber washers.

6.2.3. Remove the horn plate. Be careful that the 3 springs stay attached to the horn plate. If the springs come loose, reinstall as needed and set aside the horn plate and components until reassembly.

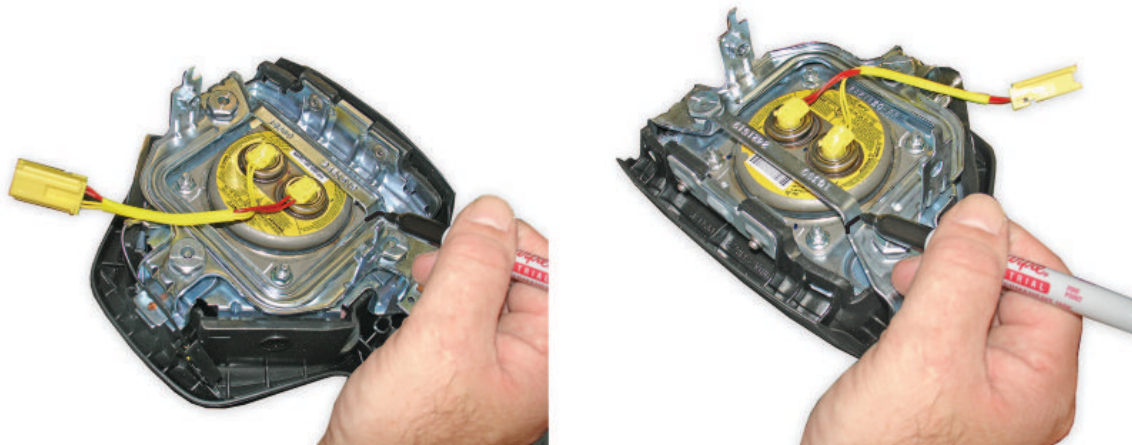
6.3.1. Using a marker, draw a line on the horn plate as shown.

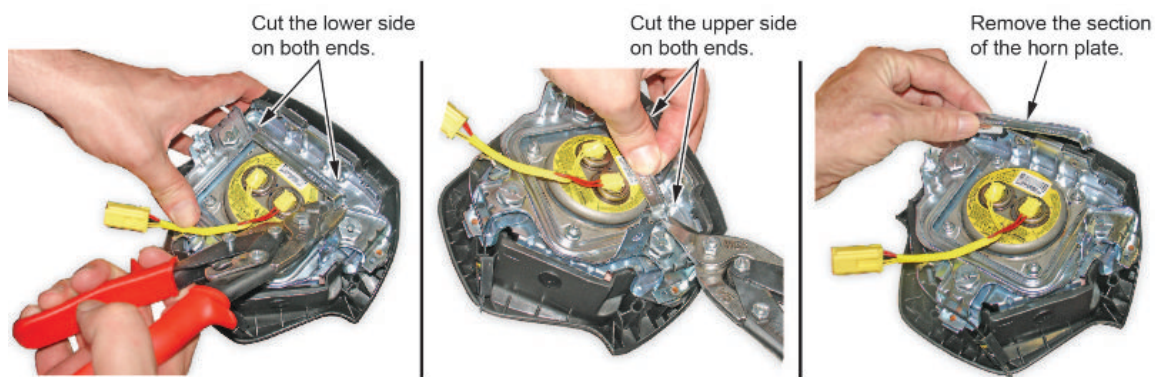
6.3.2. Using the snips, cut along the line drawn.

Always use sharp snips. If they are dull and you twist or wiggle them back and forth, you may warp the horn plate, which would require a new airbag module.

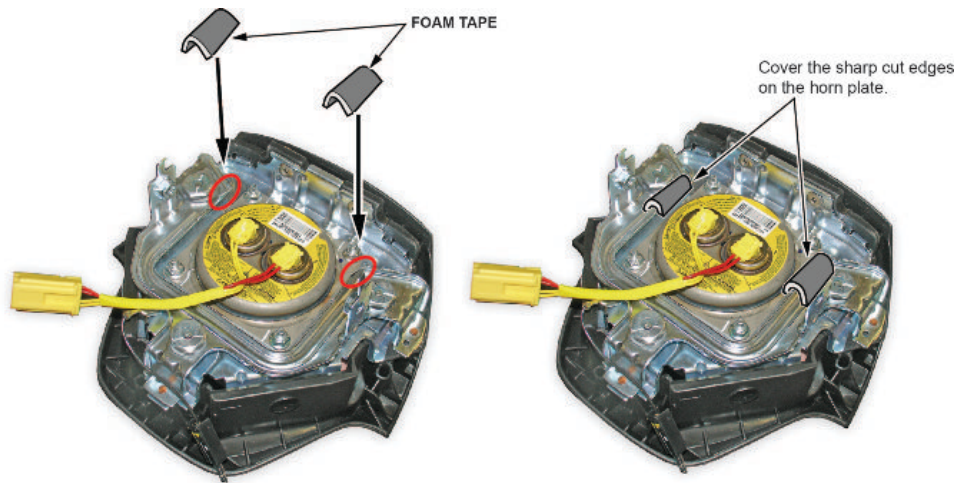
6.3.3. Take the felt tape and cut it into two pieces. Apply to the cut surface for protection.

- Do not file the metal edges.
- Make sure the felt tape does not interfere with the horn plate or horn plate springs.

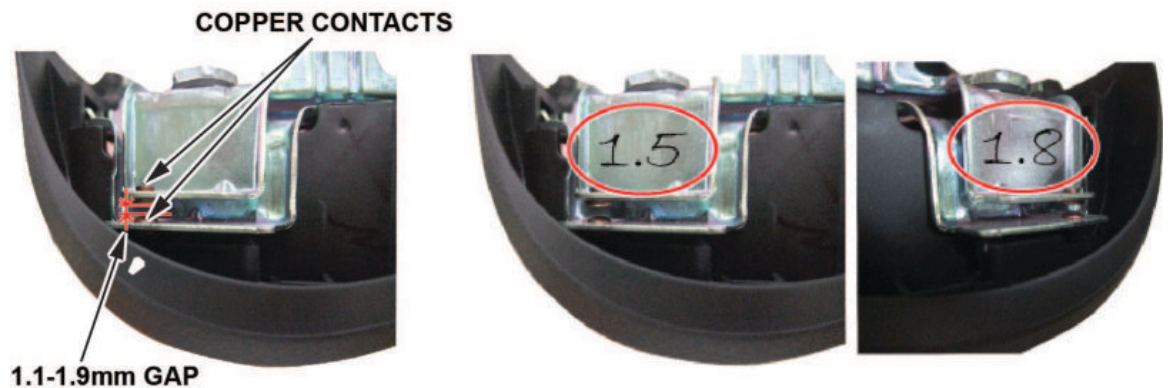
6.3.4. Measure the space between the two copper contacts on the horn plate as shown. The space should be between 1.1 and 1.9 mm.

- If the spaces are within specification, write the measurements on the side of the horn plate.
- If either of the spaces is out of specification, try to correct it. If the space is too large, use a pair of pliers to close the space, or if the gap is too small, use a flat headed screwdriver to open it up so that the copper contacts are within specification. Write down the measurement on the side of the horn plate.

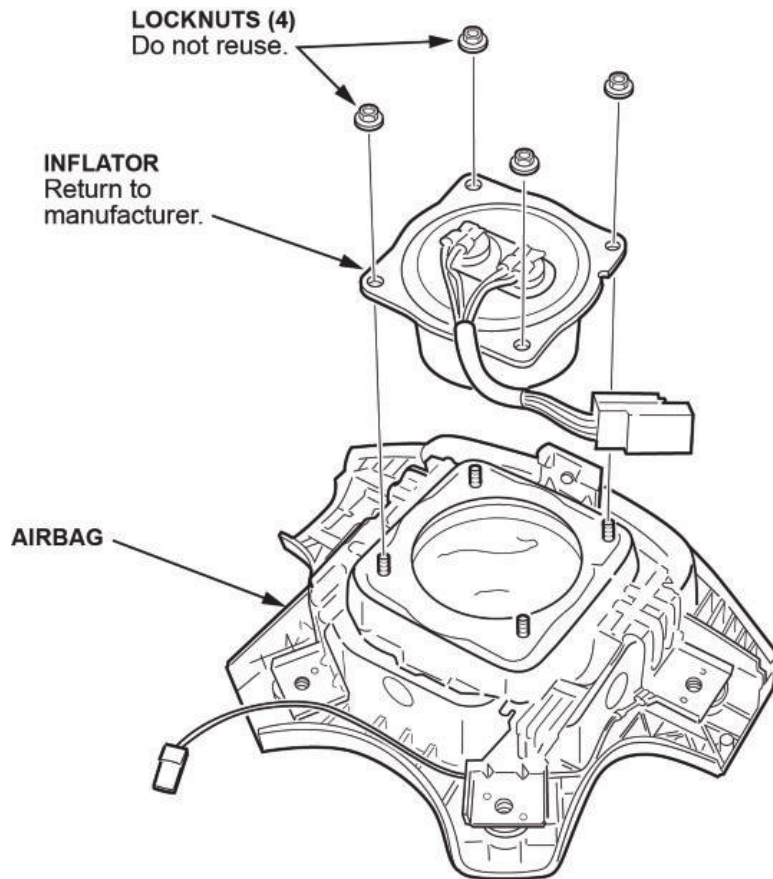
7. Using needle-nose vise grips or a 3/8 in. 6-point socket, remove the four locknuts from the inflator. The locknuts will not be reused.

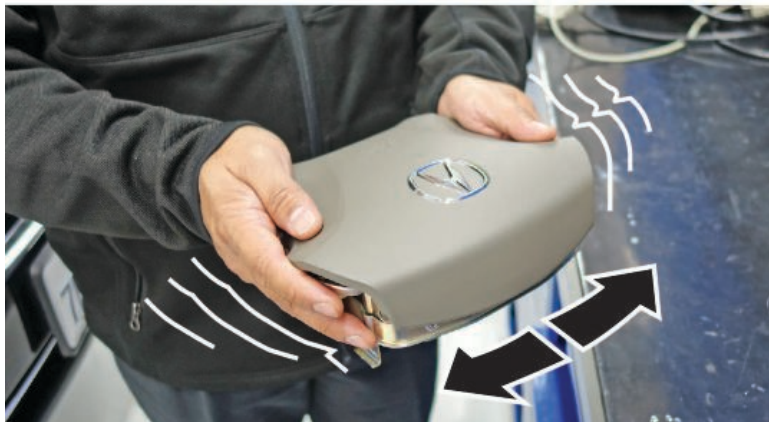
9. Turn over the airbag (inflator side down), and shake it to remove any debris from the inflator opening.

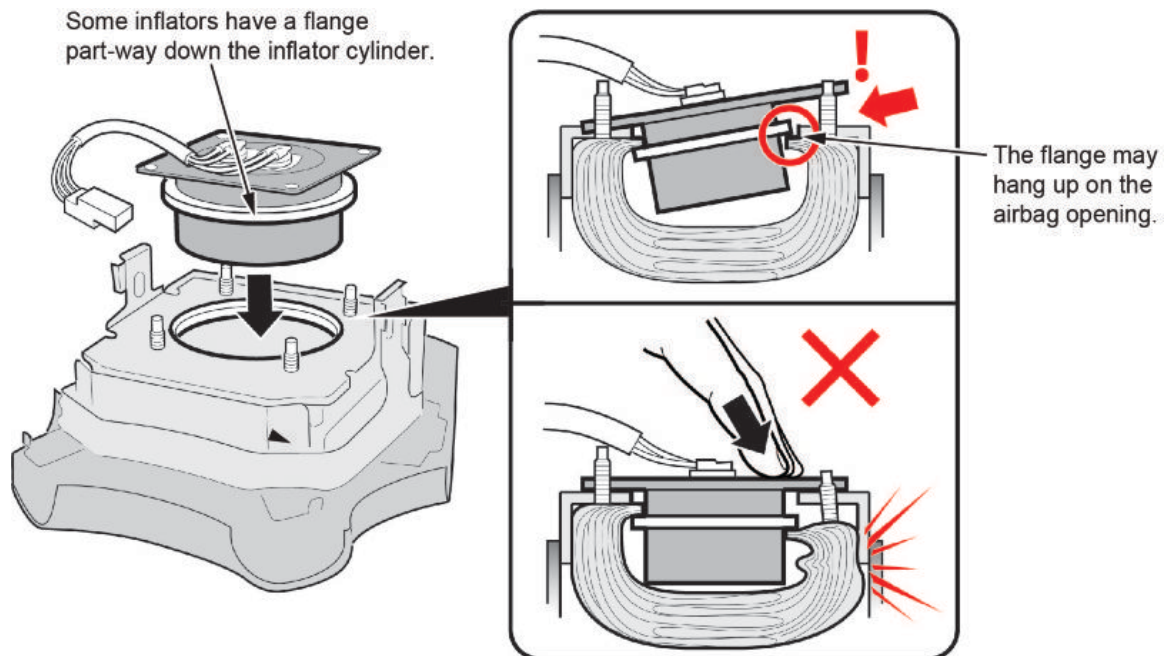
10.1.1. Insert the airbag inflator into the opening. Do not force it into the airbag module.

Make sure the inflator wires are positioned toward the bottom of the airbag. If you install the inflator incorrectly, you may not be able to reconnect the SRS airbag harness.

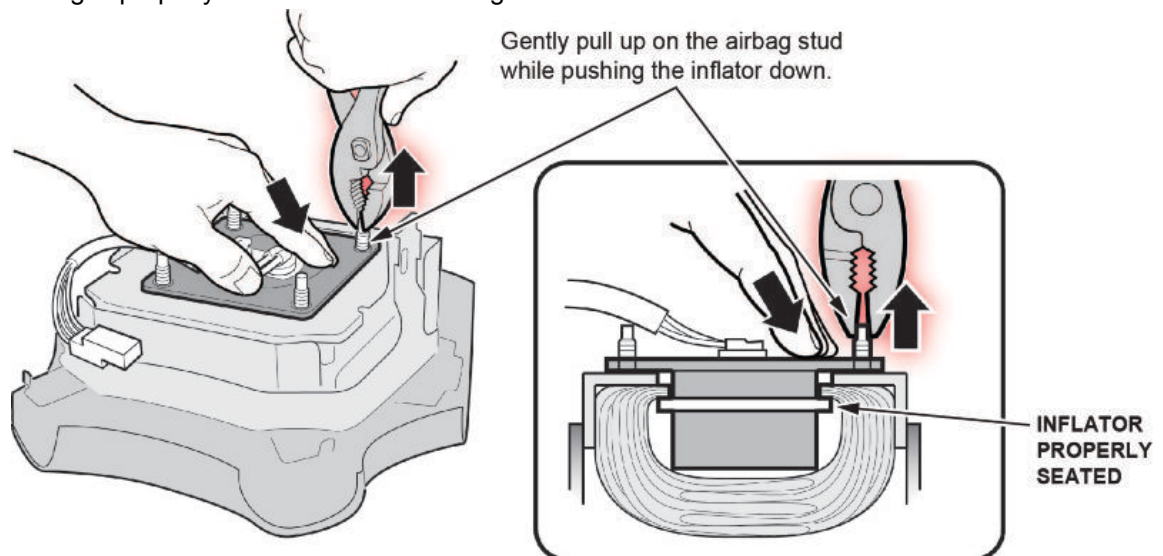
10.1.2. Using a pair of pliers, gently pull up on each stud up while pushing the inflator module down until the airbag is properly seated within the airbag module.

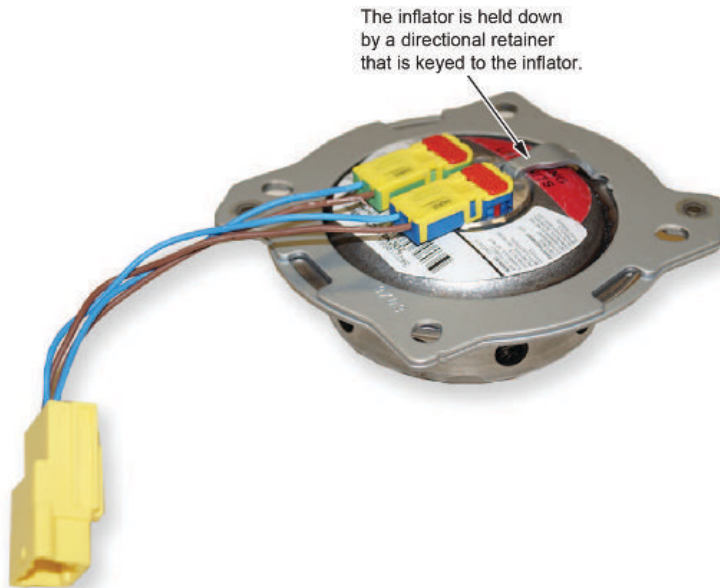
- 10.2.1. Place the inflator into the opening with the inflator harness toward the bottom of the airbag.

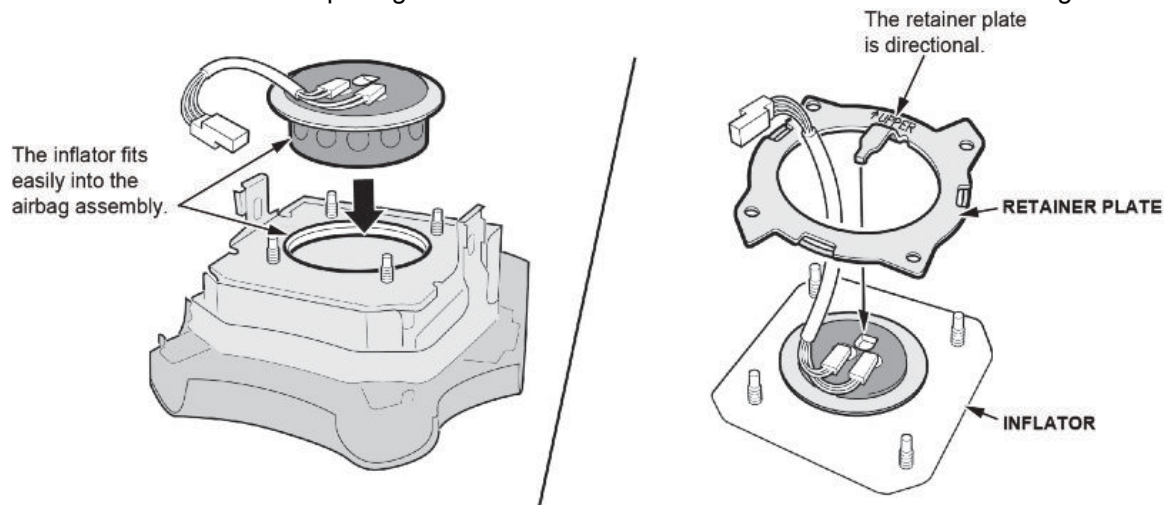
- 10.2.2. Install the bracket onto the studs. Make sure the locator tab fits into the locator hole as shown.

Make sure the harness comes out through the center opening. Do not install the bracket over the harness wires.

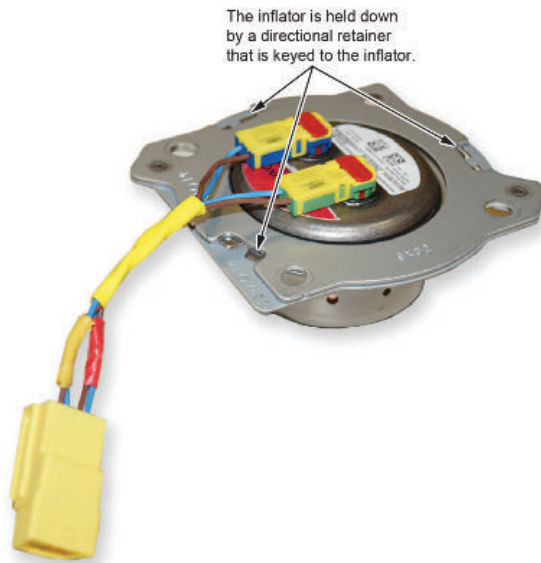
- 10.3.1. Place the inflator into the opening with the inflator harness toward the bottom of the airbag.

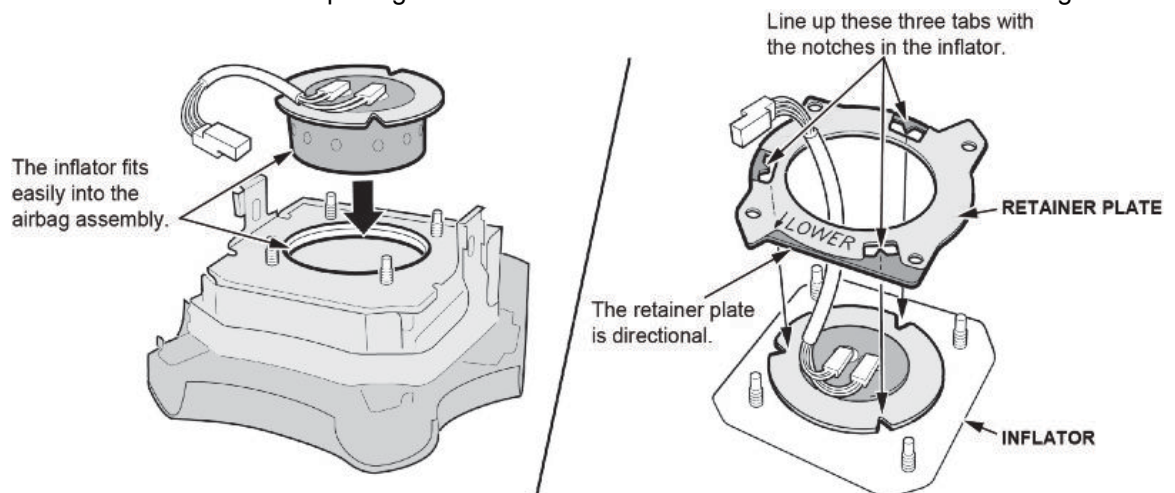
- 10.3.2. Install the bracket onto the studs with the stamp LOWER at the bottom of the airbag.

- 10.3.3. Make sure the three tabs and notches are properly aligned.

- The tabs and notches are designed to align in one direction only. If the tabs and notches are not aligned, the inflator and bracket are not installed correctly.
- Make sure the harness comes out through the center opening. Do not install the bracket over the harness wires.

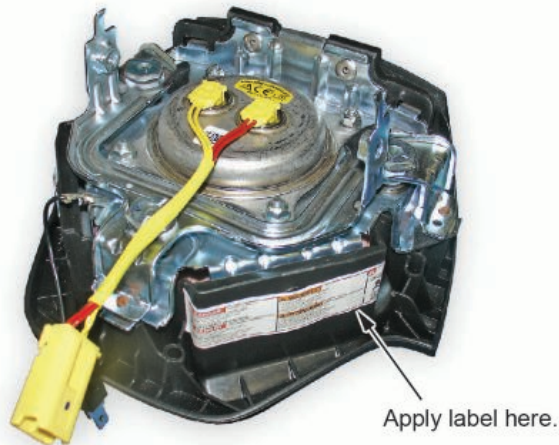
ILX, ILX Hybrid, RDX, TL, ZDX:

11. Install and torque the new locknuts to **3.9 N·m (2.8 lb-ft, 34 lb-in)**.
12. If the inflator kit came with a label, attach it to the airbag assembly as shown.

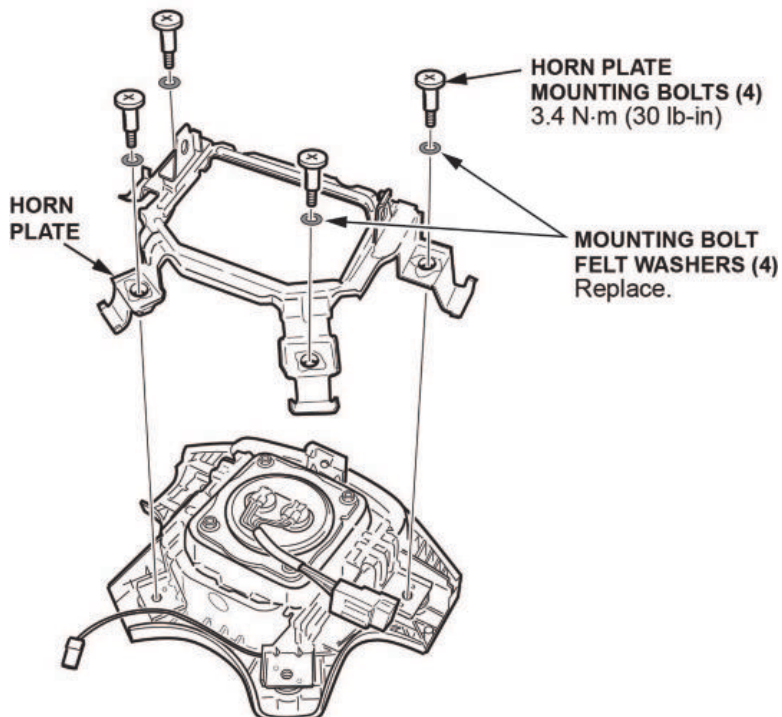
13. If applicable, install the horn plate.
 - 13.1. Cover the lower two inflator locknuts with new felt tape.
 - 13.2. Install the horn plate with new felt washers on its mounting bolts. Torque the mounting bolts to **3.4 N·m (2.5 lb-ft, 30 lb-in)**, then make sure the horn plate moves freely.

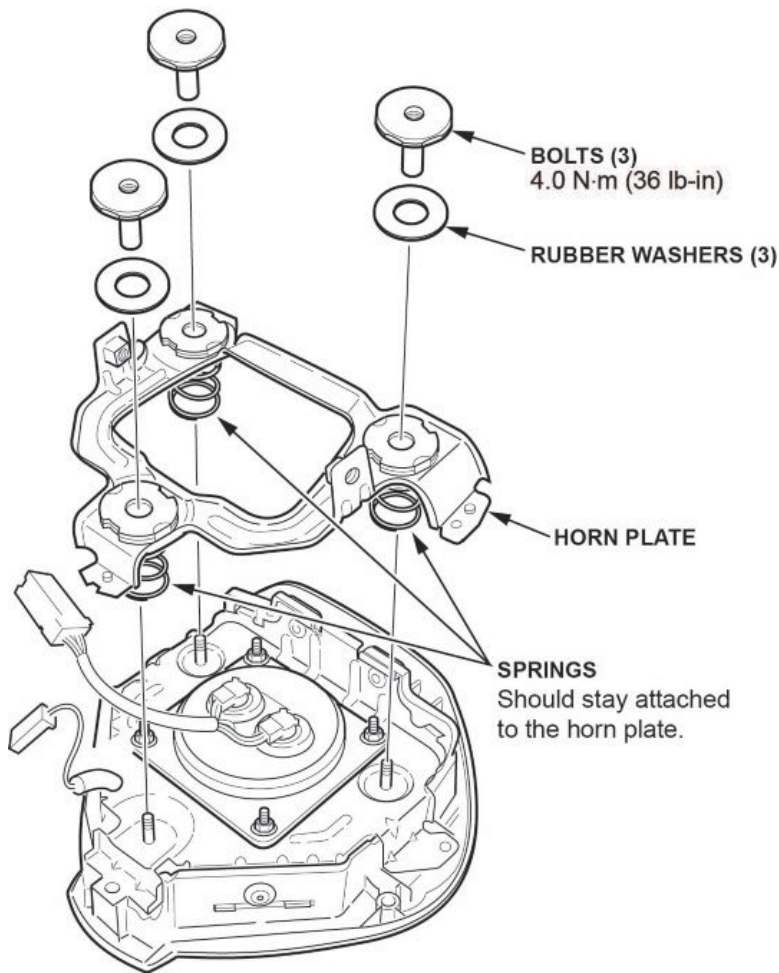
13.1. Make sure the three springs are mounted to the back side of the horn plate as shown.

13.2. Make sure the rubber washers are installed on their respective bolts.

13.4. Install the 3 bolts and evenly tighten to **4.0 N·m (3.0 lb-ft, 36 lb-in)**.
