Recall #	19V-240		
Description/Title:	ASA Voyager Mirror Monitors		
Affected Product Line(s):	Certain Model Year 2018 Chateau & Four Winds Motorhomes 2019/2020 Magnitude & Omi Motorhomes		
Service Campaign # :	RC000168	Released Date:	7/1/2020
Repair Code:	Repair: TMCRC80481V Inspect: TMCRC80482Y	Document Date:	7/1/2020
Time Allowed:	Repair: 0.5 Inspect: 0.2	Document Revision:	B

Mirror Monitor Replacement

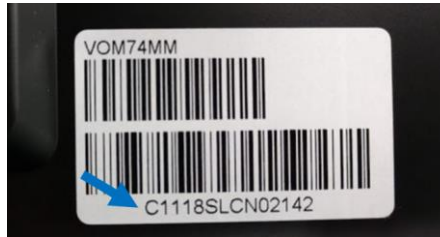
PHOTO OF SERIAL NUMBER STICKER IS REQUIRED

Be sure to verify Serial Number of Mirror Monitor before starting repair process. Serial number is found on the back of the mirror. TMC will not be reimbursing for recall repairs if they do not fit following description: ***This recall condition only relates to vehicles that have the VOM74MM Mirror Monitor that has a serial number starting with "A", "B", or "C".***

A photo of the serial number sticker will be required for ALL claims.

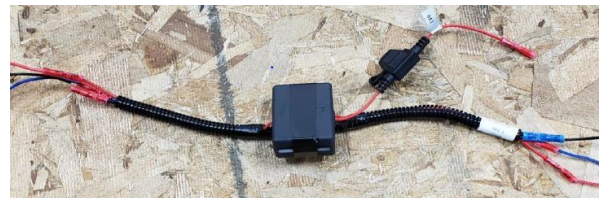
NOTE: The Voyager Mirror Monitor VOM74MM with Serial Number starting with an A, B, or C has been recalled due to the possibility of the image inverting. If a Field Fix Kit harness was installed. It should be removed if the monitor is replaced with a monitor that starts with E, F, or G. The Field Fix Kit harness is then not needed.

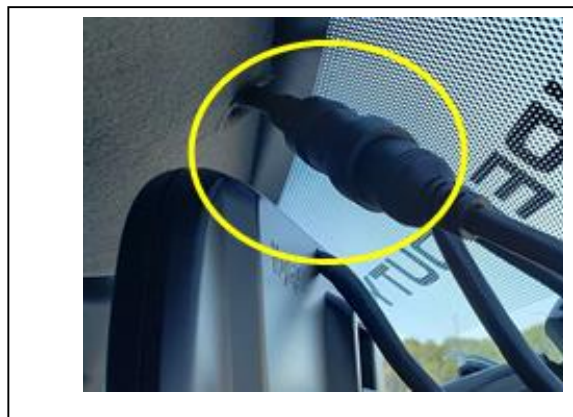
Locate the Monitor Connector.

1. The Monitor Connector will most likely be pushed in the Headliner of the Vehicle.
2. The connector may be able to be carefully pulled out of the headliner or the headliner may need to be partially pulled down to access it. The Monitor Connector is 17" from the Monitor.

3. Once located, disconnect the Monitor Connector.

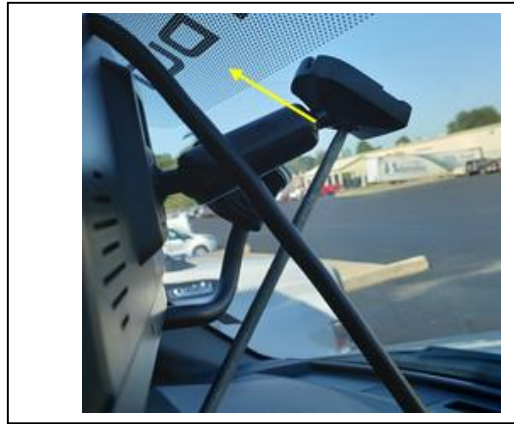
Removing Monitor from Windshield.

1. To remove the Monitor from the Windshield mount, use a Phillips screwdriver to loosen the screw on the Mirror Mount stem.

2. Once loose, slide the monitor UP to remove it from the Windshield.

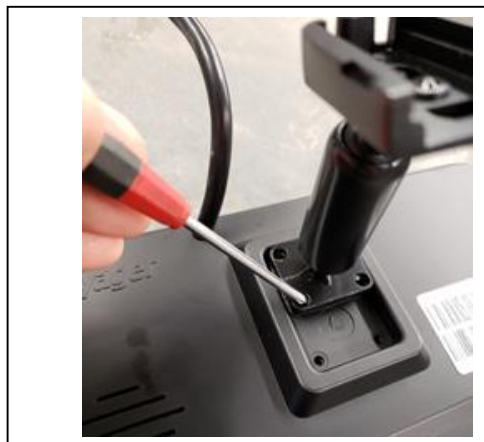
Removing/Transferring Mirror Mount

1. Remove the Mirror Mount by removing the four screws that hold the Mount to the Monitor, shown below:

2. Install the Mirror Mount to the new Monitor using the same screws.
