SAFETY RELATED RECALL

Recall Action
Number: N336v4

| Door Will Not Latch | Publication No.: N336v4 |
| | Model: Range Rover (LG) |

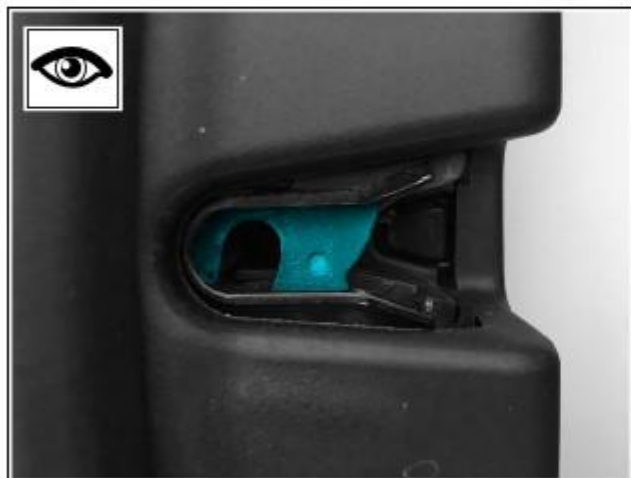
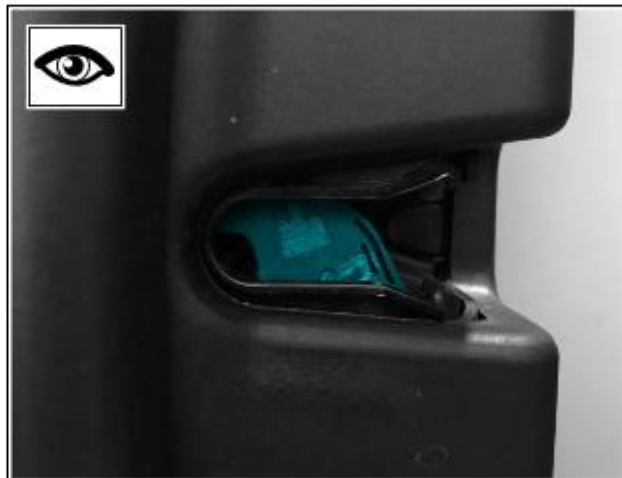
E258158

Use a quick and smooth motion to grasp and pull the exterior door handle, hold the handle in the open/extended position, and observe the position of the door latch lever.

- If the door latch is in the latched position **GREEN (✓)**, continue to step 5.
- If the door latch is **not** in the latched position **RED (X)**, return to step 2.

If necessary, watch the Service Information video again and pay particular attention to the speed of operation of the door handle.

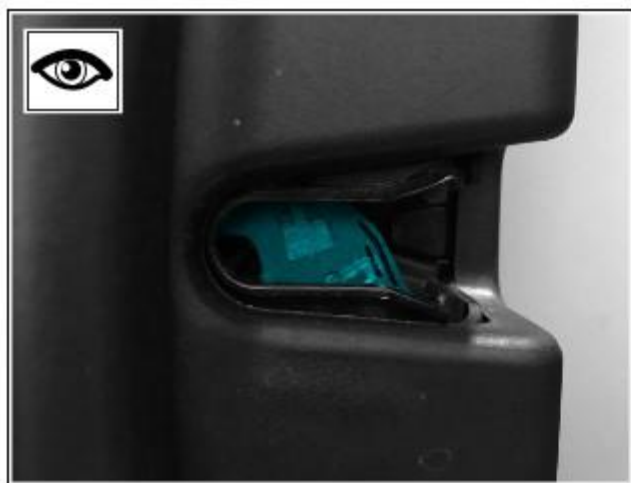
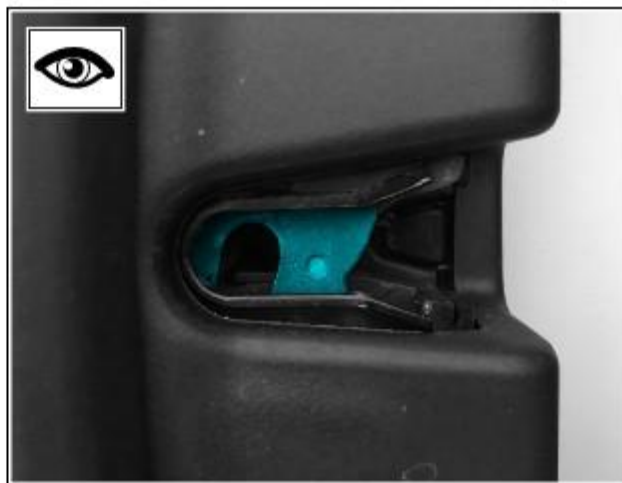
E258160

7. Observe the position of the door latch lever.

- If the door latch lever is in the unlatched position, as shown by the **GREEN (✓)** in the illustration, the front left door latch has passed the functionality test, **go to Service Instruction 'B'**.
- If the door latch lever is still in the latched position, as shown by the **RED (X)** in the illustration, **go to step 8**.

8. Renew the front left door latch (see TOPIx Workshop Manual section 501-14: Handles, Locks, Latches and Entry Systems - Removal and Installation - Front Door Latch).

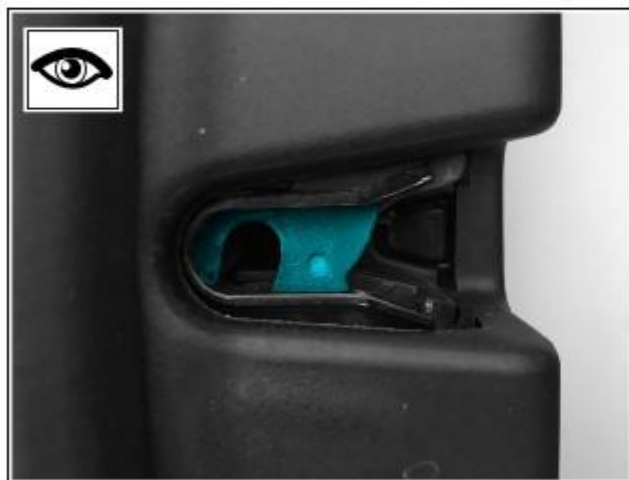
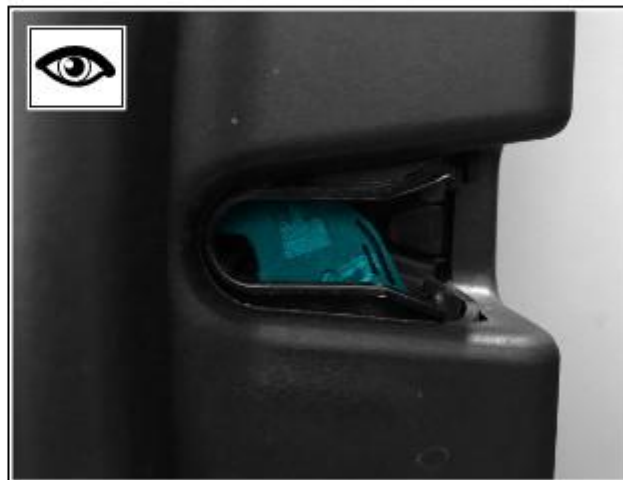
E258158

Use a quick and smooth motion to grasp and pull the exterior door handle, hold the handle in the open/extended position, and observe the position of the door latch lever.

- If the door latch is in the latched position **GREEN (✓)**, go to step 5.
- If the door latch is **not** in the latched position **RED (✗)**, return to step 2.

If necessary, watch the Service Information video again and pay particular attention to the speed of operation of the door handle.

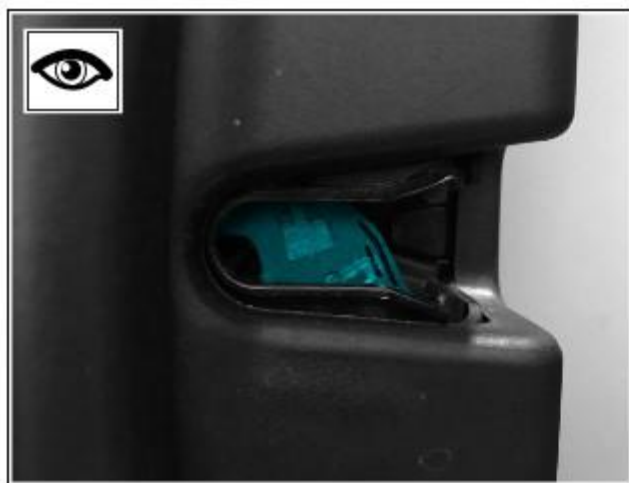
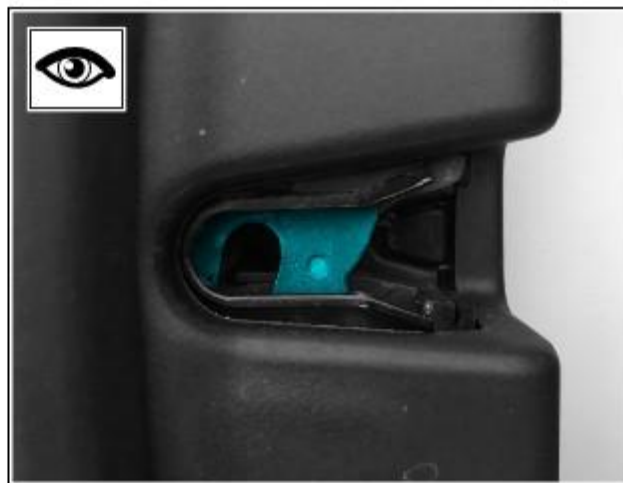
E258160

7. Observe the position of the door latch lever.

- If the door latch lever is in the unlatched position, as shown by the **GREEN (✓)** in the illustration, the rear left door latch has passed the functionality test, **return the vehicle to the customer.**
- If the door latch lever is still in the latched position, as shown by the **RED (X)** in the illustration, **go to step 8.**

8. Renew the rear left door latch:

- **Range Rover Sport** - (see TOPIx Workshop Manual section 501-14: Handles, Locks, Latches and Entry Systems - Removal and Installation - Rear Door Latch).
- **Range Rover - Standard wheelbase** - (see TOPIx Workshop Manual section 501-14: Handles, Locks, Latches and Entry Systems - Removal and Installation - Rear Door Latch - Standard Wheelbase).
- **Range Rover - Long wheelbase** - (see TOPIx Workshop Manual section 501-14: Handles, Locks, Latches and Entry Systems - Removal and Installation - Rear Door Latch - Long Wheelbase).
- When all tasks are complete, **return the vehicle to the customer.**
