Service Bulletin

19-040

Safety Recall: Front Passenger's Airbag Inflator Can Be Over-Pressurized (Phase 5)

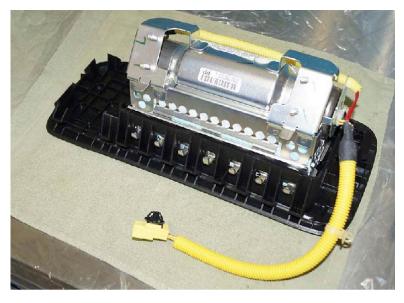
- 4. Place the airbag, face-down, on a clean shop towel.

- The orientation of the airbag is critical because if the inflator is installed incorrectly, the harness will be too short when you reinstall the airbag.
- The brackets between the various models are similar but may differ from the example shown.

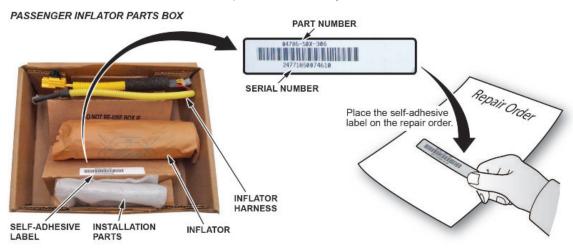
- The replacement part number is printed on the top part of the label, and the serial number is printed on the bottom. Make sure you attach the label to the RO and give it to the warranty clerk.
- There may also be a colored sticker located in the kit; ignore it because it is not used.
- Not all inflator kits have a label included. In those cases, write the serial number and part number from the side of the inflator box on the RO. The part number always starts with 047.

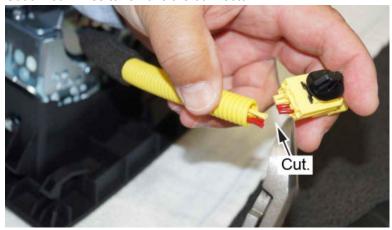
9.1. Cut all four wires to remove the connector.

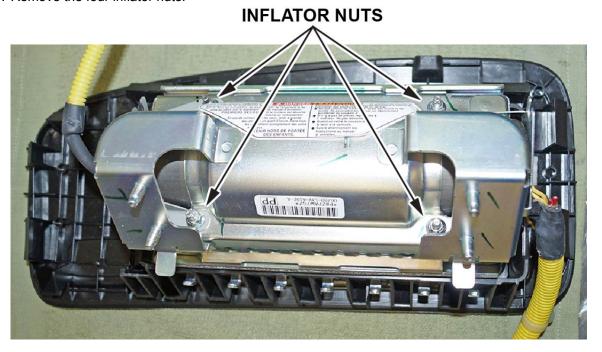
10. Remove the four inflator nuts.

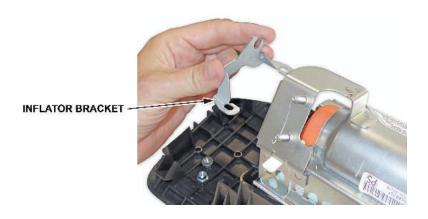
11. Remove the inflator bracket.

You can only remove one of the brackets, as the other is welded to the airbag housing.

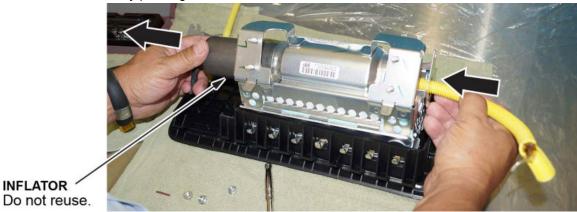
12. Remove the inflator by pushing it out.

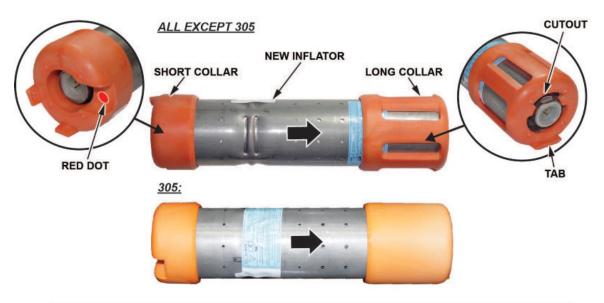
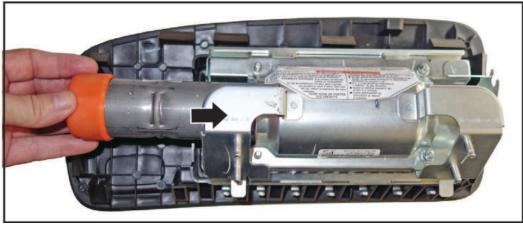
For part numbers ending in 315 and A00: One side of the inflator has a shorter collar, two tabs, and a notch with a red dot. The other side of the inflator has a longer collar, a tab, a plastic cutout, and a small flat spot on the connector. Make sure you insert the end with the longer collar into the airbag first.

For part numbers ending in 305: One side of the inflator has a shorter collar with no tabs, and a notch with a red dot. The other side of the inflator has a longer collar, a tab, a plastic cutout, and a small flat spot on the connector. Make sure you insert the end with the longer collar into the airbag first.

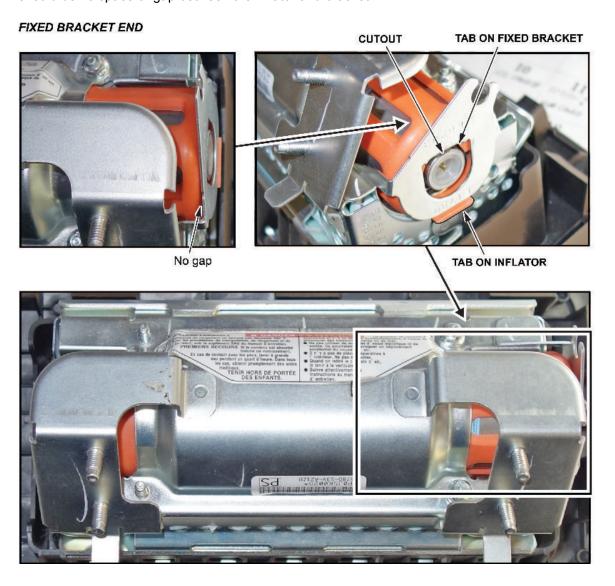
13.3. Slide the inflator in until the plastic cutout and the small flat spot align with the tab on the bracket. There should be no space or gap between the inflator and bracket.

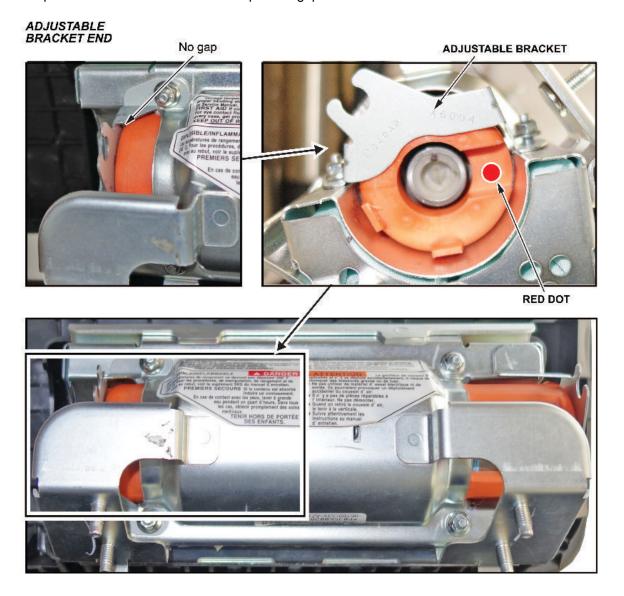
13.4. Install the bracket included in the kit onto the airbag module. There should be a red dot visible on the end of the plastic collar. There should be no space or gap between the inflator and bracket.

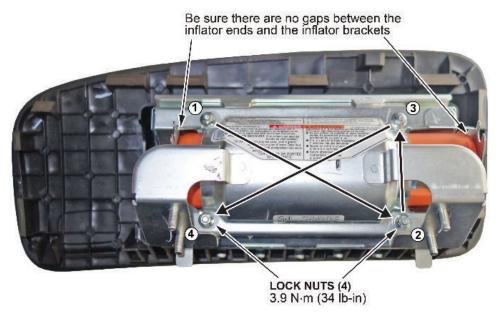
14. Install the new 5 mm locknuts and torque them in sequence to 3.9 N-m (34 lb-in).

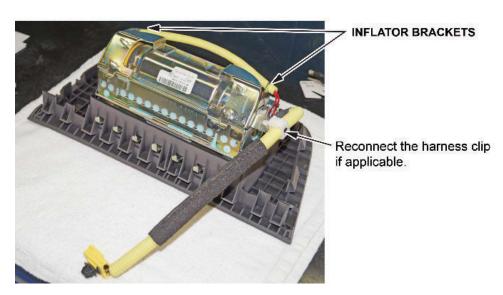
- Make sure you have the orientation correct as shown below. If you connect the harness incorrectly, the harness cannot be removed, and you will not be able to reinstall the airbag because the harness will be too short.
- Connect the red wire connector to the short collar side of the inflator with the red dot.

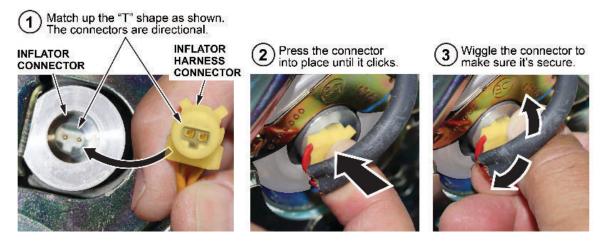
17.2. Connect the two connectors. Align the "T" shape in the inflator harness connector with the T-shaped inflator connector, then press the connector into place.

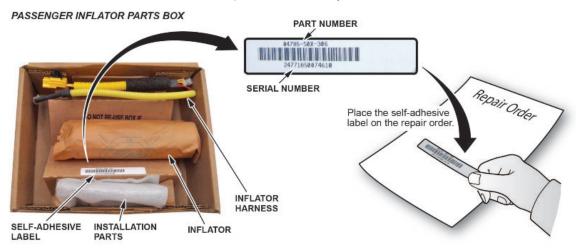
- The replacement part number is printed on the top part of the label and the serial number is printed on the bottom. Make sure you attach the label to the RO and give it to the warranty clerk.
- There may also be a colored sticker located in the kit, ignore it because it is not used.
- Not all inflator kits have a label included. In those cases, write the serial number and part number from the side
 of the inflator box on the RO. The part number always starts with 047.

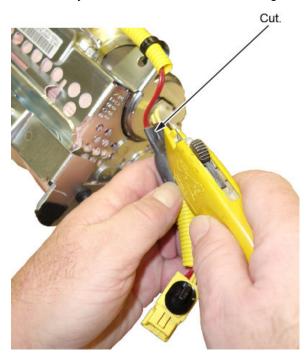
8.1. Cut the black rubber tubing to separate the red and yellow wires.

Make sure you don't cut the wires at this stage.

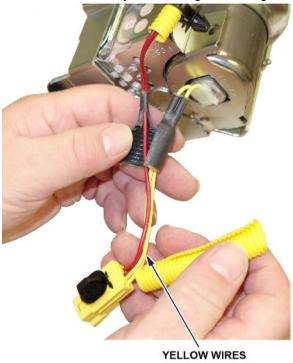
8.2. Cut and remove the yellow corrugated tubing.

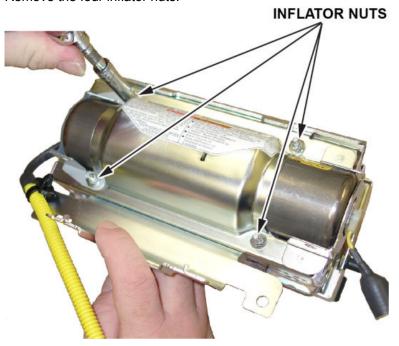
9. Remove the four inflator nuts.

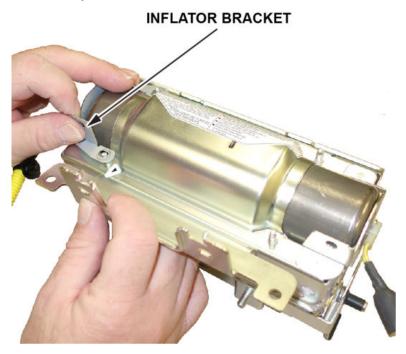
10. Remove the inflator bracket.

You can only remove one of the brackets, as the other is welded to the airbag housing.

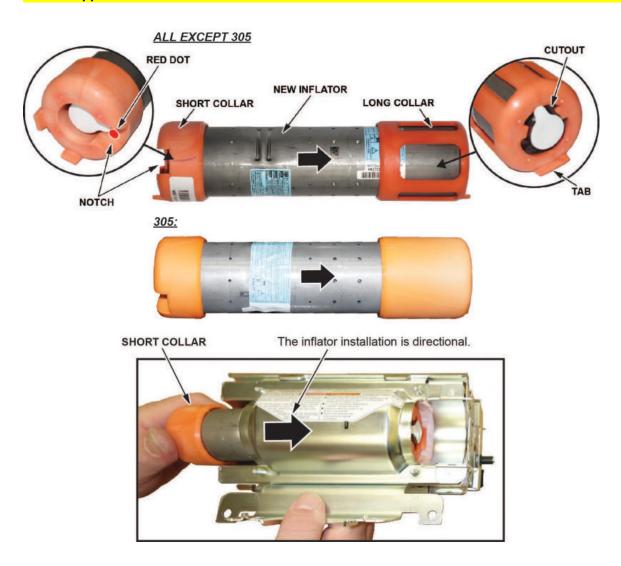
For part numbers ending in 315 and A00: One side of the inflator has a shorter collar, two tabs, and a notch with a red dot. The other side of the inflator has a longer collar, a tab, a plastic cutout, and a small flat spot on the connector. Make sure you insert the end with the longer collar into the airbag first.

For part numbers ending in 305: One side of the inflator has a shorter collar with no tabs, and a notch with a red dot. The other side of the inflator has a longer collar, a tab, a plastic cutout, and a small flat spot on the connector. Make sure you insert the end with the longer collar into the airbag first.

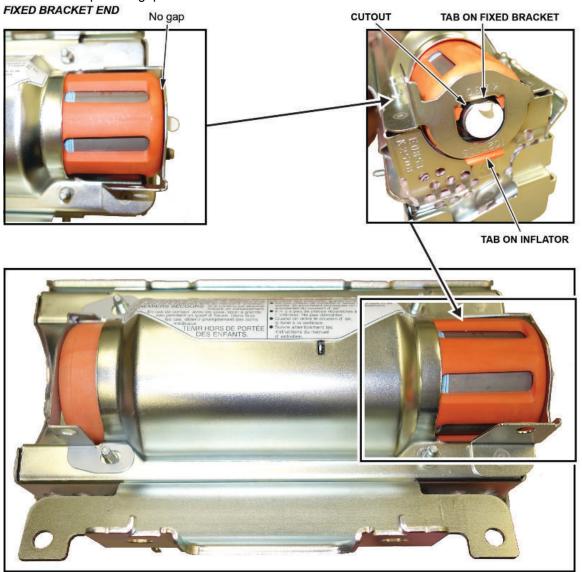
12.3. Slide the inflator in until the plastic cutout and the small flat spot align with the tab on the bracket. There should be no space or gap between the inflator and bracket.

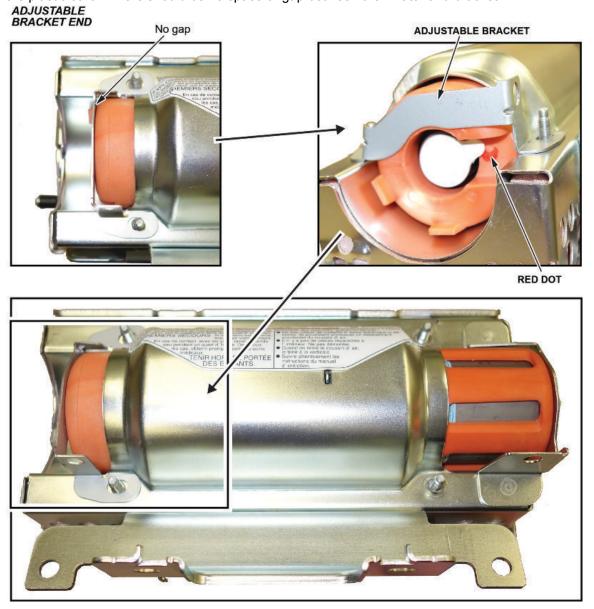
12.4. Install the bracket included in the kit onto the airbag module. There should be a red dot visible on the end of the plastic collar. There should be no space or gap between the inflator and bracket.

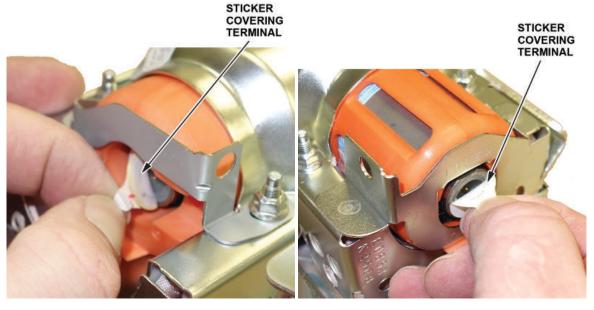
14. Remove the stickers covering the terminals on both sides of the new inflator.

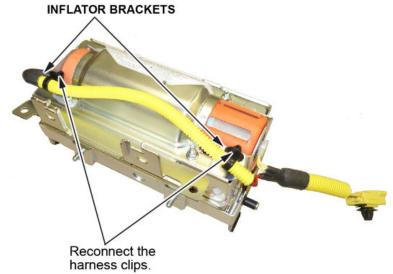
17. Connect the harness to the inflator brackets.

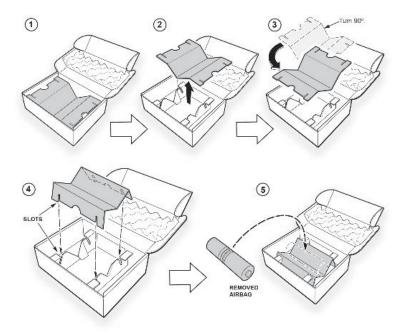
- Do not reuse the shipping insulation.
- The cardboard insert needs to be adjusted to send back the original inflator otherwise the original inflator removed from the vehicle will rattle around and may be rejected by the courier.
