R19AH – Insufficient Roof Rivet Quantity

Models Affected: Certain 2019-2021 Vision and All American buses

Issue: On certain units, the roof sheet rivet spacing may be incorrect in some segments, resulting in noncompliance with FMVSS 221, School Bus Body Joint Strength.

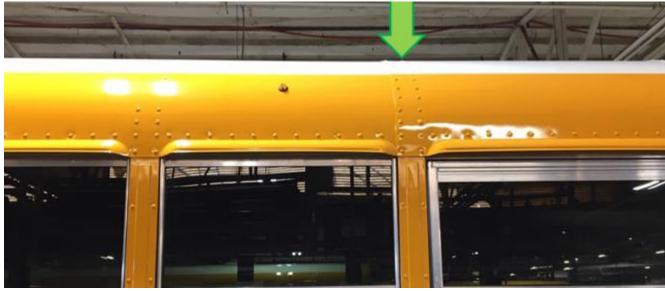
1. On one side of the bus, starting at either the front or the rear, go to the first roof panel joint seam of double rivets. These will be the rivet rows that need to be inspected. 2. Use a ladder or scaffold that will allow access to the roof of the bus.

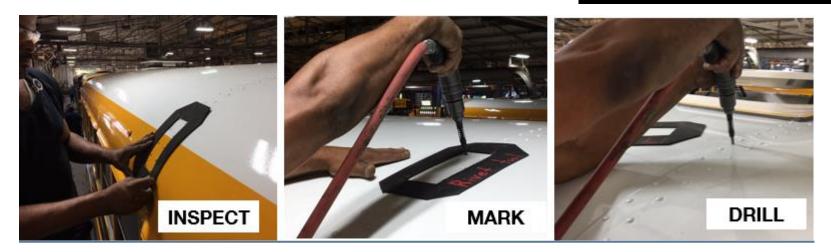
- 3. Inspect rivet spacing at each roof sheet joint. Roof sheet joints are assembled with two rows of rivets. Joint must have a minimum of six rivets in an eight inch segment. The full length of the roof sheet joint, including the top of the bus, must be inspected and corrected, if needed.

- a. Place the supplied rivet spacing template over the joint and parallel to the edge of the roof sheet, allowing roof rivets to be exposed through the opening in the template, as shown.

- b. Move the template from one side of the roof sheet towards the center of the roof.
 - c. If a segment in the roof joint contains less than six rivets, additional rivets are required. Mark each area that requires additional rivets.

- d. If one rivet is required; add a rivet equally spaced between the two rivets with the largest space in this section.
 - e. If additional rivets are required; add additional rivets between the largest spaces until a minimum of six (6) rivets have been added in the eight (8) inch segment.

- 4. Using a short 17/64" drill bit, drill a hole through the roof sheet and bow flange only. Be sure not to drill through the inside headliner. Drill any required holes on a common centerline with existing rivets.

- 5. Install rivet (Item 1) in each drilled hole.
- 6. With the correct color paint, touch up each blind rivet installed.
- 7. Repeat procedure on the opposite side of the bus.
