TECHNICAL INSTRUCTIONS
FOR
SAFETY RECALL J0A/J0B/J0C
FRONT PASSENGER AIRBAG INFLATOR MODULE
CERTAIN 2003 – 2006 MODEL YEAR TUNDRA

UPDATE 10/17/2019

Front Passenger Airbag Inflator Module - Safety Recall

SSC - E04

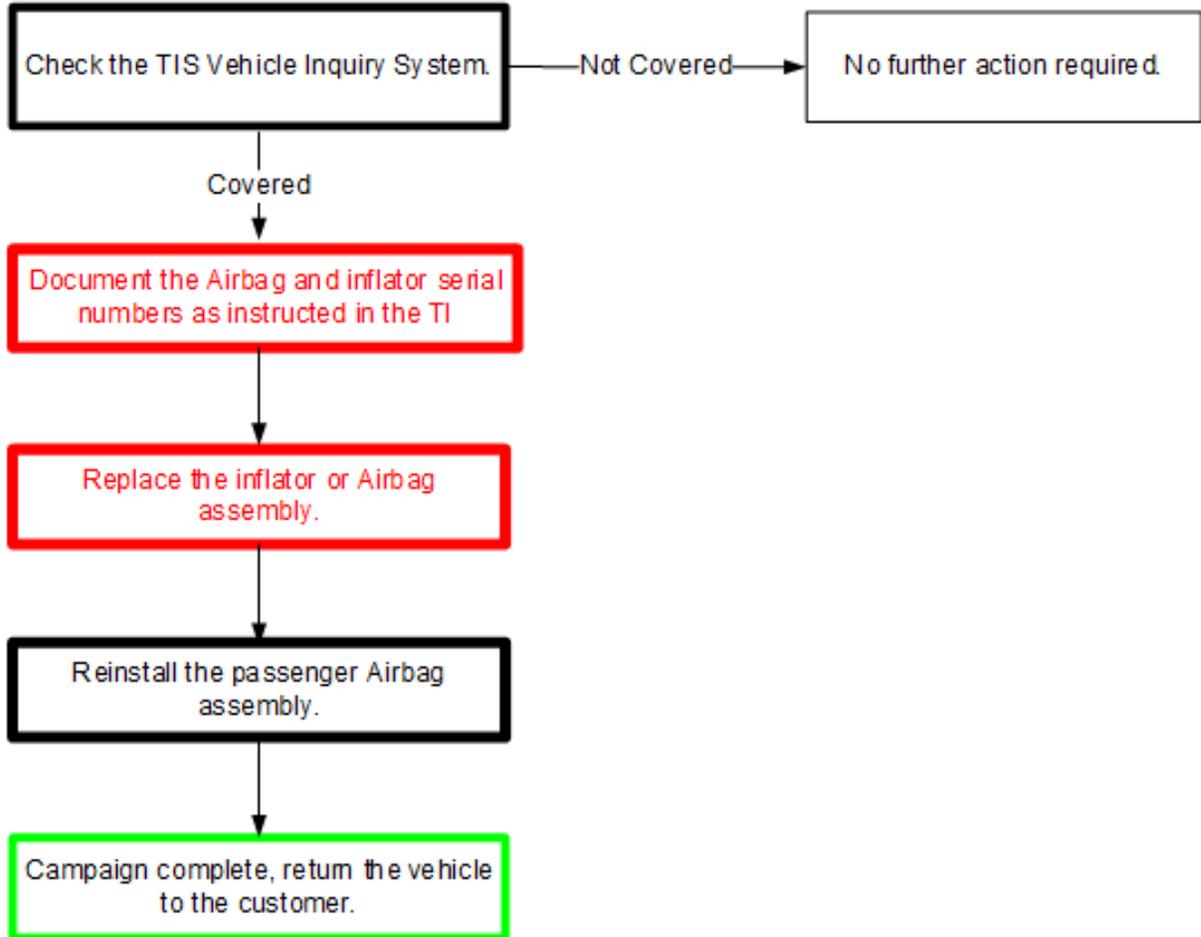
I. OPERATION FLOW CHART

The flow chart is for reference only. **DO NOT** use it in place of the full technical instructions. Follow **ALL** steps as outlined in the full technical instructions to confirm the campaign is completed correctly.

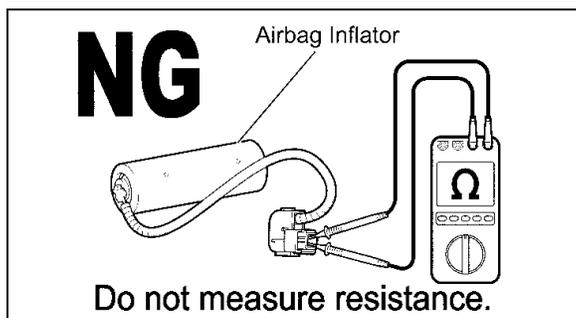
2. DO NOT MEASURE RESISTANCE

- a) **DO NOT** measure resistance of airbag components, this may cause accidental activation.

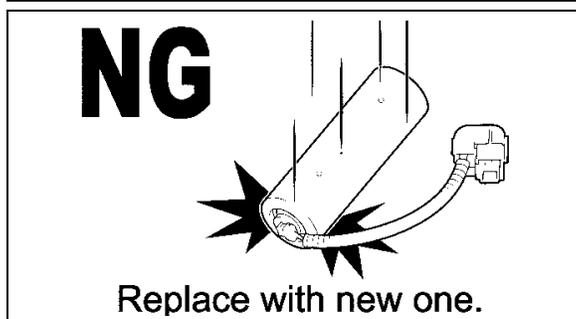
3. HANDLE THE AIRBAG CAREFULLY

- a) If an inflator is dropped, replace it with a **NEW** inflator.

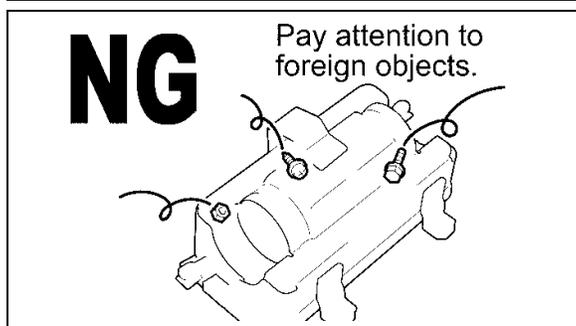
4. DO NOT ALLOW FOREIGN OBJECTS NEAR AIRBAG

- a) Be sure to collect and account for all removed nuts/bolts to prevent them from landing in the airbag assembly.
- b) Any foreign objects in the airbag assembly may cause damage or injury if the airbag is activated.

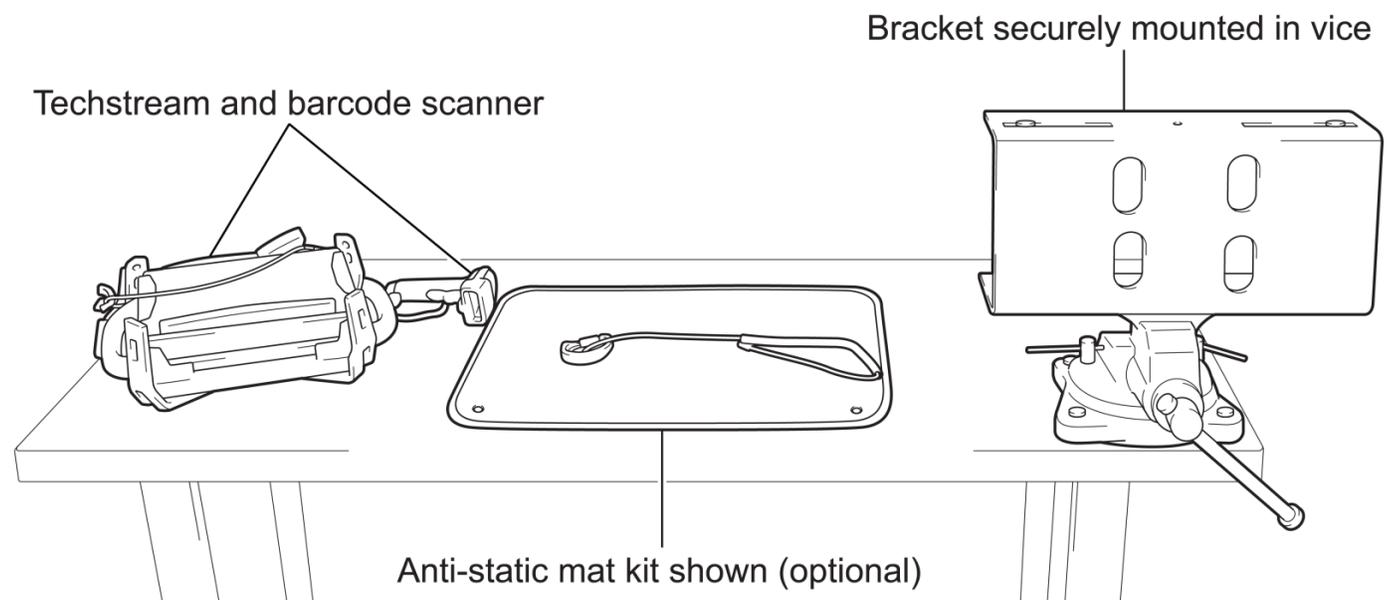
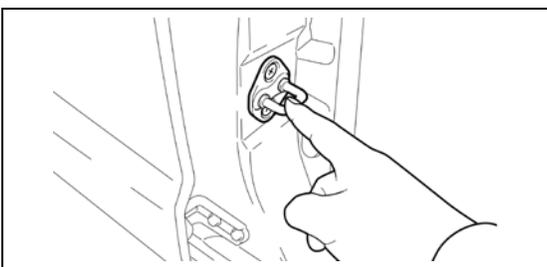
The bracket assembly that was provided at the launch of SSC D0F is a critical added-safety feature that **MUST** be used when replacing the inflator module. Confirm the bracket assembly is installed securely in the vise and confirm the work area being used is appropriate. The anti-static mat set that is an essential SST may be available at your dealership and is optional to use during inflator replacement. If the anti-static kit is not available, before starting work and periodically while working on the vehicle, touch a metallic part of the vehicle to discharge static electricity in the body.

Confirm there are no loose objects or people exposed to the back side of the bracket for safety in the unlikely event of airbag deployment due to improper work procedures (Remember that the inflator **IS NOT** being replaced due to an inadvertent deployment concern).

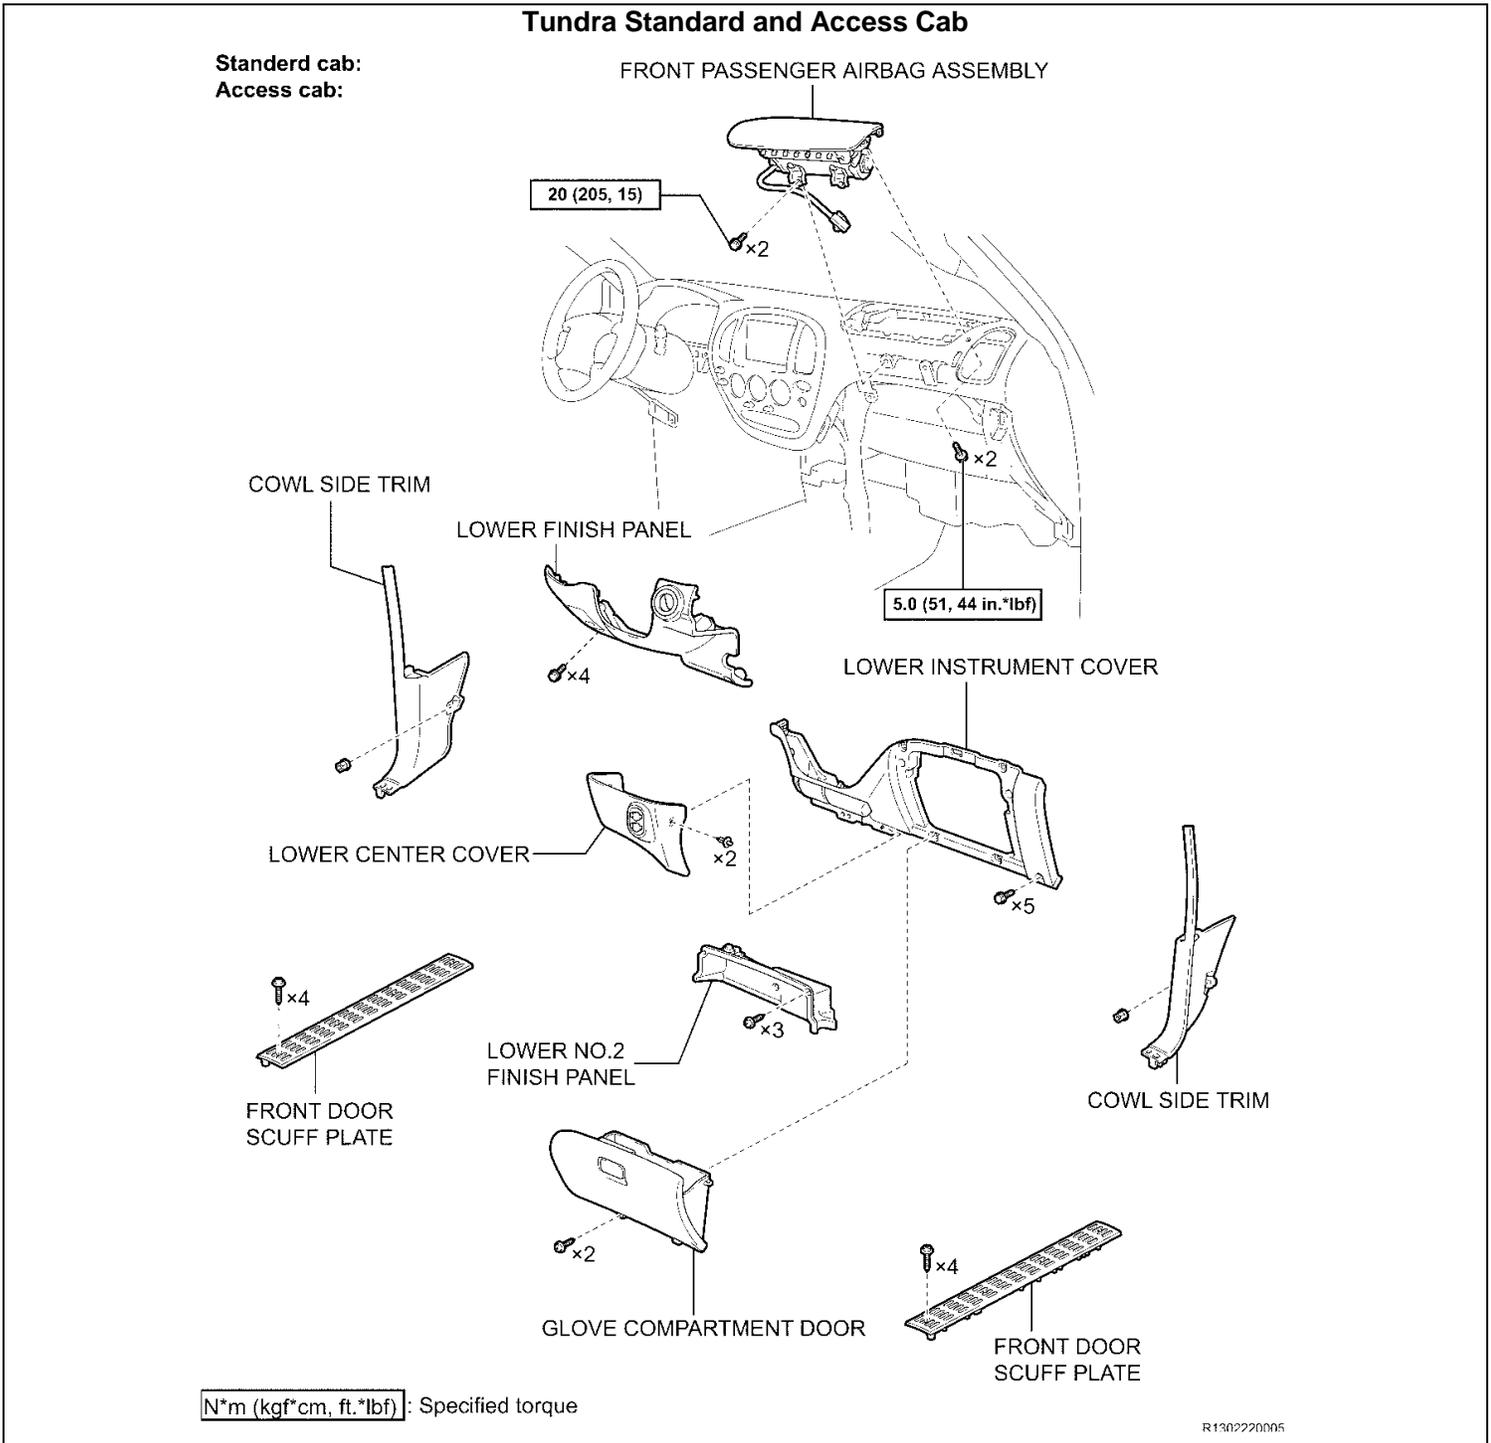
- a) Refer to TIS for instructions on airbag removal:
- b) [2003-2005](#) [2006](#)

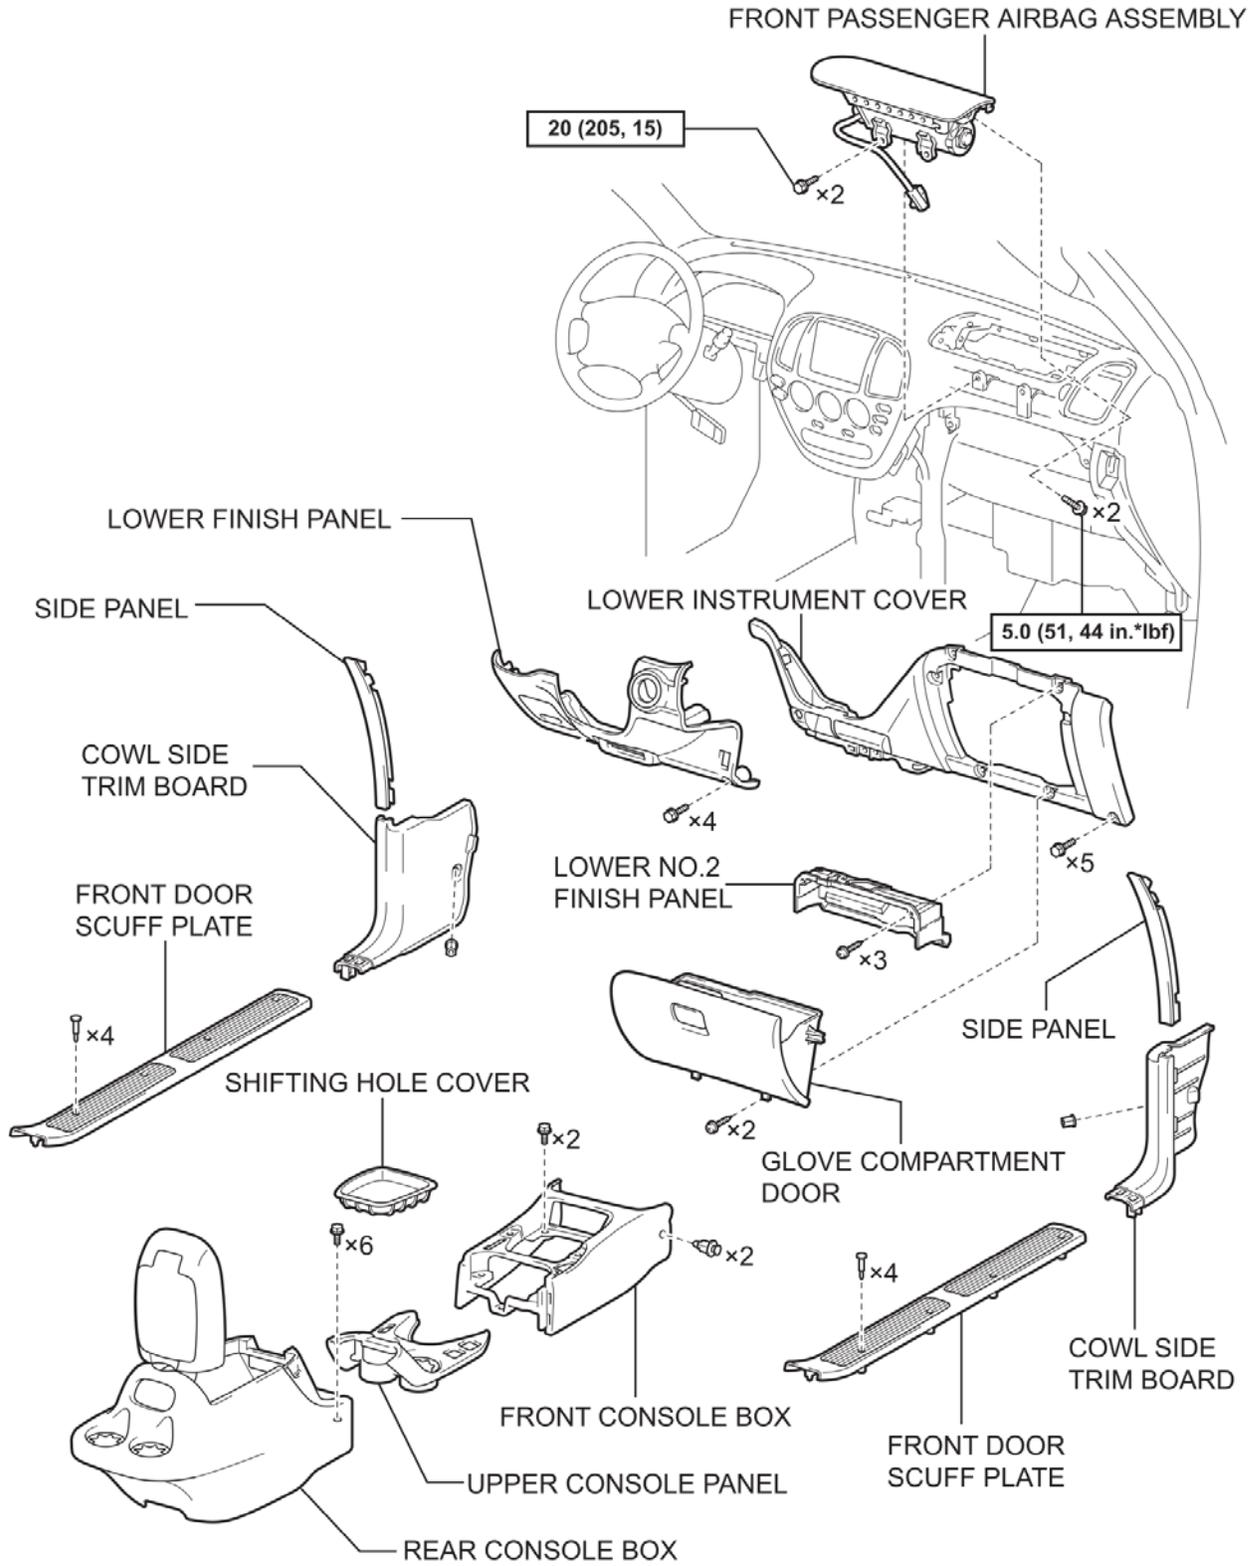
R1302220006

Double cab:

N*m (kgf*cm, ft.*lbf) : Specified torque

**3.9 N·m (40, 35 in.*lbf)
Be careful not to
overtighten.**

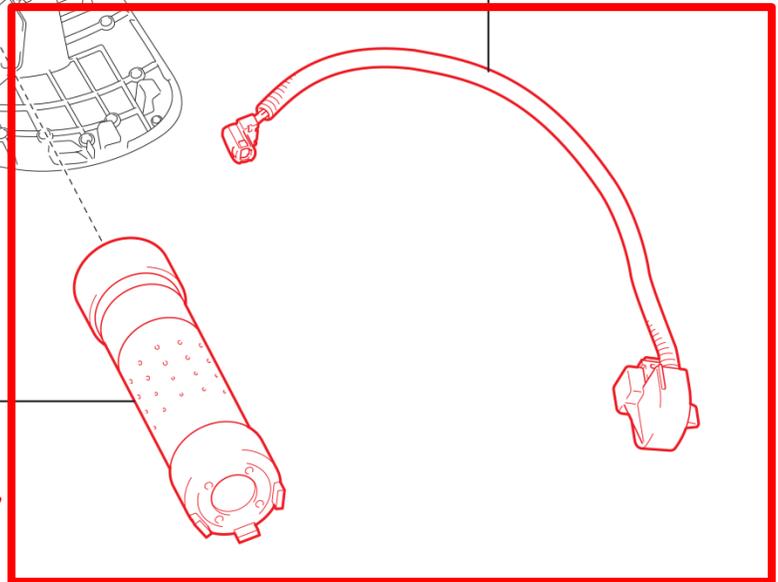
R1806210001

STOPPER PLATE

● INFLATOR

● Replacement part

The inflator wire harness has been connected to the new inflator.

Don't remove the wire harness from the inflator.

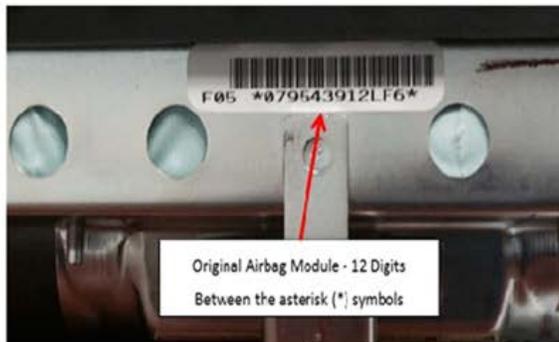
How to Identify an Airbag module Assembly number?

The Airbag module Assembly serial number is a **12 digit code**. It can be found along with a bar code on opening the Airbag assembly unit. To manually enter these details into the application, the technician has to identify the 12 digit code between two Asterisks (*) inside the Airbag assembly unit. The first seven characters of this 12 digit code are numbers and the 10th digit is either 'K' or 'L' always.

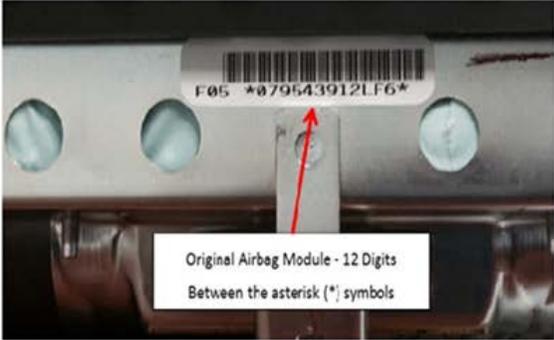
Record Airbag Serial Number

The Airbag module Assembly serial number is a **12 digit code**. It can be found along with a bar code on opening the Airbag assembly unit. To manually enter these details into the application, the technician has to identify the 12 digit code between two Asterisks (*) inside the Airbag assembly unit. The first seven characters of this 12 digit code are numbers and the 10th digit is either 'K' or 'L' always.

Use of a barcode scanner is strongly recommended when entering Airbag Assembly Serial Number.
If manually typing serial number, you MUST include all leading zeros. (If applicable)

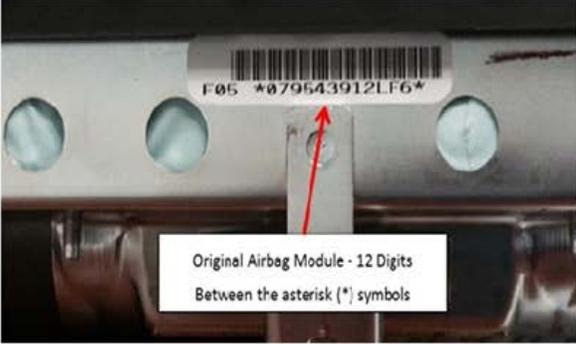
Record Airbag Serial Number

The Airbag module Assembly serial number is a **12 digit code**. It can be found along with a bar code on opening the Airbag assembly unit. To manually enter these details into the application, the technician has to identify the 12 digit code between two Asterisks (*) inside the Airbag assembly unit. The first seven characters of this 12 digit code are numbers and the 10th digit is either 'K' or 'L' always.

Use of a barcode scanner is strongly recommended when entering Airbag Assembly Serial Number.

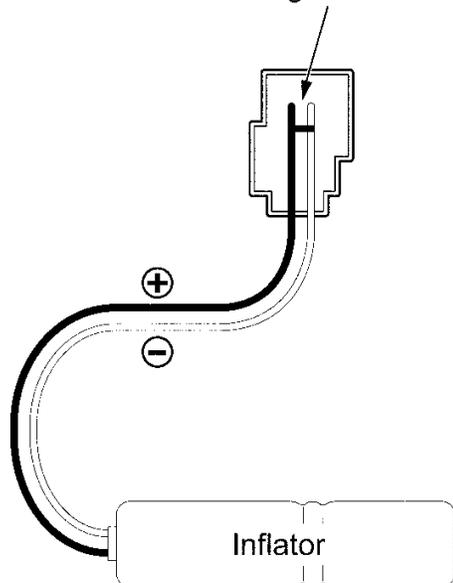
(1)

The connector of the inflator module contains a short circuiting mechanism to eliminate voltage variances when the connector(1) is disconnected. To allow for the replacement of the inflator module, a new short circuit(2) *MUST* be created before cutting the wires(3) and removing the inflator. The following steps *MUST* be followed exactly as described to ensure the work is completed correctly and safely.

Short circuiting on both sides.

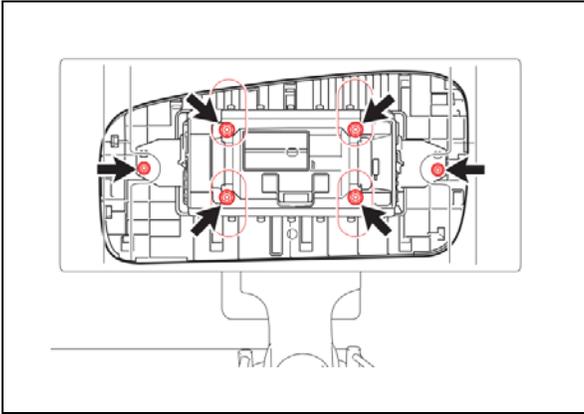
1. MOUNT THE AIRBAG IN THE MOUNTING BRACKET

- a) Position the airbag assembly so that the center mounting bracket is facing towards the ground.
- b) Install the airbag to the support bars with the bolts supplied in the bracket kit.

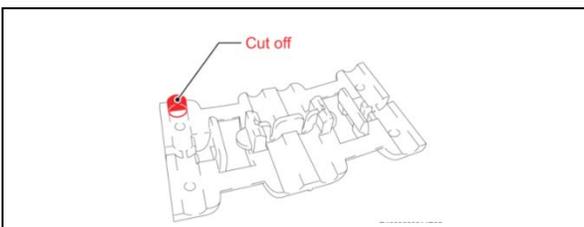
- b) Cut off the tab of the electro tap shown in the illustration.

NOTE: The electro tap is included in the inflator parts kit.

This tab **MUST** be removed to ensure a good short.

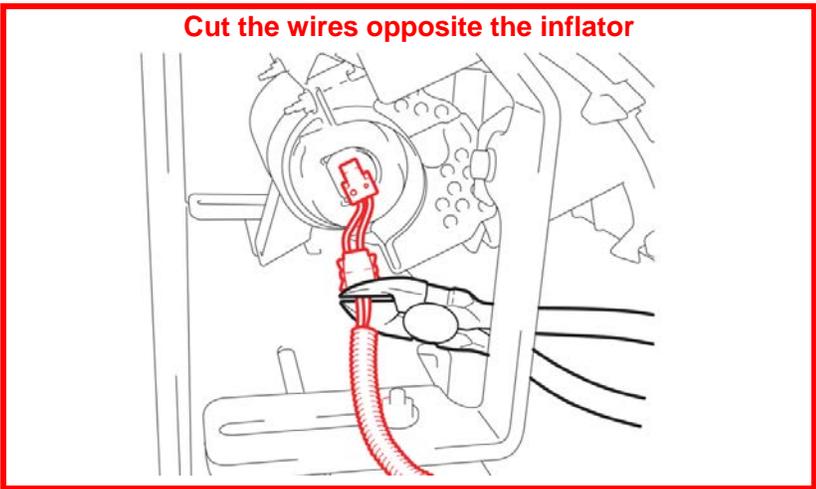
a) Cut the 2 wires at the side of the electro tap that is farthest away from the inflator.

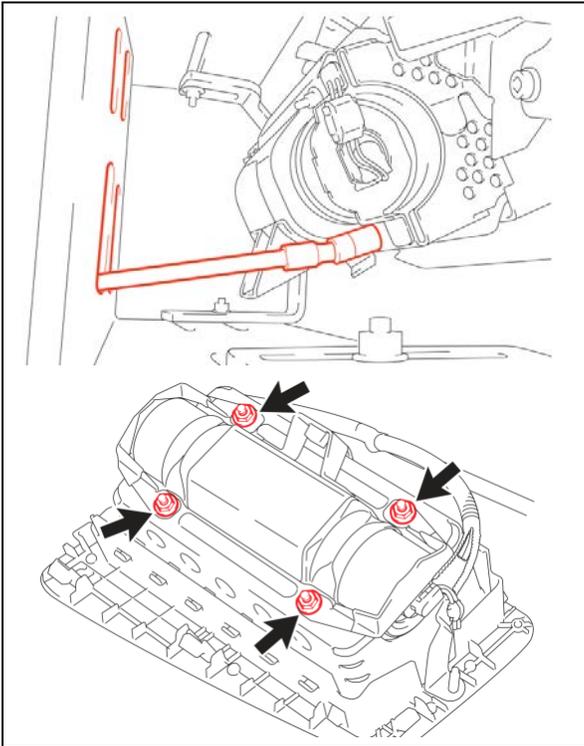
5. REMOVE THE SELF LOCKING NUTS

a) Use the access holes in the bracket to remove the 4 nuts.

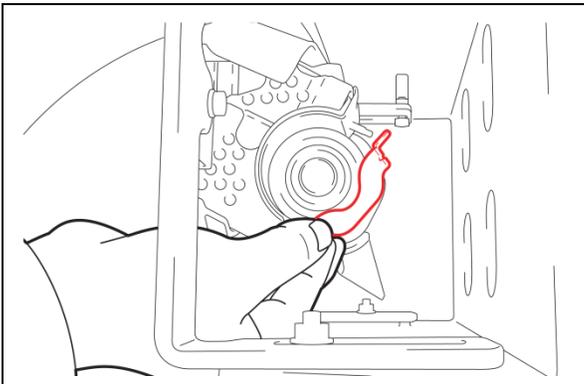
- **DO NOT** use power tools.
- The bracket support bars may need to be repositioned to remove the nuts through the access holes.

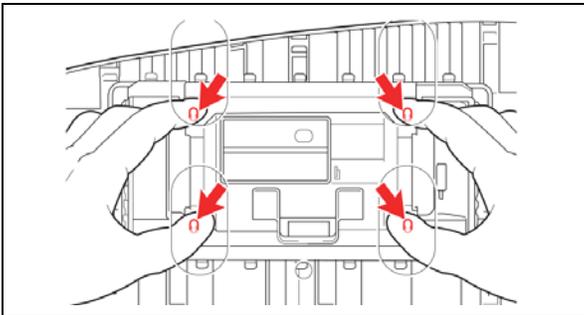
b) Remove the stopper plate and place in a secure location because it will be reused.

STOP **DO NOT** discard the Stopper Plate, it will be reused.

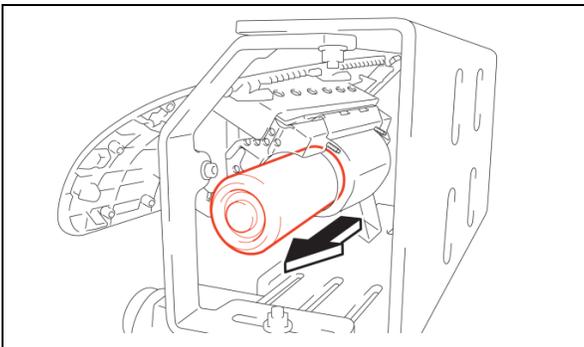
a) Gently push in the 4 studs to loosen the inflator for removal.

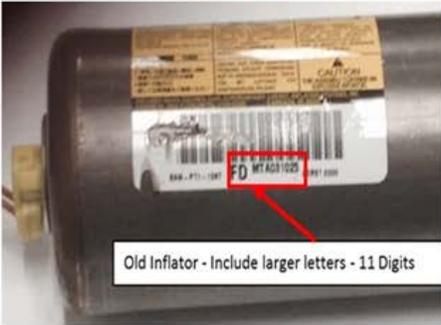
Original Inflator

Old Inflator - Include larger letters - 11 Digits

The Inflator serial code is an **11 digit code** on the Inflator can. It can be found with a bar code on removing the Inflator can from the Airbag Assembly unit.

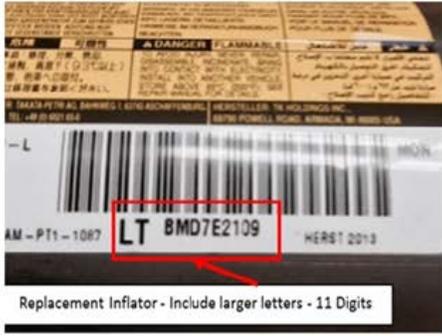
The first two characters of the **Replacement Inflator Serial code** will be either 'LT' or 'LR'.

Replacement Inflator - Include larger letters - 11 Digits

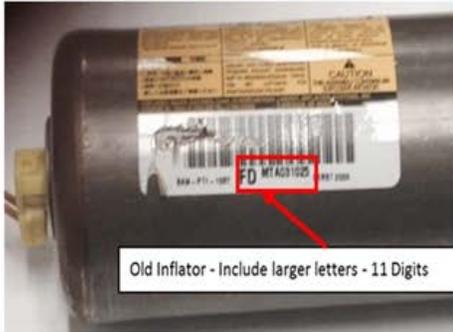
Original Inflator

Old Inflator - Include larger letters - 11 Digits

The Inflator serial code is an 11 digit code on the Inflator can. It can be found with a bar code on removing the Inflator can from the Airbag Assembly unit.

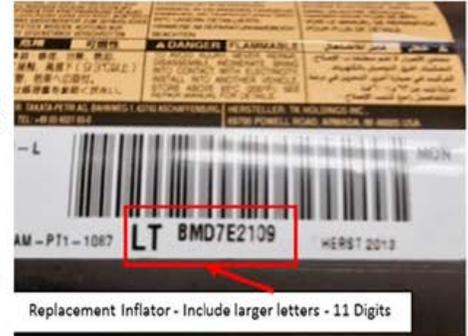
The first two characters of the Replacement Inflator Serial code will be either 'LT' or 'LR'.

Replacement Inflator - Include larger letters - 11 Digits

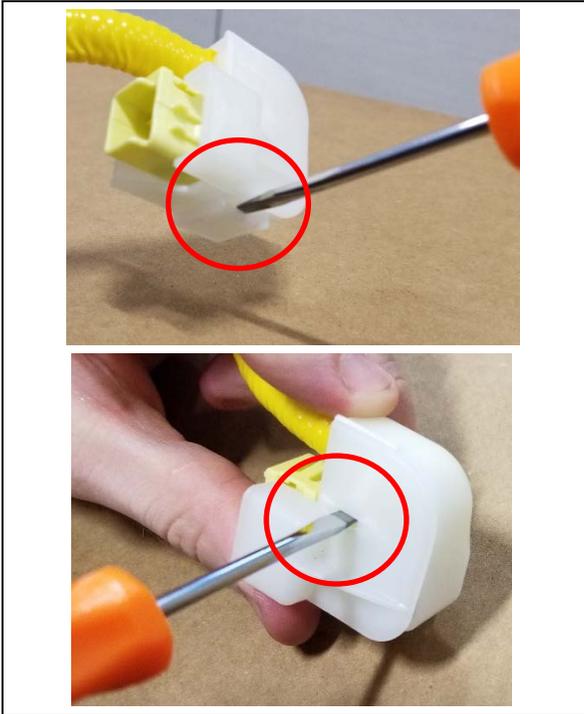
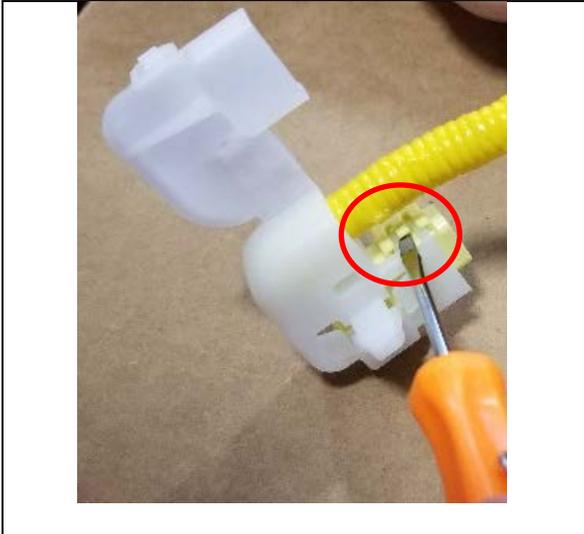
8. REMOVE NEW INFLATOR CONNECTOR COVER

- a) Carefully use a pocket screwdriver to disengage the first release tab as shown in the image
- b) Carefully use a pocket screwdriver to disengage the second release tab as shown in the image
- c) Open the connector cover. Once open carefully use a pocket screwdriver to disengage the release tab and remove the connector cover from the connector

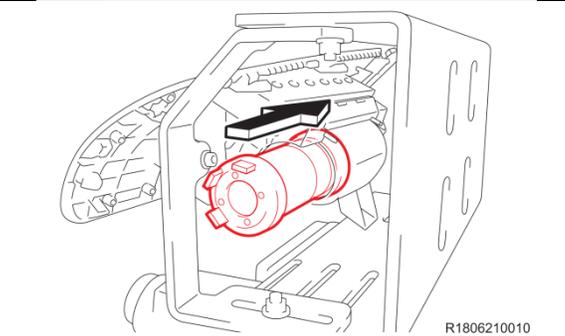
a) Route the inflator wire harness through the stopper plate

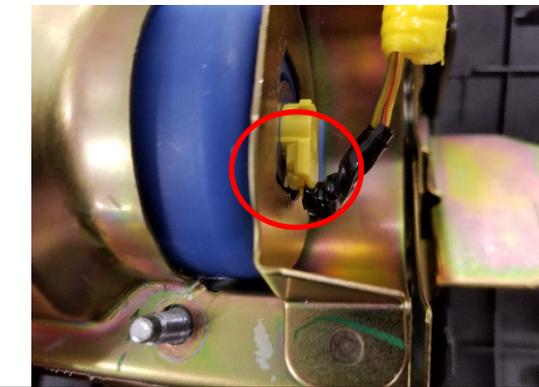
b) Carefully slide the new inflator into the airbag assembly.

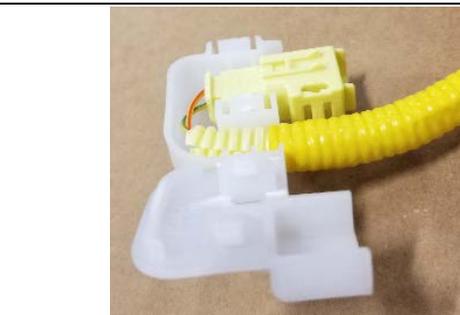
c) Confirm the harness is not pinched by the stopper plate

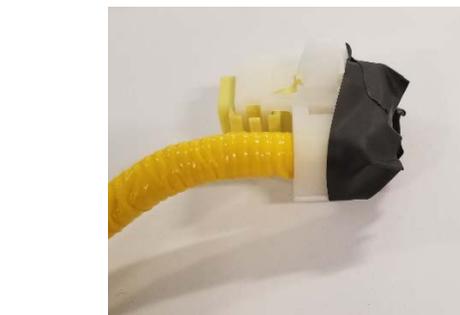
d) Install the connector into the connector cover. Ensure the release tab on the connector is engaged into the connector cover.

e) Once the connector is installed into the connector cover, close the connector cover over the connector.

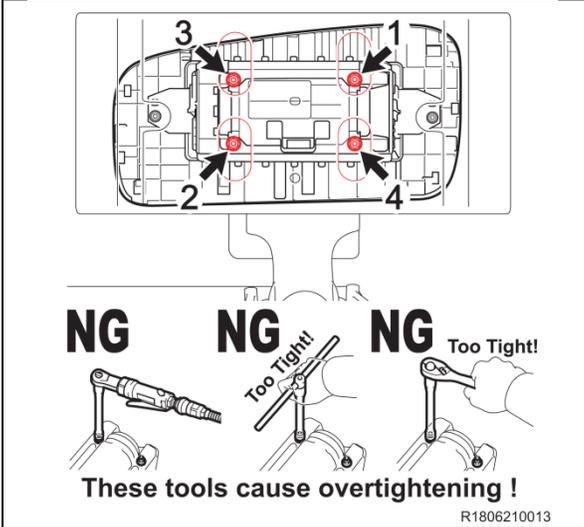
- g) Place the stopper plate on the airbag assembly.

STOP The inflator stopper plate is reused at this step; a new one is not included in the inflator kit.

- h) Install stopper plate nuts (**NEW**) by hand. They will be torqued on a later step.
- i) Install the **NEW** nuts on the airbag assembly bracket by hand. They will be torqued on a later step.
