SIB 65 06 20

RECALL CAMPAIGNS 19V-852 AND 19V-853: DRIVER'S FRONT AIR BAG (NADI) INFLATOR

This Service Information Bulletin (Revision 6) replaces SI B65 06 20 **dated February 2021**.

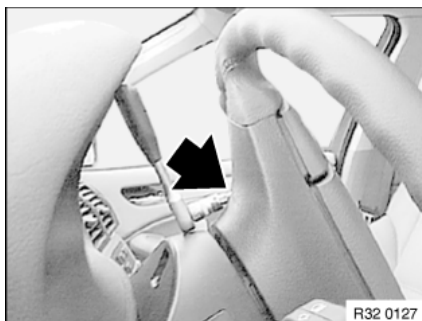
Release screws (Torx T30) on both sides.

Tightening torque 32 34 1AZ.
