Mercedes-Benz

Campaign No. 2020040011, June 2020

SUBJECT: **Models C-Class, CLK-Class, E-Class, and CLS-Class (203, 209, 211, and 219 platform)**
Model Years 2006-2007
Sliding Roof Bonding - Phase 1

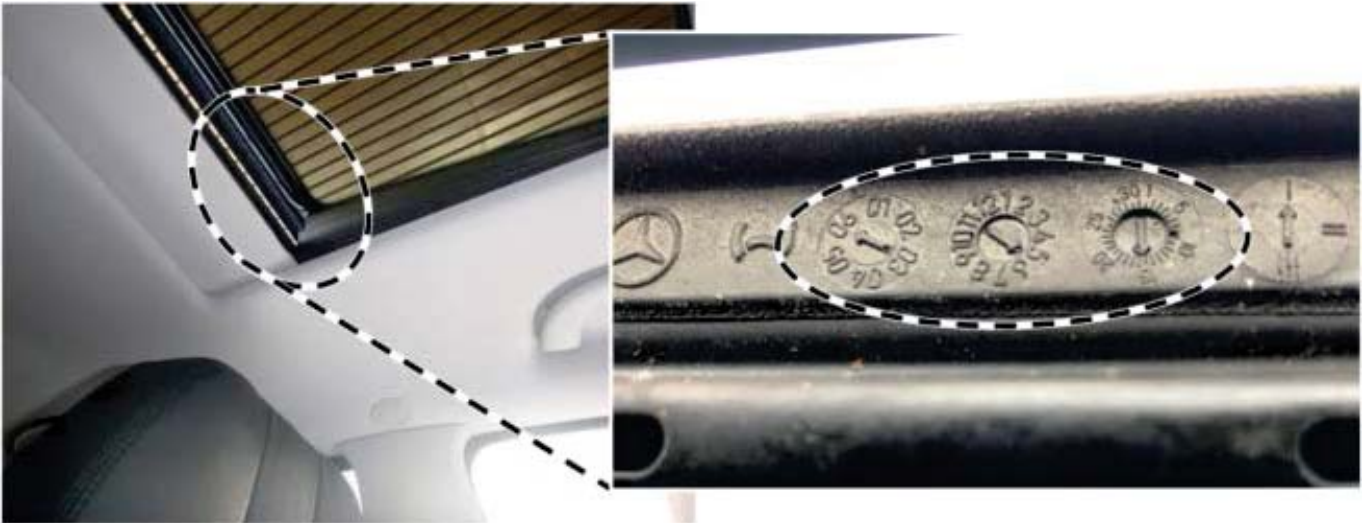
1. Move sliding sunroof to tilt position and check production date (**figure 1**).

i The production date **must** be on or **after 01-16-2006** or on or **before 07-09-2006**.

Figure 1 (The production date in the sample picture is **06 year / 5 month / 15 day**)(5-15-2006)

- A.** Production date between 01-16-2006 and 07-09-2006: Carry out **check/test procedure B**.
- B.** Production date **not** between 01-16-2006 and 07-09-2006: **End measure**.

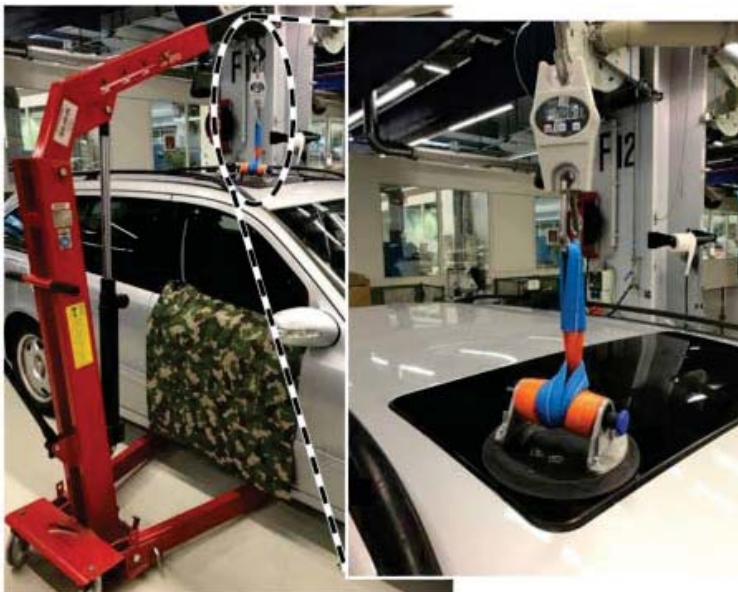
Figure 2

3. Position cup suction tool (**figure 2**) and pull as **vertically** as possible (tolerance of ± 10 degrees) using lifting tool.

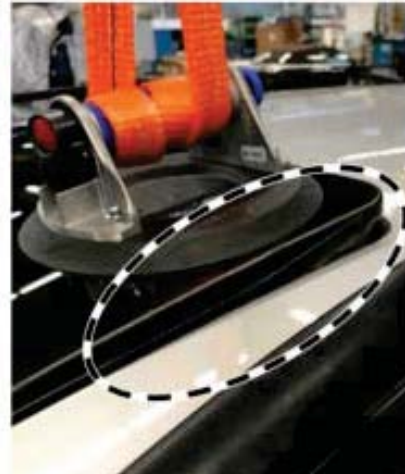
- i** The sliding roof panel is lifted out of the roof frame noticeably at the rear test positions 1 and 5 (**figure 4**).
- i** If the sliding roof panel detaches from the padding of the tilting/sliding roof frame at one of the test positions (see **figure 5**), the sliding roof panel must be replaced.

Figure 5 (**NOT OK**)

- C.** If the sliding roof panel detaches from the padding: Carry out **work procedure**.
- D.** If the sliding roof panel does **not** detach from the padding: **End measure**.

1. Replace sliding sunroof.

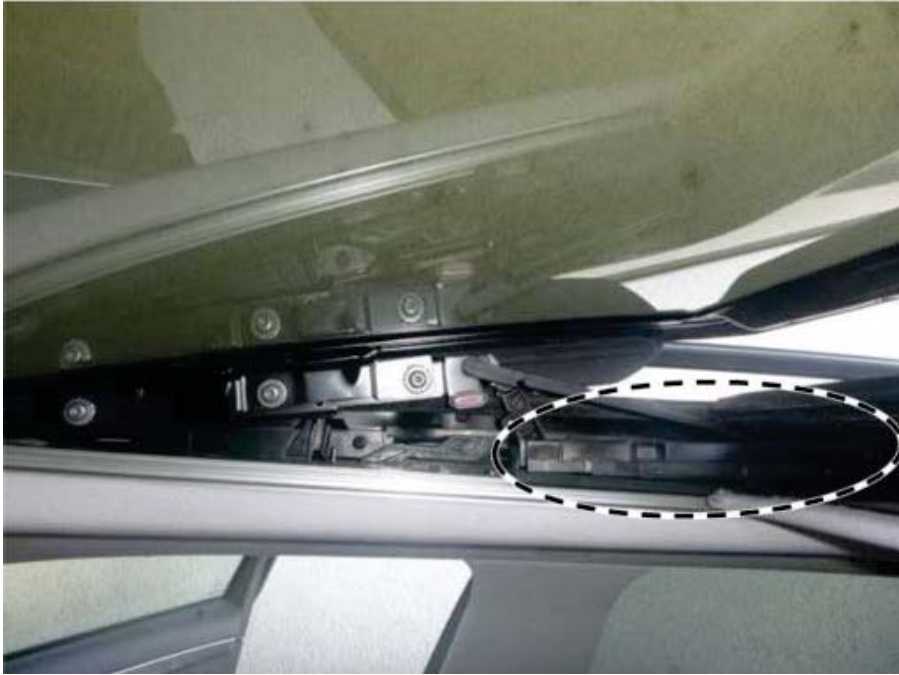
Figure 6

i The accordion boot **need** not be removed completely. It is sufficient to slide it back (**figure 6**).
