Re: Product Recall – Bulk Storage Racking Shelf Beams

Bulk Storage Beams

Bulk Storage Beams Weld Reference Guide

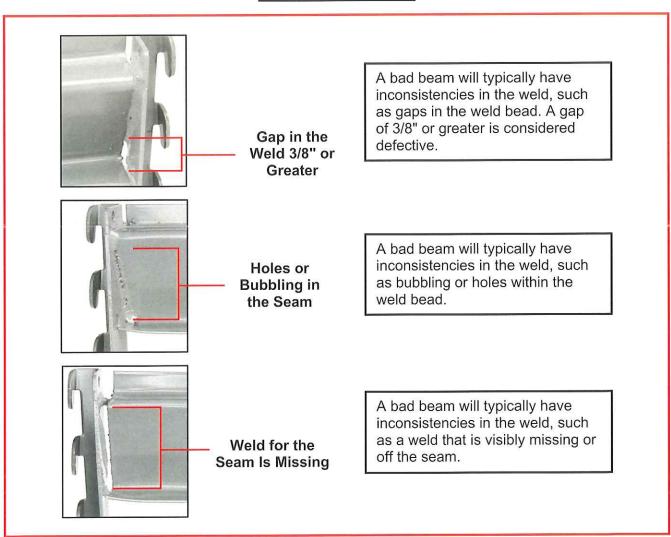
Bad Beam Examples

Our manufacturer discovered that the automated robotic welding system used for the Bulk Storage Beams could, on rare occasions, weld incorrectly. The weld bead that connects the beam and beam ends may not be centered along the seam between the components, leaving gaps or bubbling in the weld. As a result, the beam may fail when loaded. Please note, the uprights, particle boards/wire decking and shelf supports are not affected.

Please remove product from your Bulk Storage Racking and inspect your beams immediately. In the event that you find your product to be defective or have any questions regarding this voluntary recall, please contact Uline's Customer Service Department at 1-800-295-5510 or customer.service@uline.com for information on how to receive a replacement beam.
