SUBJECT: NEW VEHICLE DEMONSTRATION / DELIVERY HOLD

Safety Recall 20S50 - Supplement #1
Certain 2020 Model Year Explorer Vehicles

Second Row Center Seat Belt Buckle Bolt Not Properly Secured to Seat

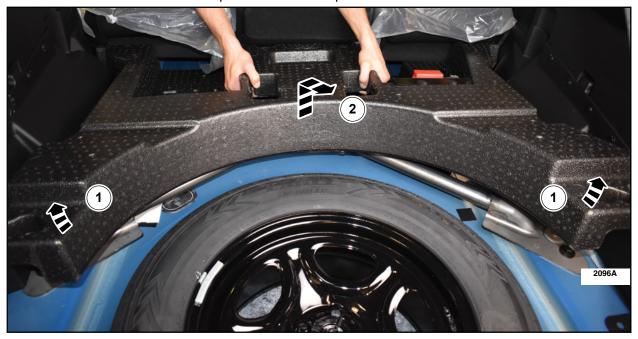
FIGURE 1

**NOTE:** To aid in the removal and prevention of damage of the loadspace floor rear trim panel, use the lifting locations shown. See Figure 1.

- 1. Using the lifting locations shown, raise the two ends of the loadspace floor rear trim panel.
- 2. Using the lifting locations shown, lift upwards and towards the rear of the vehicle to remove the loadspace floor rear trim panel.
