SUBJECT: **NEW VEHICLE DEMONSTRATION / DELIVERY HOLD**
Compliance Recall 20C19 - Supplement #1
 Certain 2020 Model Year Multiple Vehicle Lines
 Rear View Camera Improper Function

CERTAIN 2020 MODEL YEAR MULTIPLE VEHICLE LINES — REAR VIEW CAMERA IMPROPER FUNCTION

SERVICE PROCEDURE

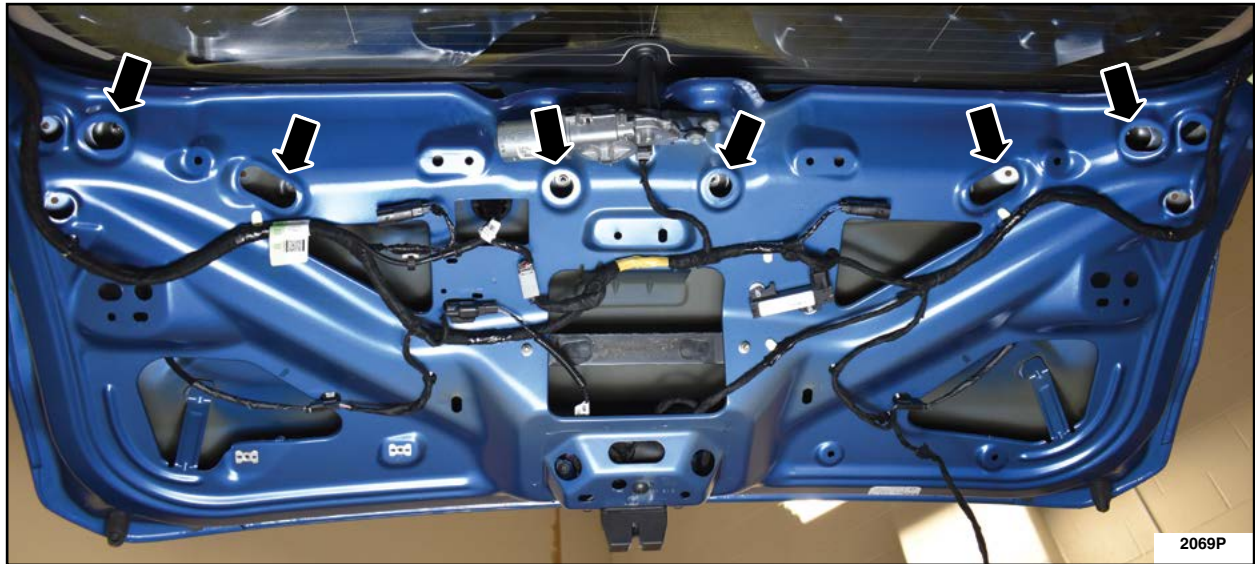
FIGURE 2

1. Remove the Reversing Lamps. Please follow the Workshop Manual (WSM) procedures in Section 417-01.
2. Remove the six (6) retainers holding the liftgate moulding to the liftgate panel. See Figure 2.

• Torque to: 28 lb.in (3.2 Nm).

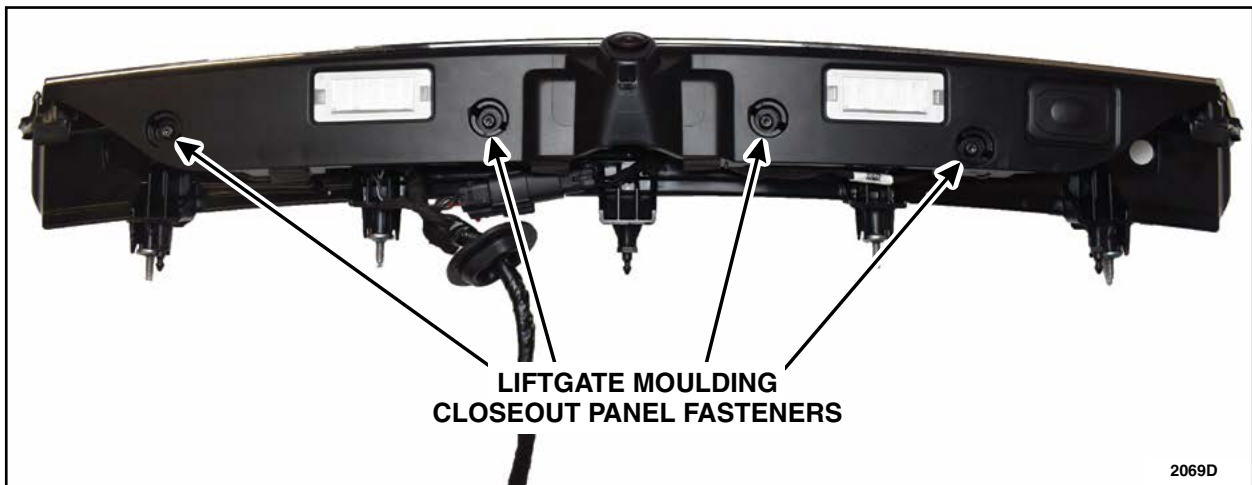
FIGURE 9

4. Remove the four (4) liftgate moulding closeout panel fasteners. See Figure 9.

- Tighten to: 15 in.lbs (1.7 Nm).

11. Install the four (4) closeout panel to liftgate moulding assembly fasteners. See Figure 9.
12. Install the four (4) closeout panel fastener covers. See Figure 8.
13. Install the Liftgate Moulding. Please follow the WSM procedures in Section 501-08.
14. Install both Rear Lamp Assemblies. Please follow the WSM procedures in Section 417-01.
15. Using a diagnostic scan tool, configure the rear parking aid camera.

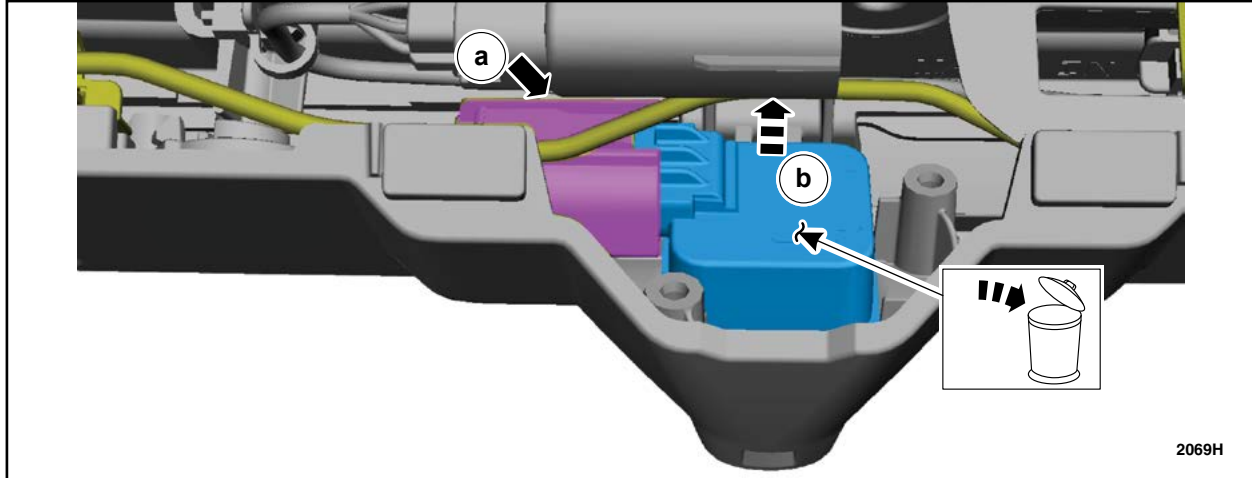
FIGURE 12

7. Disconnect the electrical connector (a) and remove and discard the rear parking aid camera (b).
See Figure 12.

8. Install the *new* rear parking aid camera by reversing Step 7. See Figure 12.

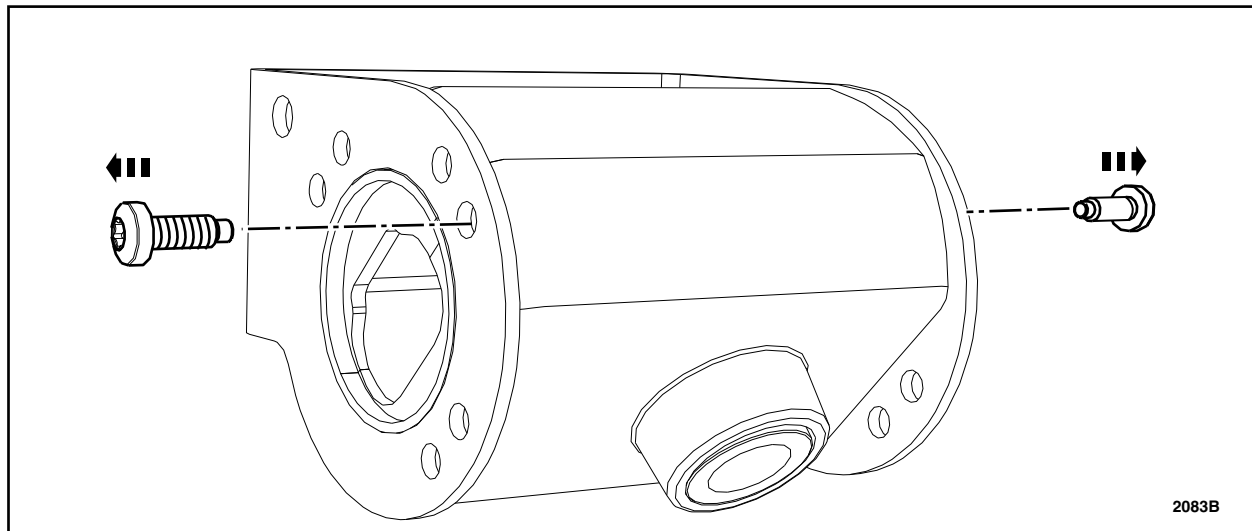
FIGURE 15

2. Make note of the fastener location on the camera bracket and remove the two (2) short camera to bracket fasteners (one on each side) and remove the camera assembly from the bracket. See Figure 15.

6. Position the camera and housing assembly into the mounting bracket. Rotate the camera until it aligns with the original alignment slots (noted before removal). Install a short screw on both sides to secure the camera in this position on the mounting bracket. See Figure 15.

- Tighten the screws to: 0.7 Nm (6.19 lb-in).
