## IMPORTANT SAFETY RECALL

Re: Safety Recall Notice NHTSA Recall ID# 20V-728

### PTO Model Number Identification Instructions

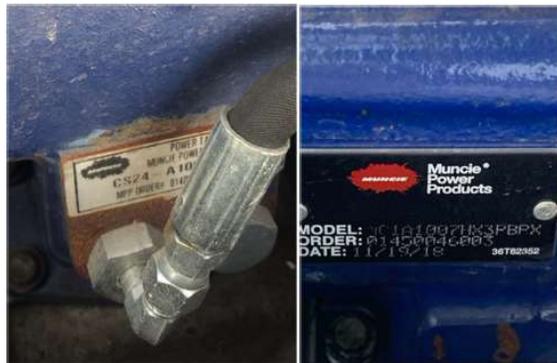
To identify your PTO model, you will need to check the first 4 digits on the ID plate. The ID plate is located on the side of the PTO. If the first 4 digits are MC1A you will need a Rear Cover/Solenoid conversion kit. If the first 4 digits are CS24 you will NOT need a Rear Cover/Solenoid conversion kit. See the following photos to aid in determining what PTO your Aerial is equipped with.

How is this safety recall resolved: We are telling the customers to contact Rosenbauer or their Dealer to line up the repair of the Muncie PTO which entails a new solenoid and case. We are giving the customer the option to do it themselves and if they want to, they can contact us to obtain the replacement parts and an instructional video and instructional document. If they prefer their dealer help, we are asking to be included in your correspondence regarding their truck. Rosenbauer America will reimburse .5 hours of labor if PTO is in the 1 o'clock position and 1 hour of labor if PTO is in the 8 o'clock position.
