## RECALL CAMPAIGN BULLETIN

ITB17-021b

# VOLUNTARY SAFETY RECALL CAMPAIGN 2002-2003 QX4; FRONT PASSENGER AIR BAG INFLATOR

CAMPAIGN ID #:	R1702, R1713, R1714
NHTSA #:	15V-287, 17V-068
APPLIED VEHICLES:	2002-2003 QX4 (JR50)

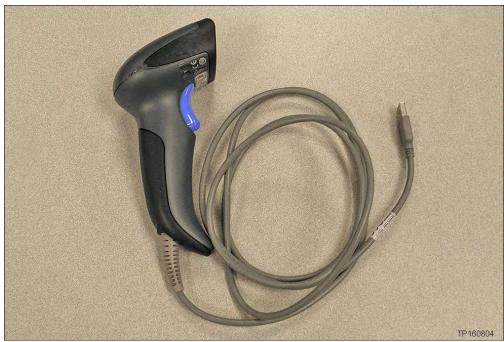
Figure B

### **REQUIRED SPECIAL TOOL (J-52352)**

Quick Scan Tool (J-52352)

- Each Infiniti retailer has been shipped one Quick Scan Tool (J-52352).
- Additional tools can be obtained from Tech•Mate: nissantechmate.com or 1-800-662-2001.
