TECHNICAL INSTRUCTIONS FOR SAFETY RECALL 20TA02

VEHICLE MAY STALL DURING DRIVING AT HIGHER SPEED

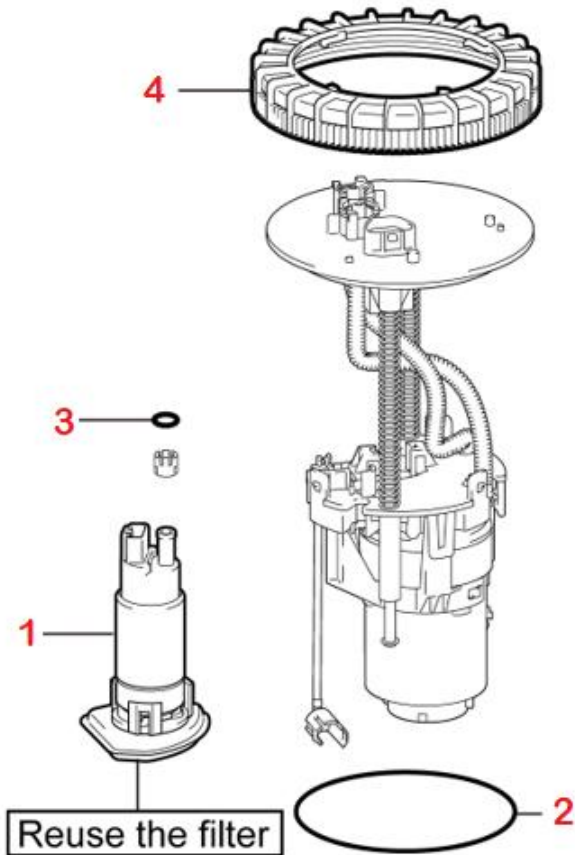
4Runner

Replacement Items in red

No.	Contents of Part Kit's	Quantity	Tape Color	Remarks
1	FUEL PUMP	1		
2	FUEL SUCTION TUBE SET GASKET	1		
3	O-RING	1	Yellow	15.2mm
4	FUEL PUMP GAUGE RETAINER	1

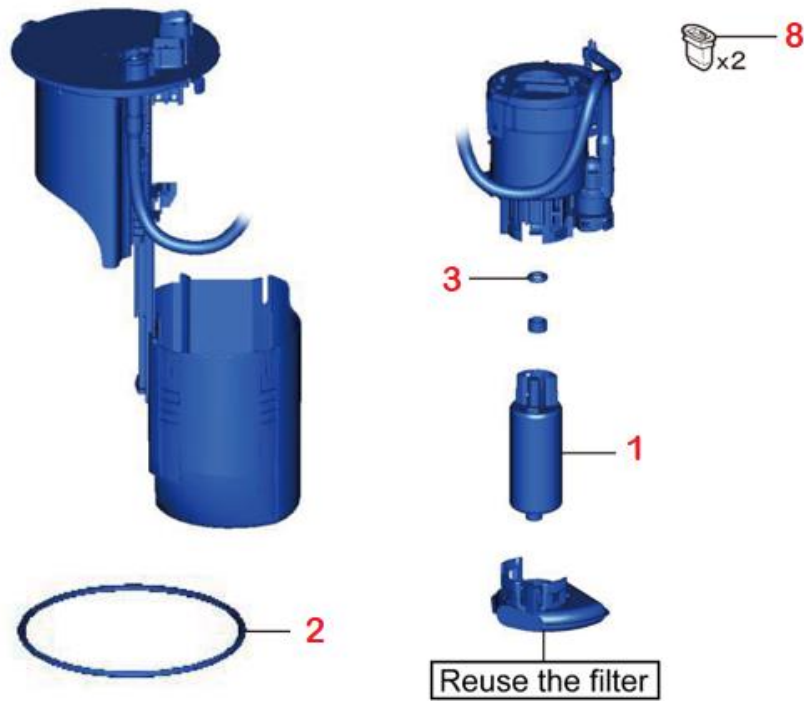
CAMRY

Replacement items in red

No.	Contents of Part Kit's	Quantity	Tape Color	Remarks
1	FUEL PUMP	1		
2	FUEL SUCTION TUBE SET GASKET	1		
3	O-RING	2*	Gold	15.2mm
4	REAR SEAT CUSHION LOCK HOOK (included in the gasket kit)	2		Not used
5	O-RING	1	Red	Not used
6	O-RING	1	Green	Not used
7	FUEL TANK PIPE SETTING HOLDER	1	White	Not used
8	REAR SEAT CUSHION LOCK HOOK (part # 04009-95106)	2

*only 1 O-Ring will be used. Discard the 2nd O-Ring.

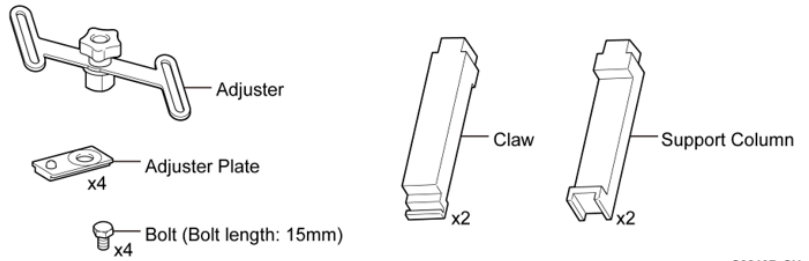
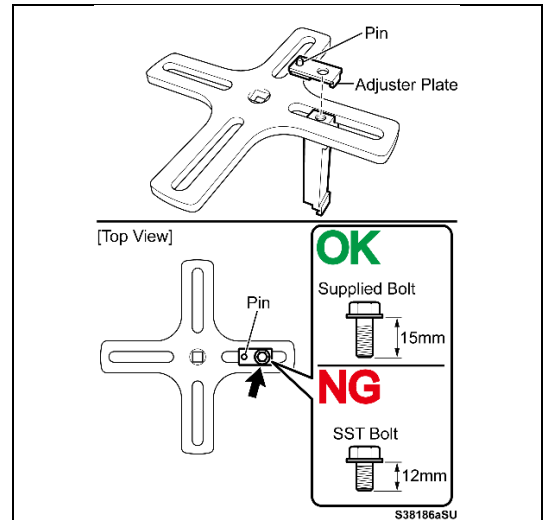
Campaign Tool Cam Lock Set:

An updated set of Cam Lock Claws and Support Columns are being supplied to each dealership for this campaign. The configuration of the retainer engagement sections of the claws have been modified from the SST that is referenced in the repair manual. The **NEW** claws have an improved design that enables a firm attachment to the retainer. In addition, 2 support columns are provided which will support the retainer more securely during installation and removal. Be sure to assemble and use the tools using the following procedures:

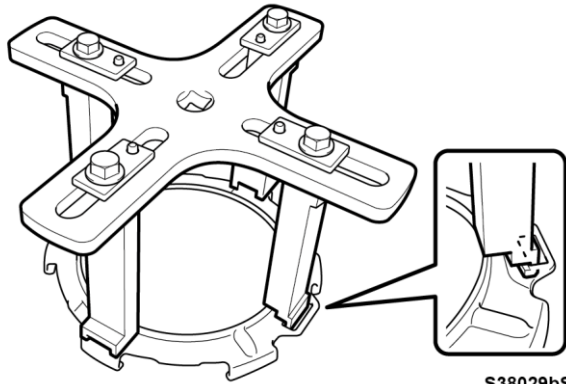
Push the claw inward firmly.

Check that the claw is engaging with the retainer.

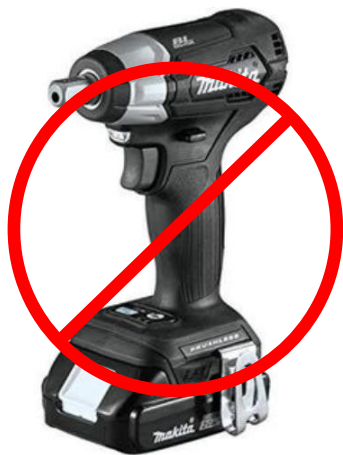
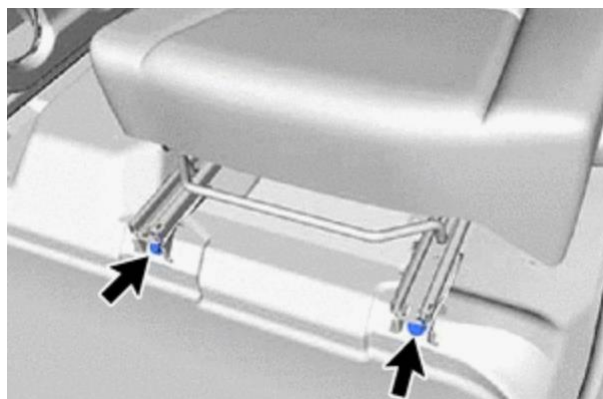
When removing and reinstalling the Highlander 2nd row seats, do not use an impact on the seat retaining bolts. Only use hand tools. The use of an impact may cause the welded nuts on the inside of the floorboard channel to break free of the sheet metal, causing an extensive repair. Be sure to properly torque the bolts during reassembly.
