TECHNICAL INSTRUCTIONS FOR SAFETY RECALL 20TA02

VEHICLE MAY STALL DURING DRIVING AT HIGHER SPEED

2018 – 2019 Sequoia	2018 – 2020 Camry	2018 – 2020 Avalon
2018 – 2020 Tundra	2014 FJ Cruiser	2014 – 2015 4Runner
2018 – 2020 Corolla	2018 – 2019 Highlander	2017 – 2020 Sienna**
2018 – 2019 Tacoma	2014 – 2015 Land Cruiser	2019 RAV4 (Japan Produced)
2019 Corolla Hatchback

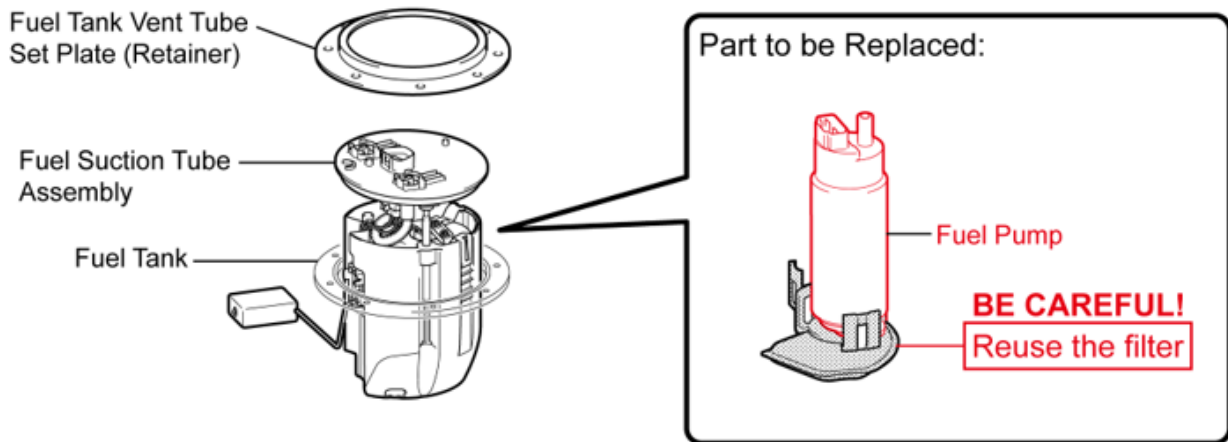
S38182aSU

The subject vehicles are equipped with a low-pressure fuel pump which may stop operating. If this were to occur, warning lights and messages may be displayed on the instrument panel, and the engine may run rough. This may result in a vehicle stall, and the vehicle may be unable to be restarted. If a vehicle stall occurs while driving at higher speeds, this could increase the risk of a crash.

*The configuration of the parts will differ depending on the specification.

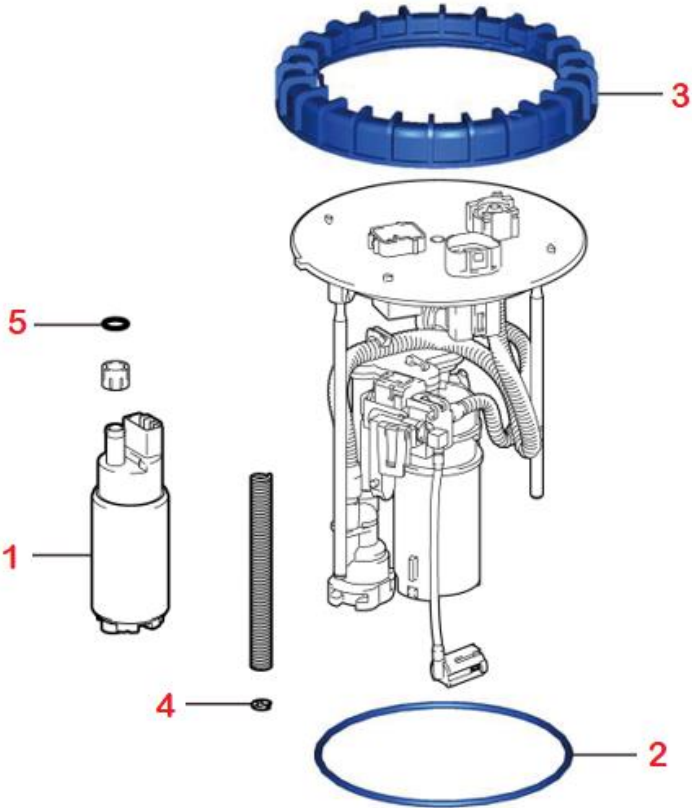
HIGHLANDER

Replacement items in red

No.	Contents of Part Kit's	Quantity	Tape Color	Remarks
1	FUEL PUMP	1		
2	FUEL SUCTION TUBE SET GASKET	1		
3	FUEL PUMP GAUGE RETAINER	1		
4	FUEL TANK PIPE SETTING HOLDER	1		
5	O RING	1	(not labeled)

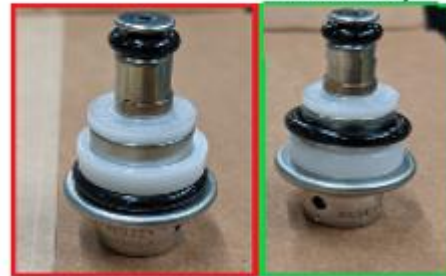
Incorrect Main Valve Assembly **Correct** Main Valve Assembly

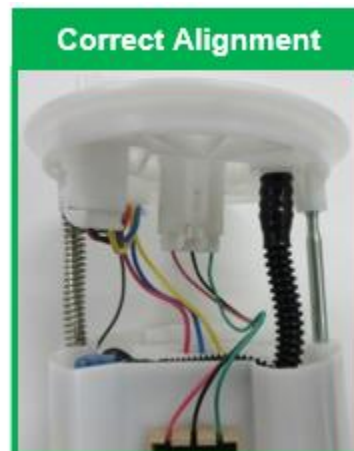
When assembling the upper and lower sections of the fuel pump assembly, be certain to correctly align the upper and lower sections as to not twist the fuel tube.
