### TECHNICAL INSTRUCTIONS

### SAFETY RECALL 20TA02

#### VEHICLE MAY STALL DURING DRIVING AT HIGHER SPEED

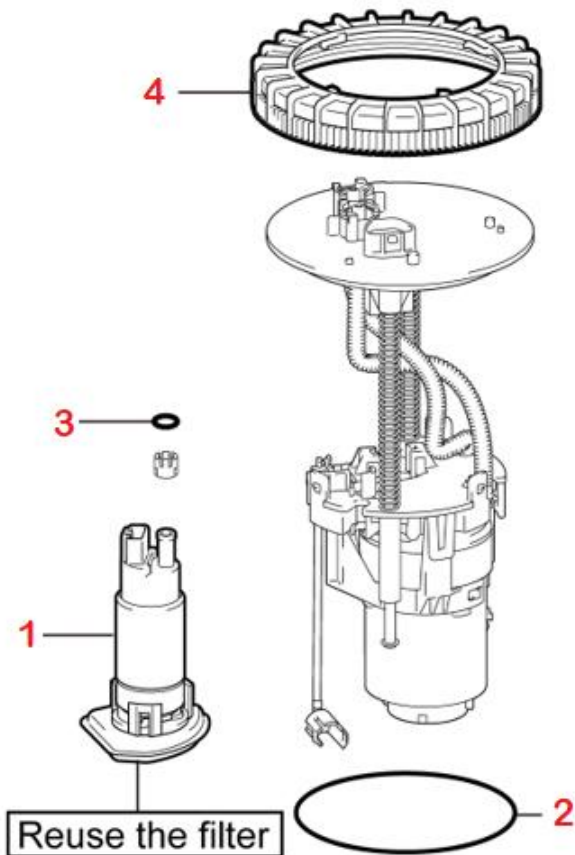
4Runner

Replacement Items in red

No.	Contents of Part Kit's	Quantity	Tape Color	Remarks
1	FUEL PUMP	1		
2	FUEL SUCTION TUBE SET GASKET	1		
3	O-RING	1	Yellow	15.2mm
4	FUEL PUMP GAUGE RETAINER	1

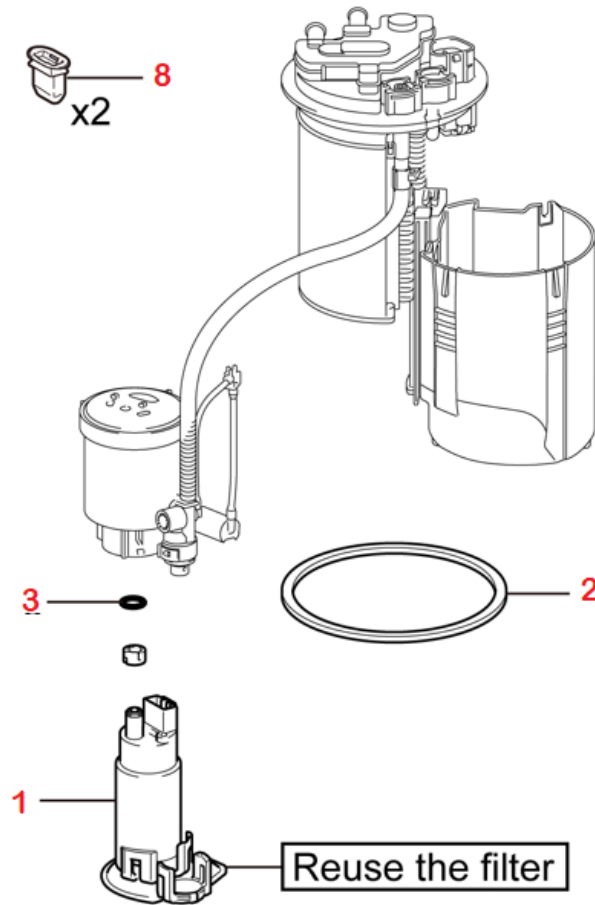
**AVALON 2019 - 2020**

Replacement items in red

No.	Contents of Part Kit's	Quantity	Tape Color	Remarks
1	FUEL PUMP	1		
2	FUEL SUCTION TUBE SET GASKET	1		
3	O-RING	2*	Gold	15.2mm
4	REAR SEAT CUSHION LOCK HOOK (included in the gasket kit)	2		Not used
5	O-RING	1	Red	Not used
6	O-RING	1	Green	Not used
7	FUEL TANK PIPE SETTING HOLDER	1	White	Not used
8	REAR SEAT CUSHION LOCK HOOK (part # 04009-95106)	2

\*only 1 O-Ring will be used. Discard the 2<sup>nd</sup> O-Ring.

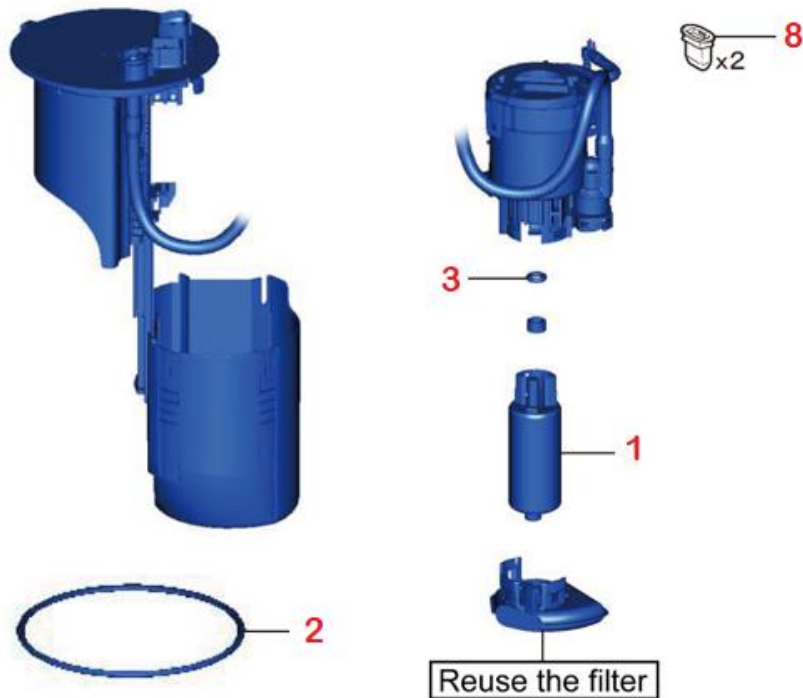
**CAMRY**  
2GR-FSE 3.5

Replacement items in red

No.	Contents of Part Kit's	Quantity	Tape Color	Remarks
1	FUEL PUMP	1		
2	FUEL SUCTION TUBE SET GASKET	1		
3	O-RING	2*	Gold	15.2mm
4	REAR SEAT CUSHION LOCK HOOK (included in the gasket kit)	2		Not used
5	O-RING	1	Red	Not used
6	O-RING	1	Green	Not used
7	FUEL TANK PIPE SETTING HOLDER	1	White	Not used
8	REAR SEAT CUSHION LOCK HOOK (part # 04009-95106)	2

\*only 1 O-Ring will be used. Discard the 2<sup>nd</sup> O-Ring.

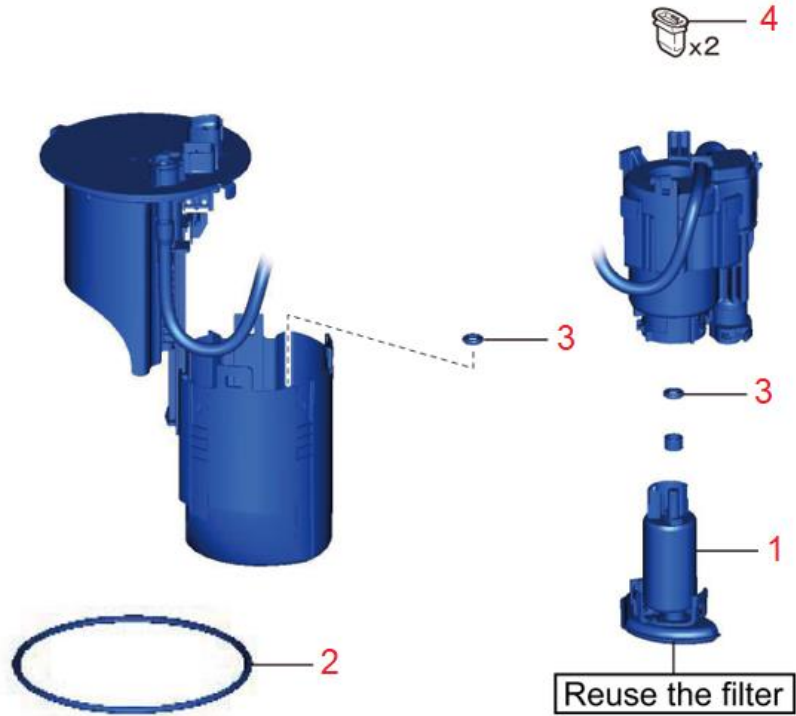
CAMRY  
A25A-FSE 2.5  
VIN: (JTN)

Replacement items in red

No.	Contents of Part Kit's	Quantity	Tape Color	Remarks
1	FUEL PUMP	1		
2	FUEL SUCTION TUBE SET GASKET	1		
3	O-RING	2	Gold	15.2mm
4	REAR SEAT CUSHION LOCK HOOK (included in the gasket kit)	2		
5	O-RING	1	Red	Not used
6	O-RING	1	Green	Not used
7	FUEL TANK PIPE SETTING HOLDER	1	White	Not used

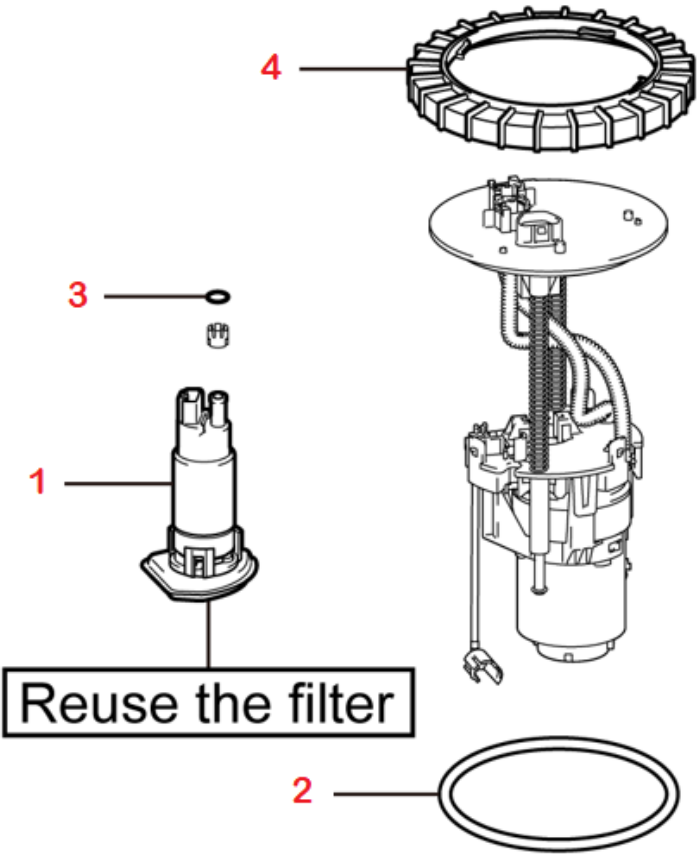
FJ CRUISER

Replacement items in red

No.	Contents of Part Kit's	Quantity	Tape Color	Remarks
1	FUEL PUMP	1		
2	FUEL SUCTION TUBE SET GASKET	1		
3	O-RING	1	Yellow	15.2mm
4	FUEL PUMP GAUGE RETAINER	1

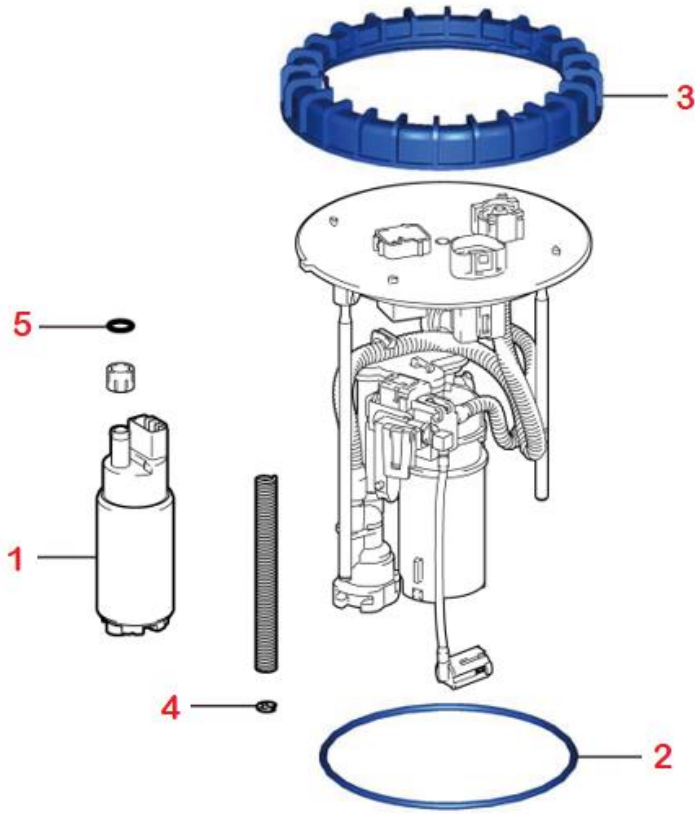
# HIGHLANDER

Replacement items in red

No.	Contents of Part Kit's	Quantity	Tape Color	Remarks
1	FUEL PUMP	1		
2	FUEL SUCTION TUBE SET GASKET	1		
3	FUEL PUMP GAUGE RETAINER	1		
4	FUEL TANK PIPE SETTING HOLDER	1		
5	O RING	1	(not labeled)

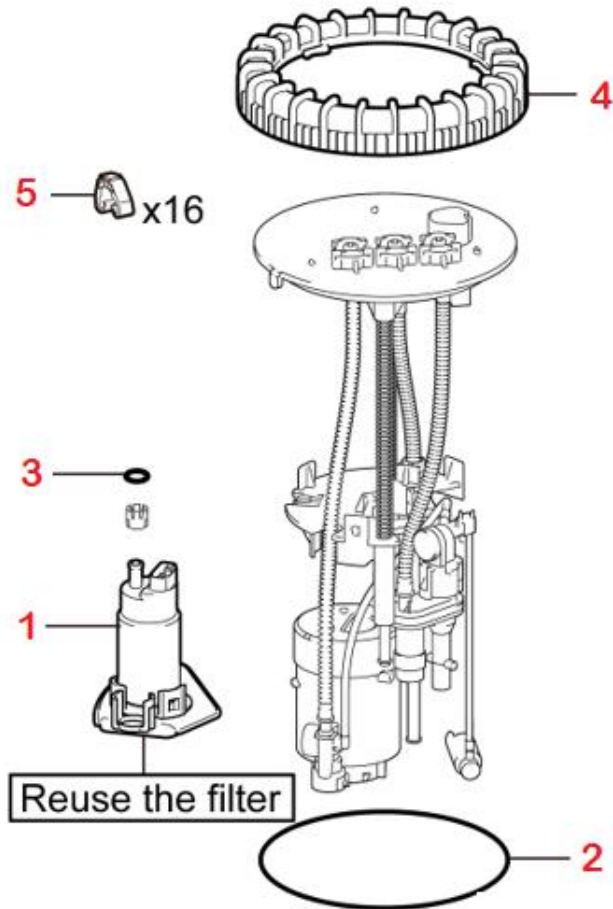
# LANDCRUISER

Replacement items in red

No.	Contents of Part Kit's	Quantity	Tape Color	Remarks
1	FUEL PUMP	1		
2	FUEL SUCTION TUBE SET GASKET	1		
3	O-RING	1	Yellow	15.2mm
4	FUEL PUMP GAUGE RETAINER	1		
5	TUBE JOINT CLIPS	16

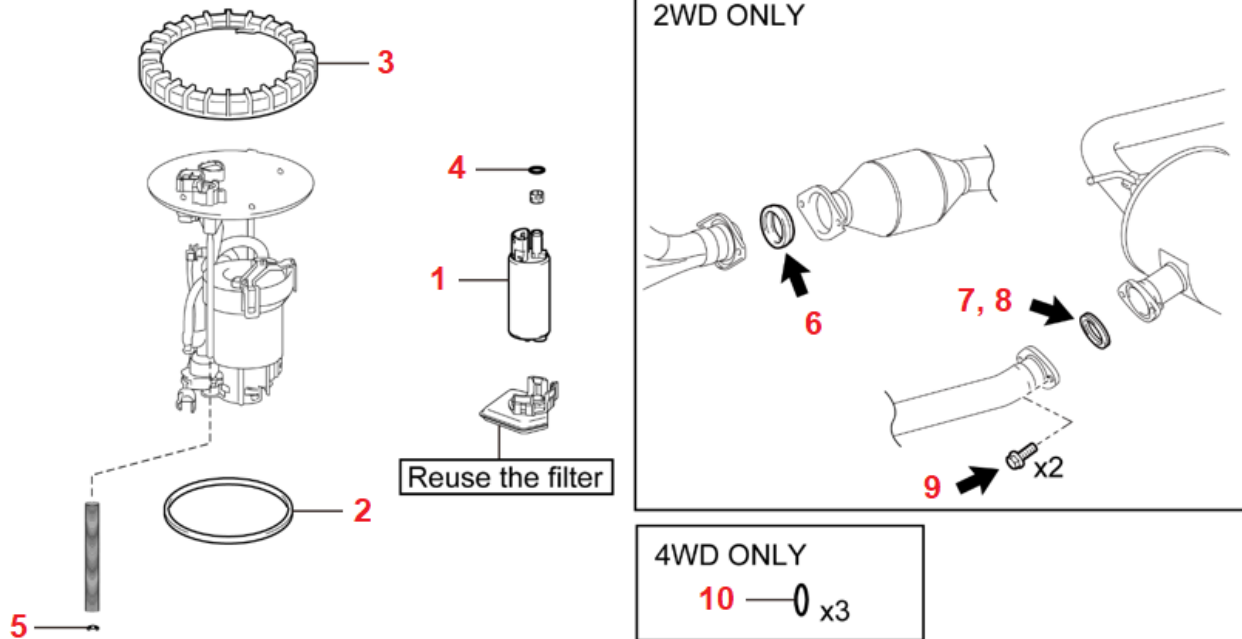
# SIENNA

Replacement items in red

No.	Contents of Part Kit's	Quantity	Tape Color	Remarks
1	FUEL PUMP	1		
2	FUEL SUCTION TUBE SET GASKET	1		
3	FUEL PUMP GAUGE RETAINER	1		
4	O-RING	1	(not labeled)	
5	FUEL TANK PIPE SETTING HOLDER	1		
6	EXHASUT PIPE GASKET (2WD)	1		16.4mm
7	EXHASUT PIPE GASKET (2WD)	1		
8	EXHASUT PIPE GASKET (2WD)	1		
9	FLANGE BOLT (2WD)	2		
10	DRAIN PLUG GASKET (4WD)	3

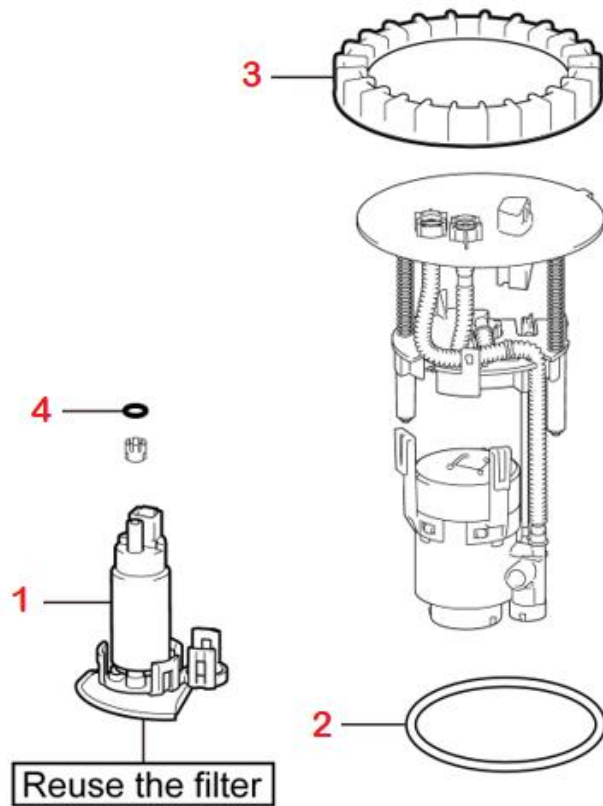
SEQUOIA  
TUNDRA

Replacement items in red

No.	Contents of Part Kit's	Quantity	Tape Color	Remarks
1	FUEL PUMP	1		
2	FUEL SUCTION TUBE SET GASKET	1		
3	FUEL PUMP GAUGE RETAINER	1		
4	O-RING	1	(not labeled)

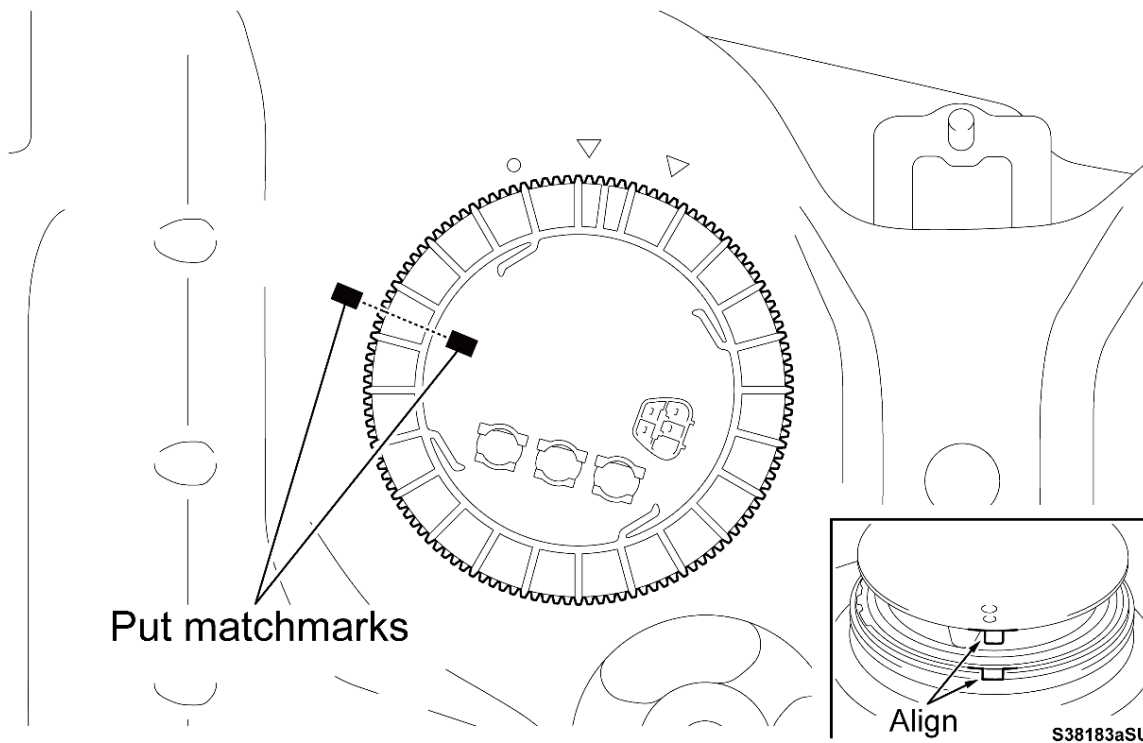
## REMOVAL TIP: TUBE ASSY ALIGNMENT

For vehicles with the plastic retainer rings, place matchmarks on both the Fuel Tube Assembly and the fuel tank. During disassembly, confirm that the Fuel Tube Assembly does not rotate. During reassembly, this will aid in aligning the locating tabs for proper installation.

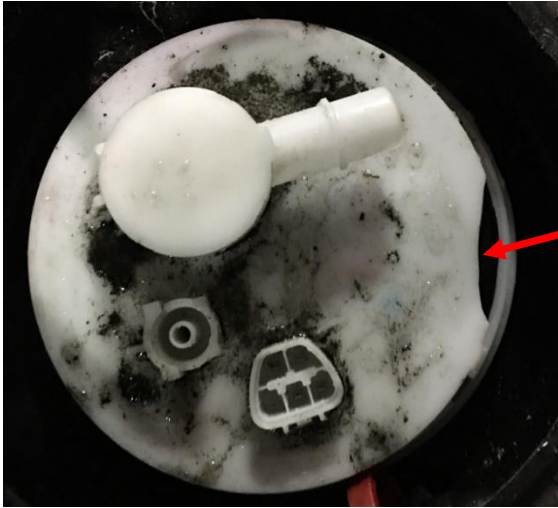
Corolla models have been identified to experience breakage of the Fuel Tube Assembly during disassembly. In order to prevent damage to the Fuel Tube Assembly during removal, perform the procedure detailed in the following steps.

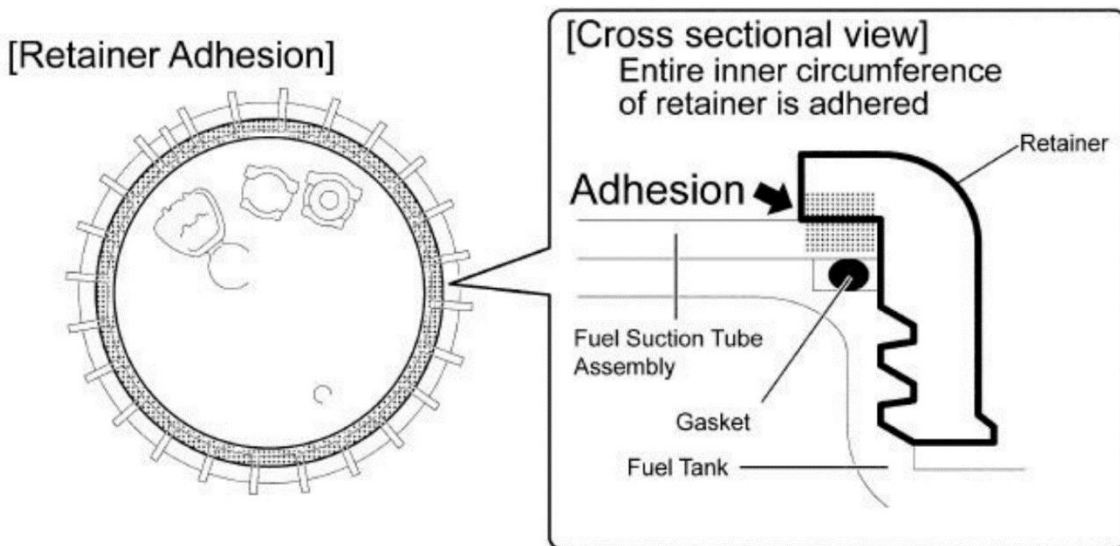
Example of Damaged Fuel Tube Assembly

The damage during disassembly is caused by adhesion, or “sticking”, of the Retainer Ring and the Fuel Tube Assembly. When the Retainer Ring is rotated on the stationary Fuel Tube assembly, the portions that are “stuck” together are under a very high load and may break off.

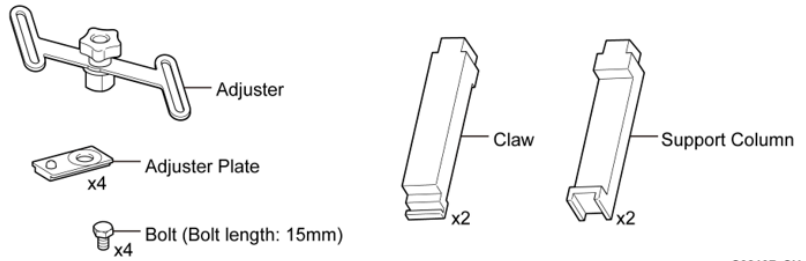
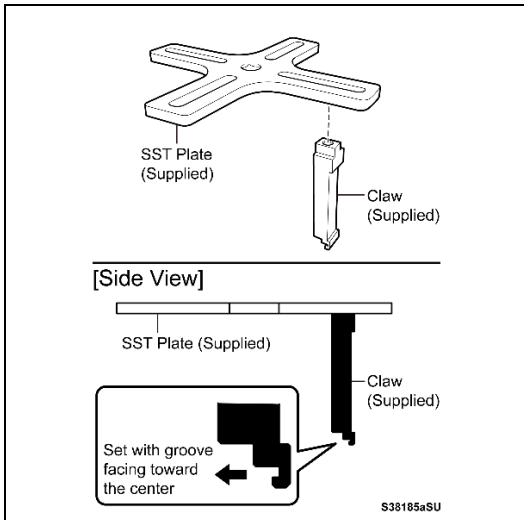
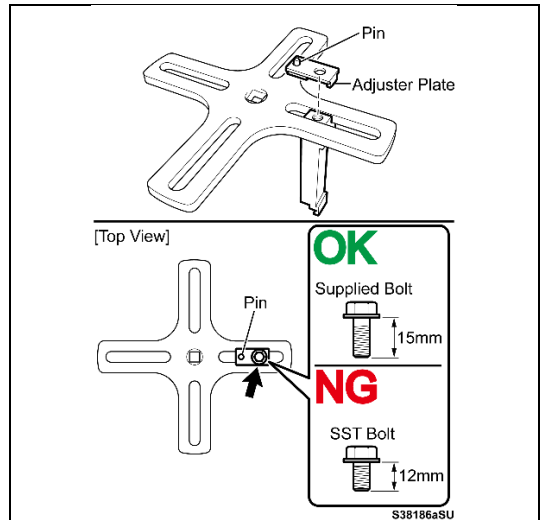
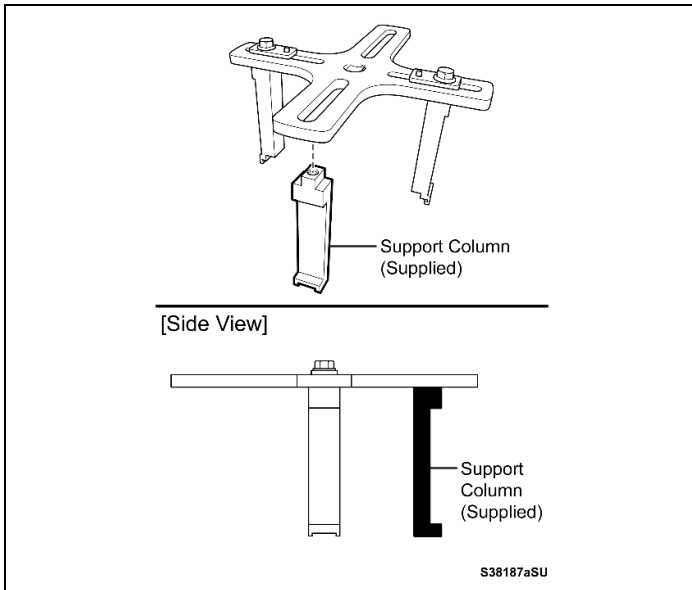
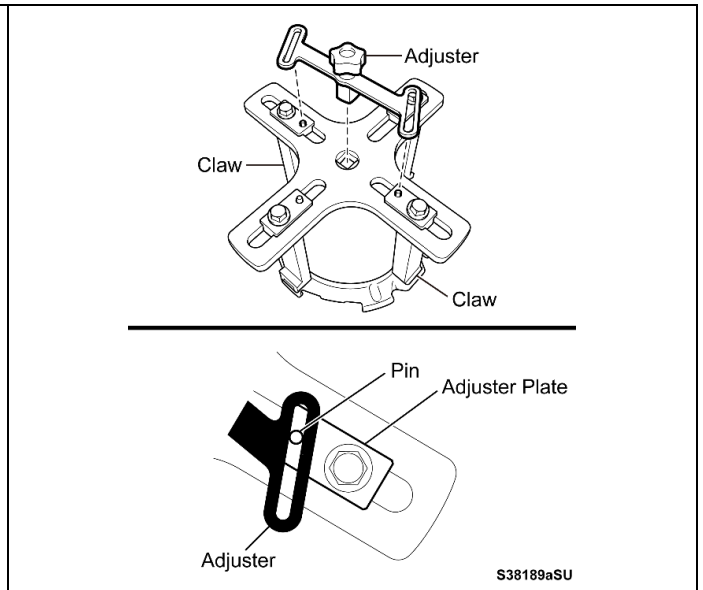
### Campaign Tool Cam Lock Set:

An updated set of Cam Lock Claws and Support Columns are being supplied to each dealership for this campaign. The configuration of the retainer engagement sections of the claws have been modified from the SST that is referenced in the repair manual. The **NEW** claws have an improved design that enables a firm attachment to the retainer. In addition, 2 support columns are provided which will support the retainer more securely during installation and removal. Be sure to assemble and use the tools using the following procedures:

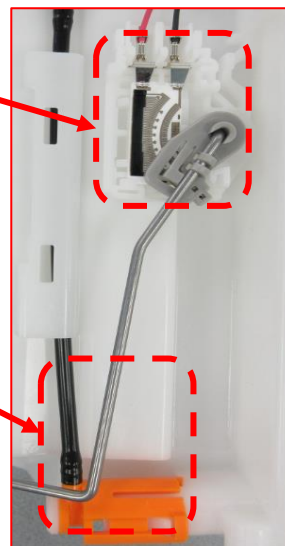
When removing and reinstalling the Fuel Level Sender from the fuel tank, take extra care with the arm of the fuel sender. It can be easily bent. Additionally, do not touch the electric circuit of the sender assembly.

Do not deform the arm of the fuel sender gauge.

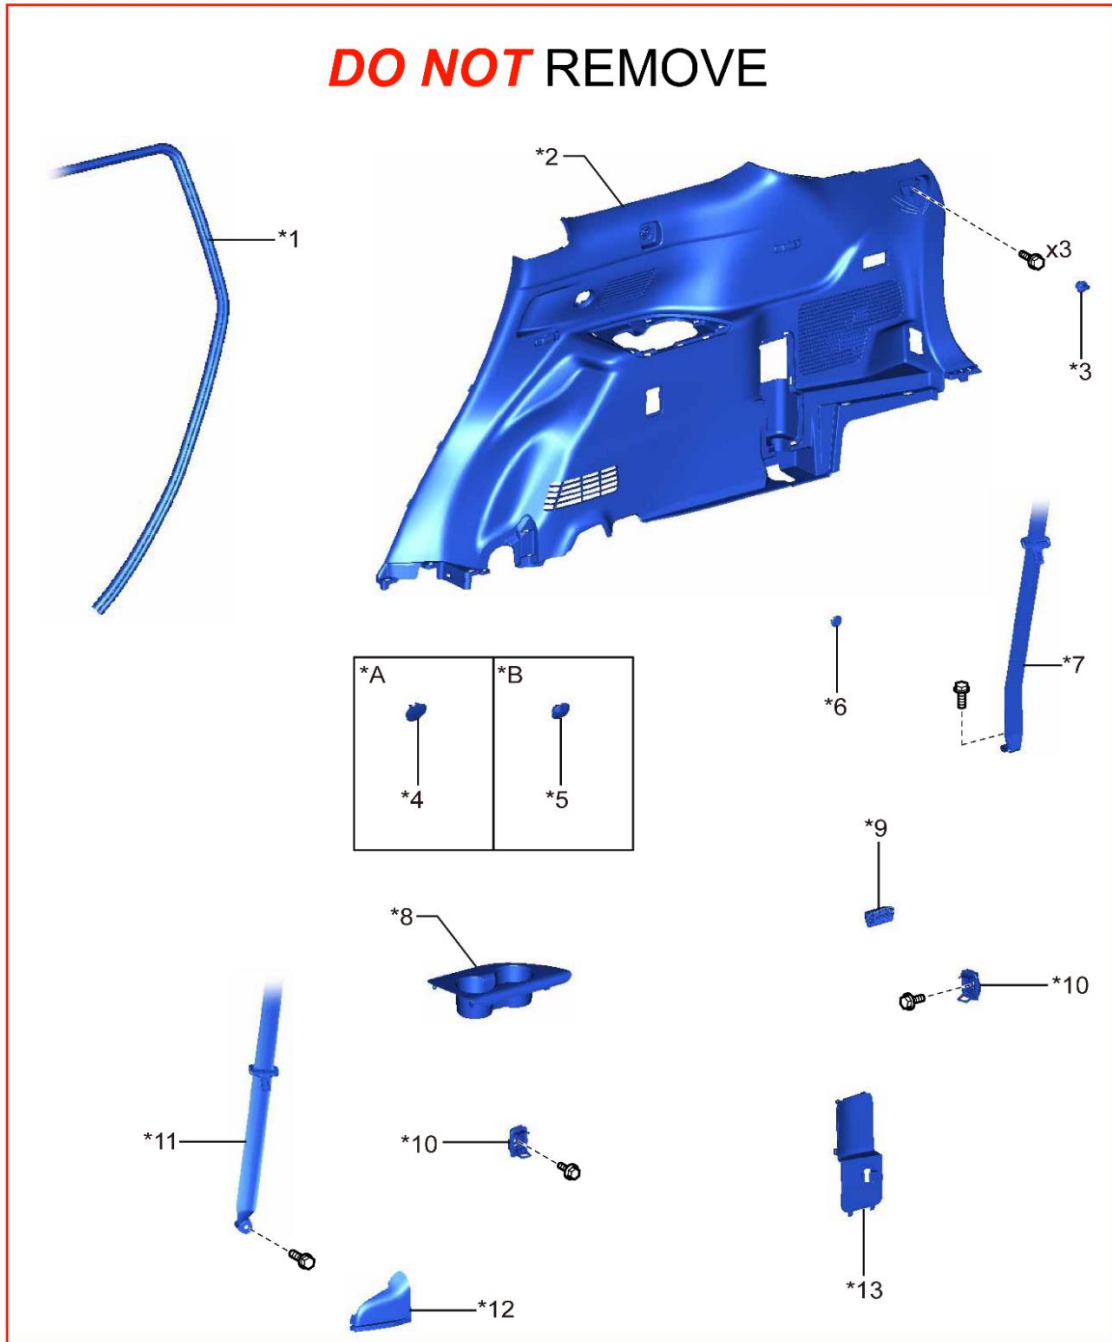
S54080aS

*A	w/o Rear Automatic Air Conditioning System	*B	w/ Rear Automatic Air Conditioning System
*1	REAR DOOR OPENING TRIM WEATHERSTRIP RH	*2	DECK TRIM SIDE PANEL ASSEMBLY RH
*3	NO. 1 LUGGAGE COMPARTMENT TRIM HOOK	*4	SIDE TRIM COVER RH
*5	COOLER (NO. 2 ROOM TEMP. SENSOR) THERMISTOR	*6	DECK TRIM POCKET COVER
*7	REAR NO. 2 SEAT OUTER BELT ASSEMBLY RH	*8	NO. 1 DECK SIDE TRIM COVER
*9	NO. 1 LUGGAGE COMPARTMENT LIGHT ASSEMBLY	*10	ROPE HOOK
*11	REAR NO. 1 SEAT OUTER BELT ASSEMBLY RH	*12	FRONT DECK SIDE TRIM COVER RH
*13	DECK TRIM SIDE BELT HOLE COVER RH	-	-

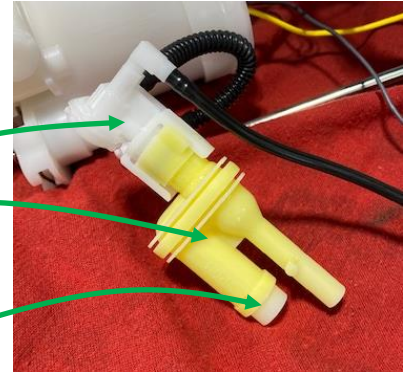
#### Example of Proper Disassembly:

Repair Manual: Using a screwdriver (\*a) with its tip wrapped in protective tape, remove the jet pump from the No. 1 fuel sub-tank.

Tube still attached

Replacement O-Ring will be installed in this location

The Part's Kit contains the necessary O-Rings for reassembly, if the Repair Manual procedure is followed. If the pump components are disassembled in a manner other than as detailed in the Repair Manual, the Parts Kit may not contain the necessary O-Rings for proper reassembly. Please follow the procedures in the Repair Manual to ensure the correct O-Rings are available.

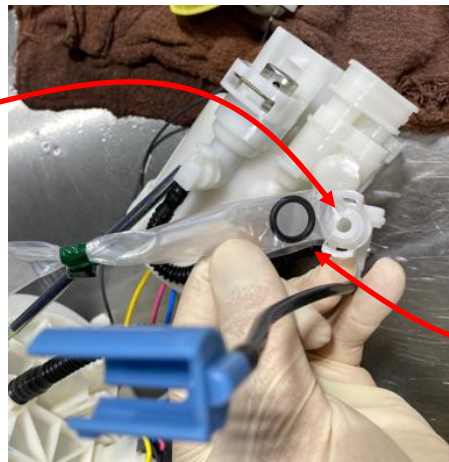
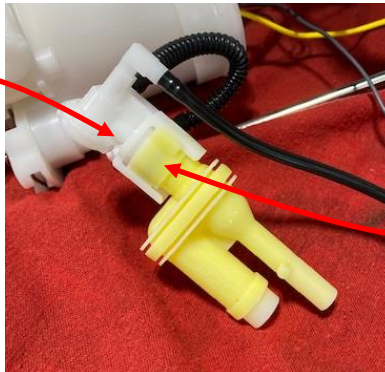
#### Example of Incorrect Disassembly:

Tube incorrectly removed from jet pump

Replacement O-ring is the incorrect size

DO NOT disconnect the tube from the jet pump

Replacement O-Ring is NOT provided for this location

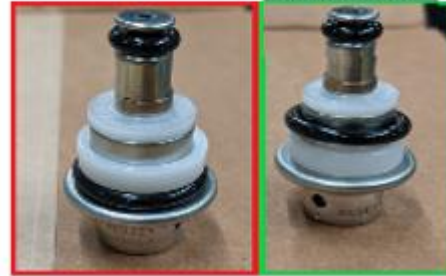
**Incorrect** Main Valve Assembly      **Correct** Main Valve Assembly

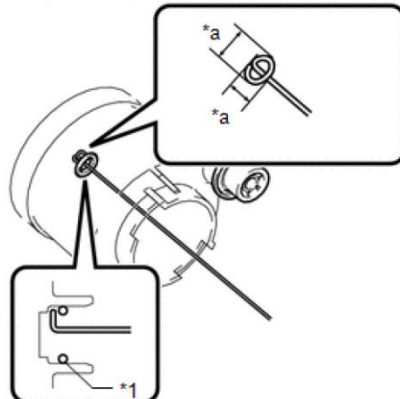
During disassembly, the O-Ring may remain in the fuel pump housing. Be sure to inspect the housing after removing the fuel pump and remove the O-Ring if necessary.

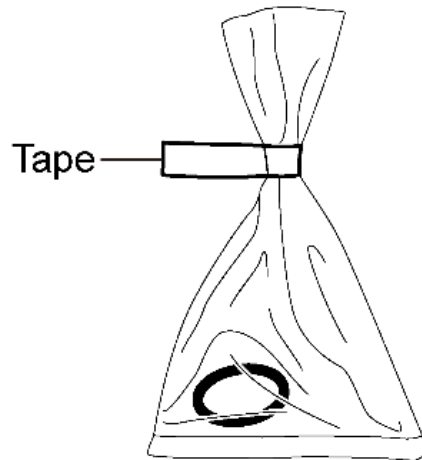
S38058aSU

The part kits may come with O-Rings of different sizes. They are very difficult to tell apart visually. To identify the different size O-Rings, they will be wrapped in individual plastic bags with a piece of **COLORED TAPE** sealing it. The **COLOR OF THE TAPE** will identify the O-Ring size. **REFER TO THE COMPONENT DIAGRAMS TO DETERMINE TO CORRECT O-RING**, as identified by the tape color.

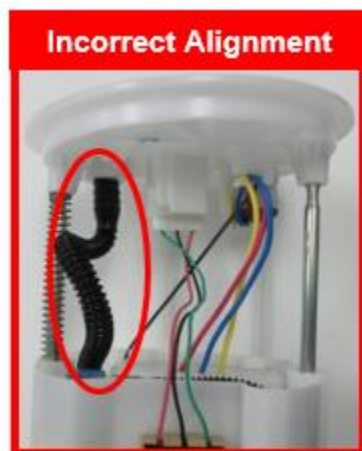
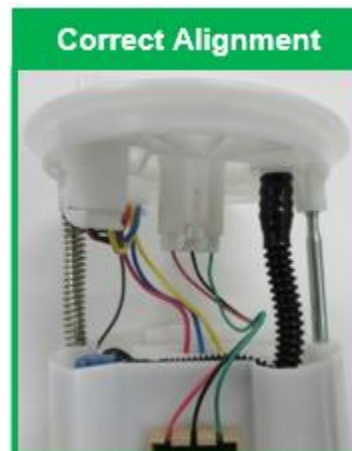
When assembling the upper and lower sections of the fuel pump assembly, be certain to correctly align the upper and lower sections as to not twist the fuel tube.

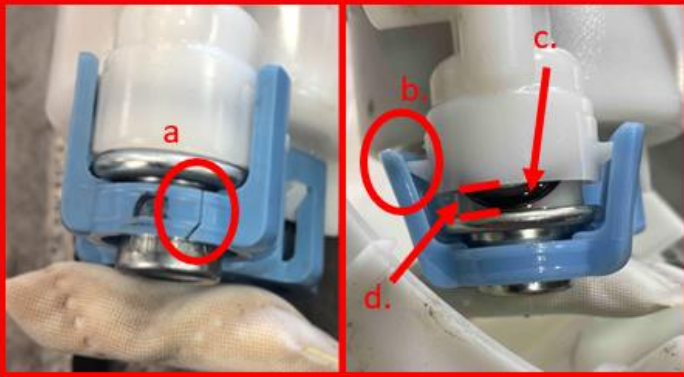
### Filter Retainer Installation – Incorrect Assembly

#### Incorrect Conditions:

- a. Crack in retainer
- b. Retainer claw below attachment point
- c. Incorrect position of O-Ring
- d. Gap visible between housing and valve

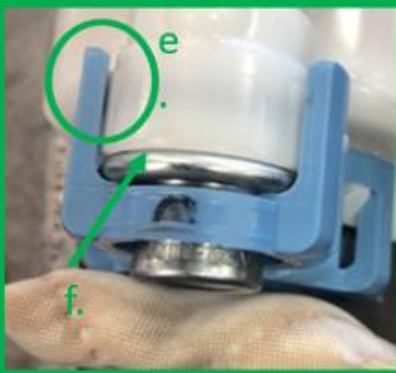
### Filter Retainer Installation – Correct Assembly

- Crack in the retainer
- Claws are properly engaged
- O-Ring is properly seated
- No gap between the housing and main valve

#### Good Condition

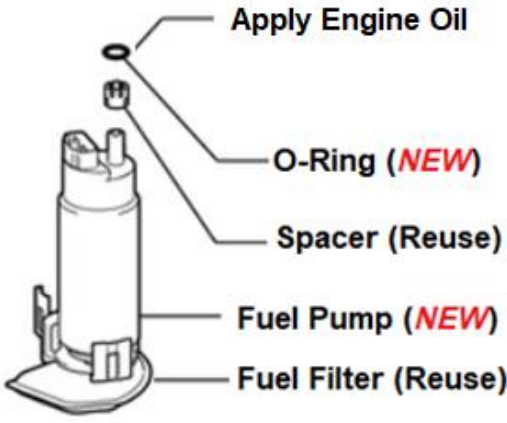
### Example Procedure:

<p><b>HINT:</b> The reused filter may be discolored.</p>	<ul style="list-style-type: none"><li>• Remove the original O-Ring, Spacer and Fuel Filter from the original Fuel Pump.</li><li>• Discard the original O-Ring and Fuel Pump, <u>saving the Spacer and Fuel Filter.</u></li><li>• Install the original Spacer onto the <b>NEW</b> Fuel Pump.</li><li>• Install the <b>NEW</b> O-Ring onto the <b>NEW</b> Fuel Pump. Refer to the Component Diagram to determine to proper O-Ring, as identified by the colored tape on the bag.</li><li>• Apply a small amount of engine oil to the <b>NEW</b> O-Ring to assure correct installation into the Tube Assembly.</li><li>• Install the original Fuel Filter onto the <b>NEW</b> Fuel Pump.</li><li>• Refer to the <u>Components diagrams</u> to review the other <b>NEW</b> parts to install.</li></ul>
---	--

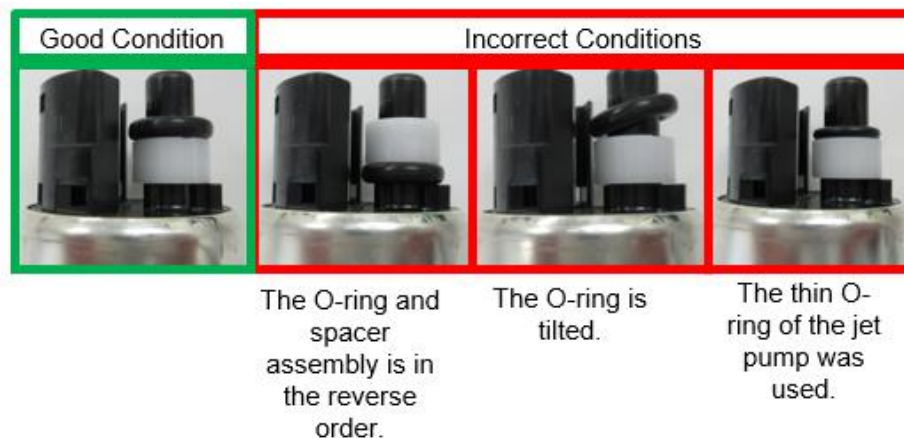
**Note:** Fuel Pump O-Ring installation is critical to this repair. A visual inspection of the final assembly will confirm the correct installation.

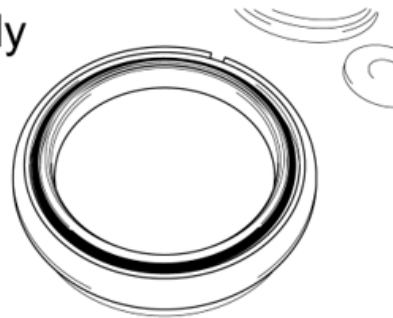
**DO NOT** apply  
silicon grease

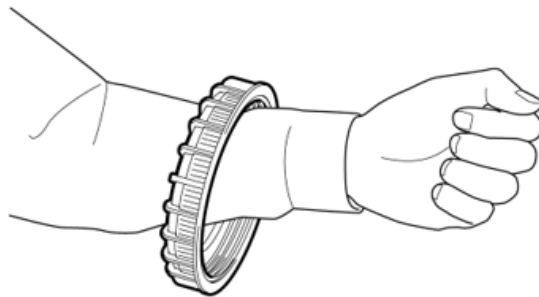
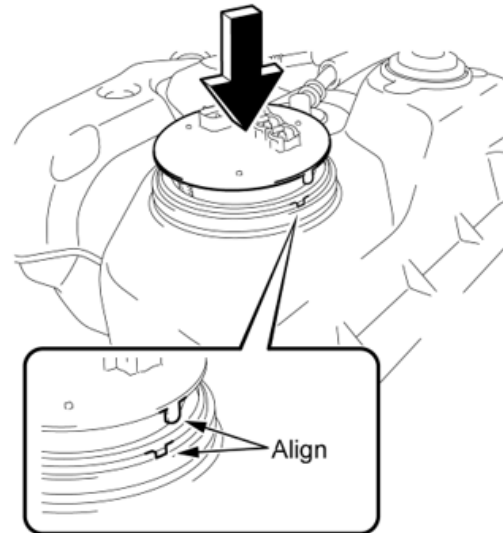
S38184aSU

Keep pressing down the fuel suction  
tube while installing the retainer.
