TECHNICAL INSTRUCTIONS FOR SAFETY RECALL 20TA02

VEHICLE MAY STALL DURING DRIVING AT HIGHER SPEED

2018 – 2019 Sequoia
2018 – 2019 Tundra
2018 – 2019 Corolla

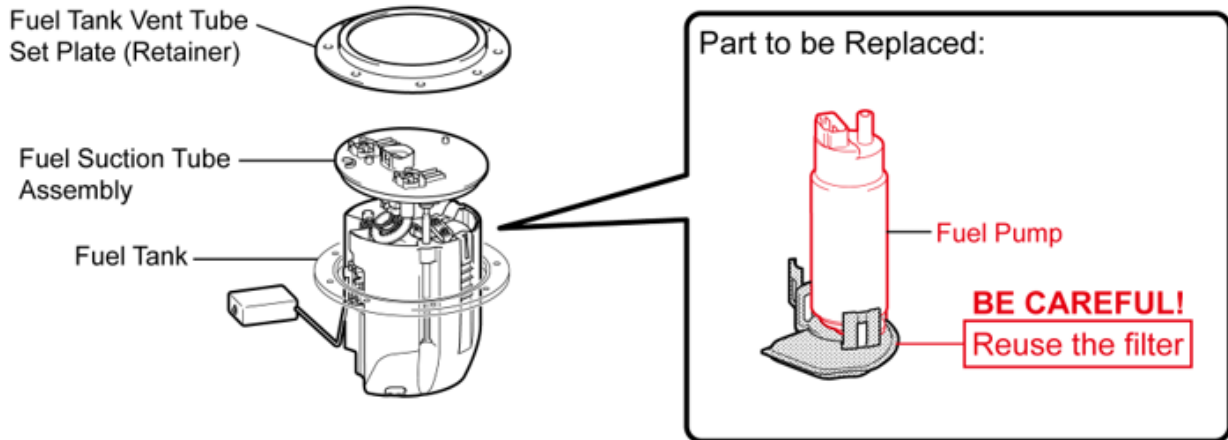
S38182aSU

The subject vehicles are equipped with a low-pressure fuel pump which may stop operating. If this were to occur, warning lights and messages may be displayed on the instrument panel, and the engine may run rough. This may result in a vehicle stall, and the vehicle may be unable to be restarted. If a vehicle stall occurs while driving at higher speeds, this could increase the risk of a crash.

*The configuration of the parts will differ depending on the specification.

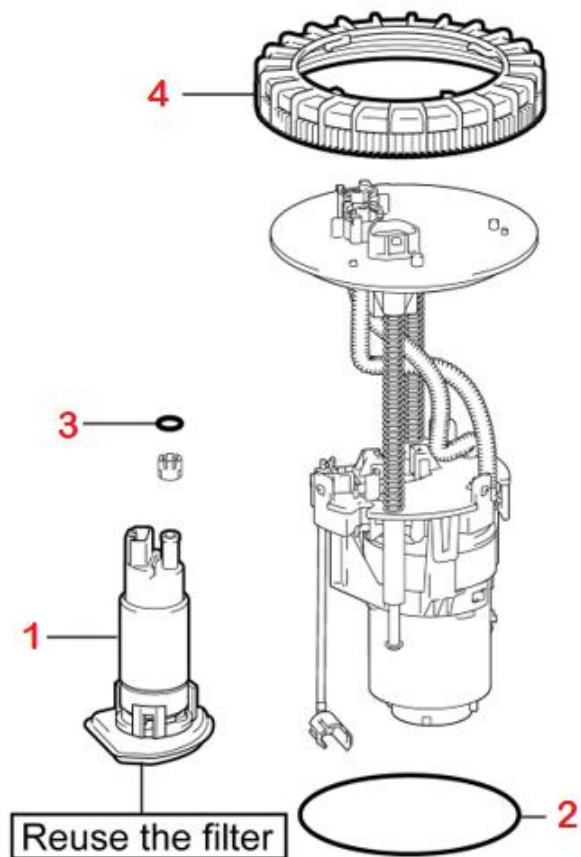
4Runner

Replacement Items in red

No.	Contents of Part Kit's	Quantity	Tape Color	Remarks
1	FUEL PUMP	1		
2	FUEL SUCTION TUBE SET GASKET	1		
3	O-RING	1	Yellow	15.2mm
4	FUEL PUMP GAUGE RETAINER	1

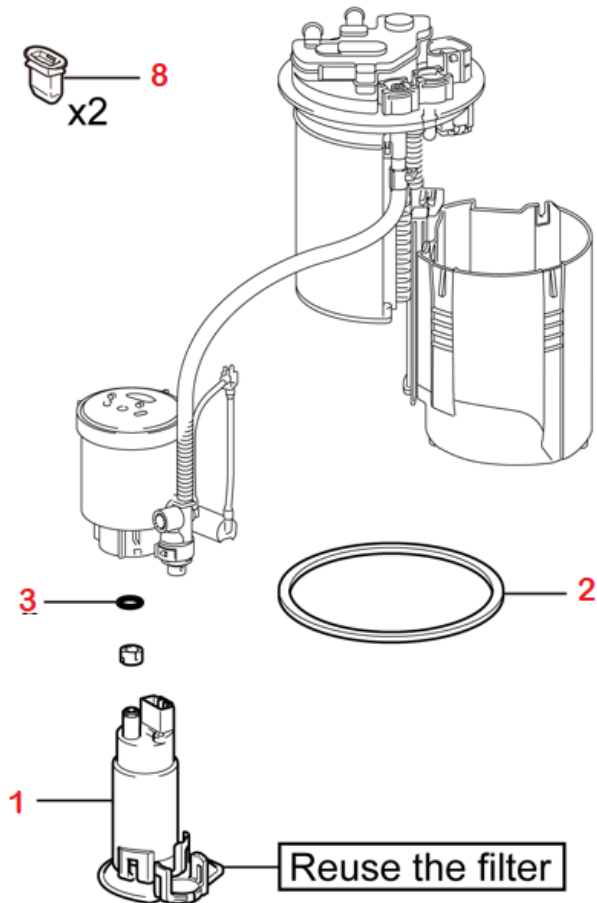
AVALON 2019

Replacement items in red

No.	Contents of Part Kit's	Quantity	Tape Color	Remarks
1	FUEL PUMP	1		
2	FUEL SUCTION TUBE SET GASKET	1		
3	O-RING	2*	Gold	15.2mm
4	REAR SEAT CUSHION LOCK HOOK (included in the gasket kit)	2		Not used
5	O-RING	1	Red	Not used
6	O-RING	1	Green	Not used
7	FUEL TANK PIPE SETTING HOLDER	1	White	Not used
8	REAR SEAT CUSHION LOCK HOOK (part # 04009-95106)	2

*only 1 O-Ring will be used. Discard the 2nd O-Ring.

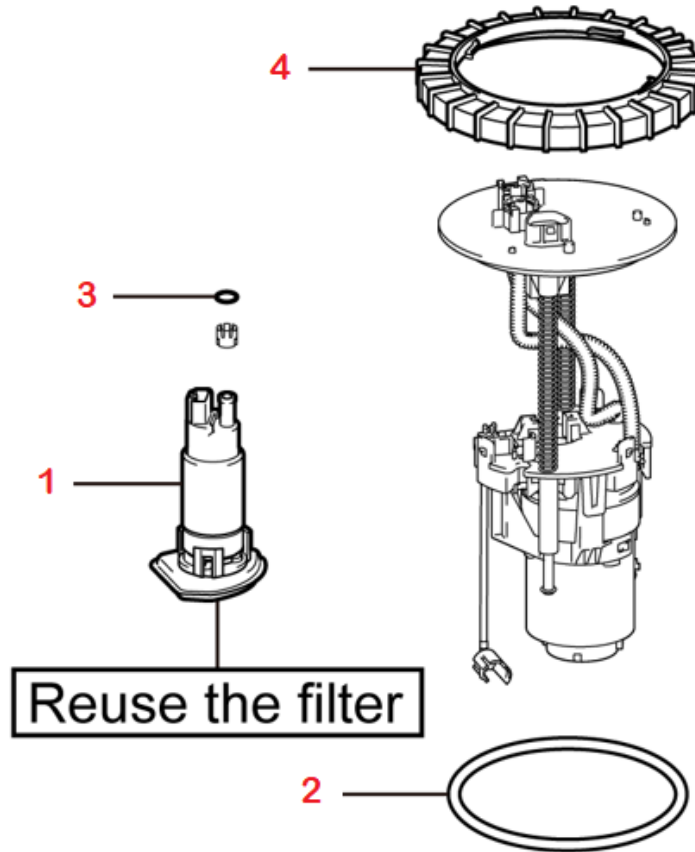
FJ CRUISER

Replacement items in red

No.	Contents of Part Kit's	Quantity	Tape Color	Remarks
1	FUEL PUMP	1		
2	FUEL SUCTION TUBE SET GASKET	1		
3	O-RING	1	Yellow	15.2mm
4	FUEL PUMP GAUGE RETAINER	1

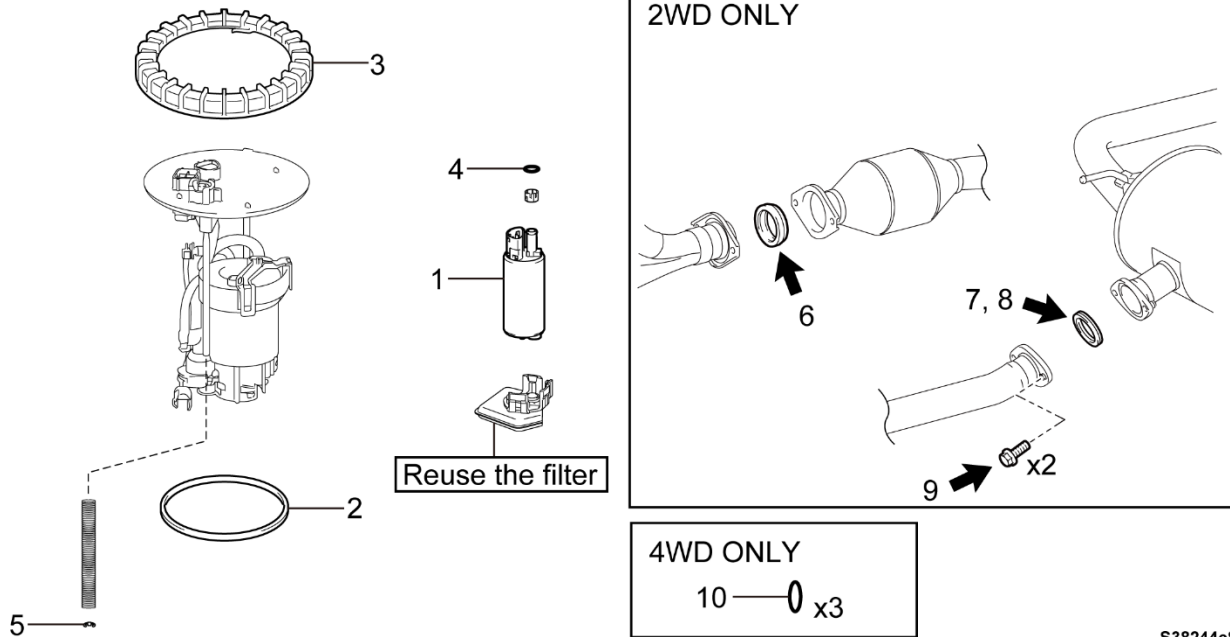
SIENNA

Replacement items in red

No.	Contents of Part Kit's	Quantity	Tape Color	Remarks
1	FUEL PUMP	1		
2	FUEL SUCTION TUBE SET GASKET	1		
3	FUEL PUMP GAUGE RETAINER	1		
4	O-RING	1	(not labeled)	
5	FUEL TANK PIPE SETTING HOLDER	1		
6	EXHASUT PIPE GASKET (2WD)	1		16.4mm
7	EXHASUT PIPE GASKET (2WD)	1		
8	EXHASUT PIPE GASKET (2WD)	1		
9	FLANGE BOLT (2WD)	2		
10	DRAIN PLUG GASKET (4WD)	3

Note: Some items in the Fuel Pump Replacement Kit will not be used.

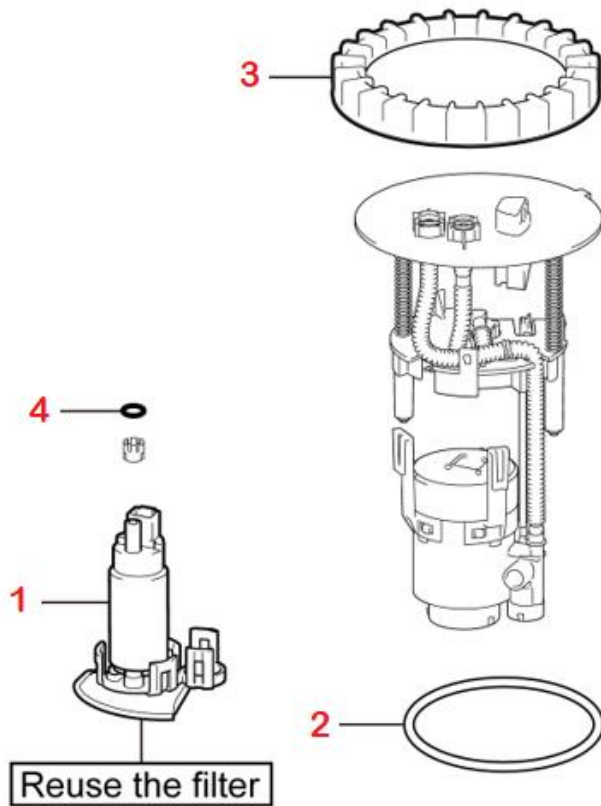
SEQUOIA
TUNDRA

Replacement items in red

No.	Contents of Part Kit's	Quantity	Tape Color	Remarks
1	FUEL PUMP	1		
2	FUEL SUCTION TUBE SET GASKET	1		
3	FUEL PUMP GAUGE RETAINER	1		
4	O-RING	1	(not labeled)

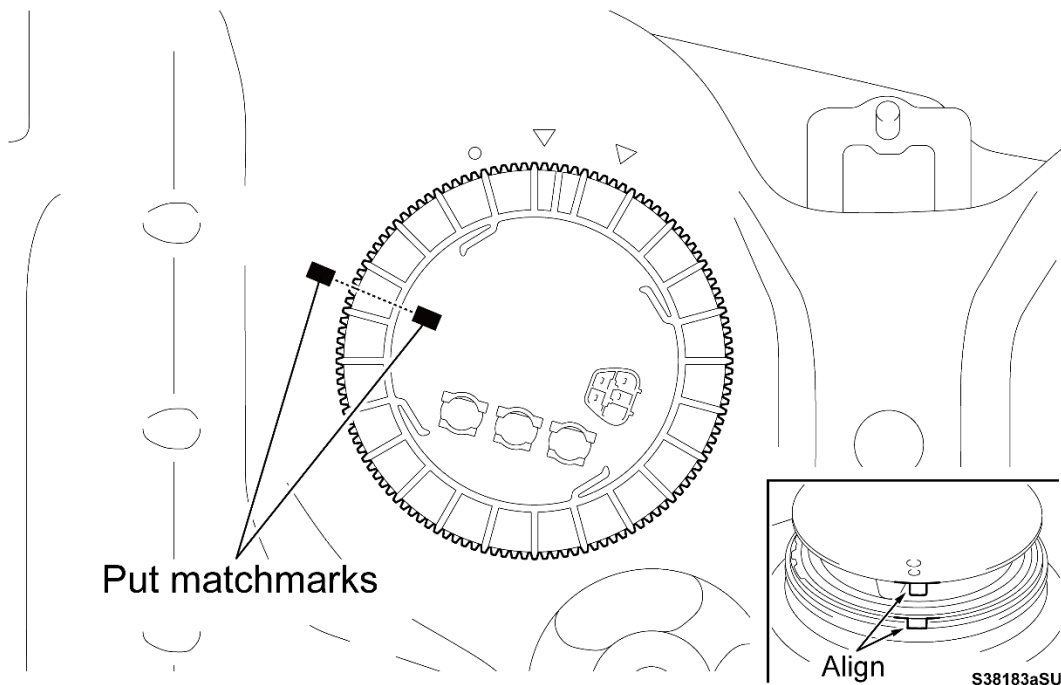
REMOVAL TIP: TUBE ASSY ALIGNMENT

For vehicles with the plastic retainer rings, place matchmarks on both the Fuel Tube Assembly and the fuel tank. During disassembly, confirm that the Fuel Tube Assembly does not rotate. During reassembly, this will aid in aligning the locating tabs for proper installation.

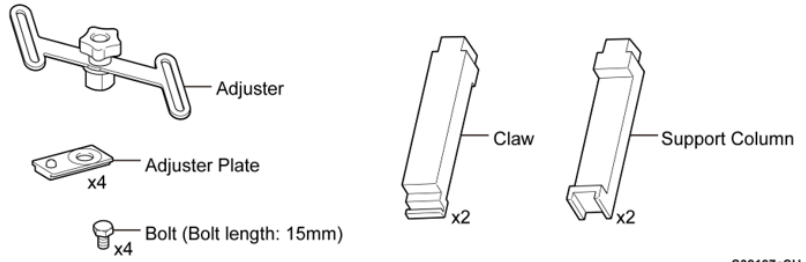
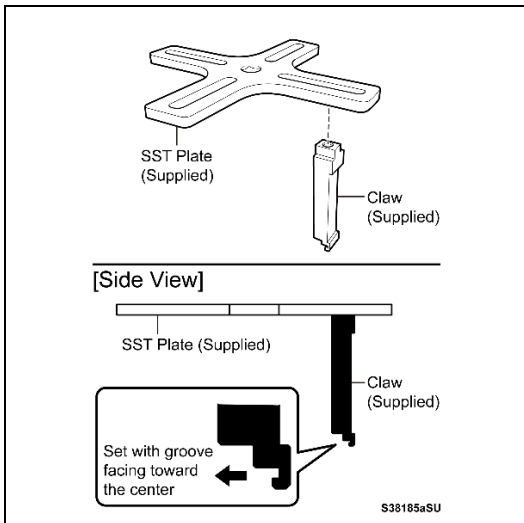
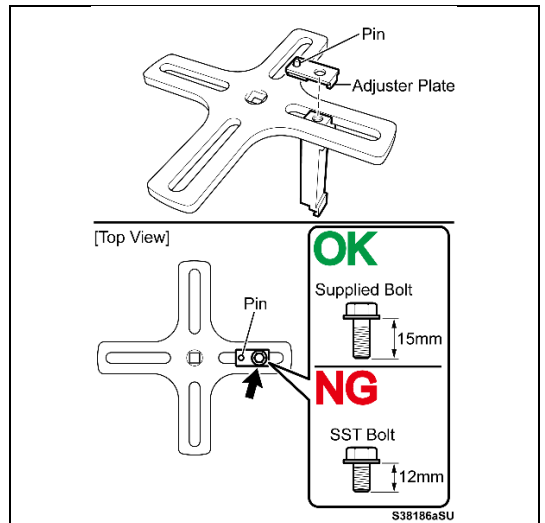
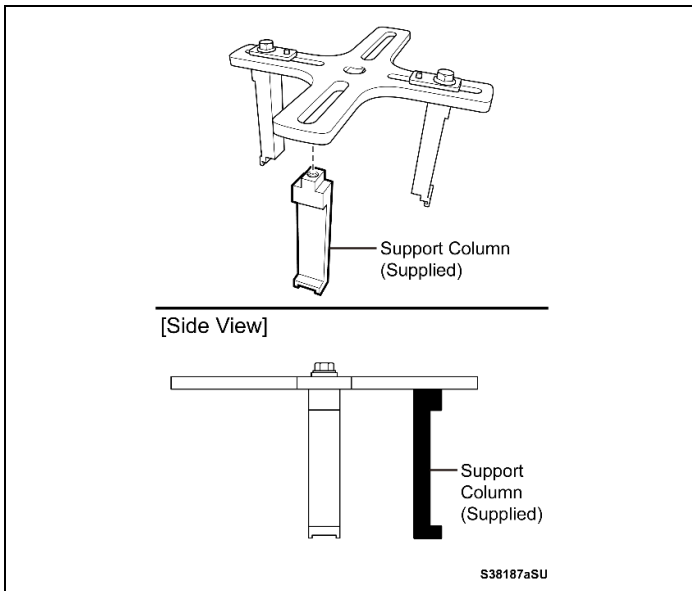
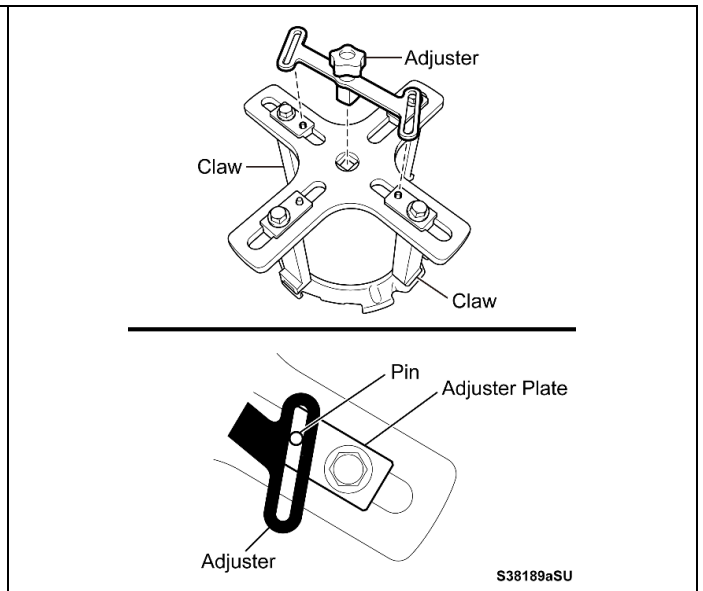
REMOVAL TIP: CAM LOCK RETAINER TOOL

An updated set of Cam Lock Claws and Support Columns are being supplied to each dealership for this campaign. The configuration of the retainer engagement sections of the claws have been modified from the SST that is referenced in the repair manual. The **NEW** claws have an improved design that enables a firm attachment to the retainer. In addition, 2 support columns are provided which will support the retainer more securely during installation and removal. Be sure to assemble and use the tools using the following procedures:

Campaign Tool Cam Lock Set:

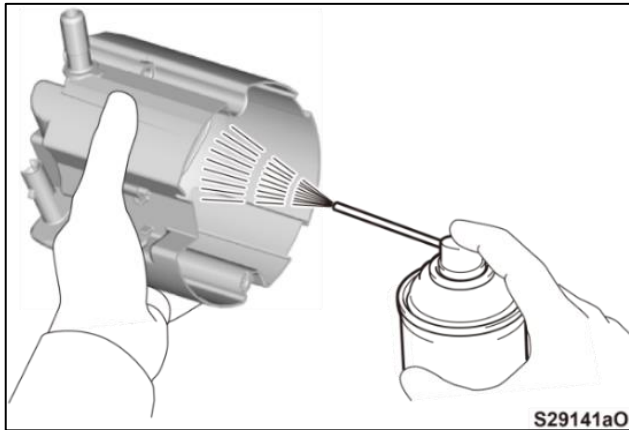
- a. Using brake cleaner, clean the sub-tank assembly.

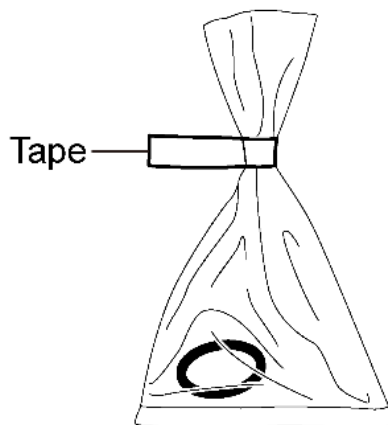
REASSEMBLY TIPS: O-RINGS

The part kits may come with O-Rings of different sizes. They are very difficult to tell apart visually. To identify the different size O-Rings, they will be wrapped in individual plastic bags with a piece of **COLORED TAPE** sealing it. The **COLOR OF THE TAPE** will identify the O-Ring size. **REFER TO THE COMPONENT DIAGRAMS TO DETERMINE TO CORRECT O-RING**, as identified by the tape color.

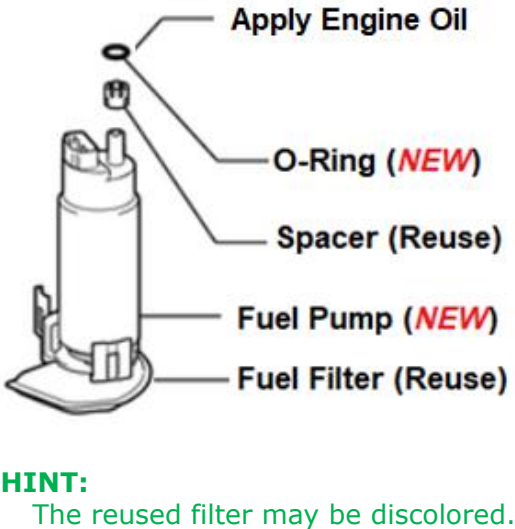
Example Procedure:

- Remove the original O-Ring, Spacer and Fuel Filter from the original Fuel Pump.
- Discard the original O-Ring and Fuel Pump, saving the Spacer and Fuel Filter.
- Install the original Spacer onto the *NEW* Fuel Pump.
- Install the *NEW* O-Ring onto the *NEW* Fuel Pump. Refer to the Component Diagram to determine to proper O-Ring, as identified by the colored tape on the bag.
- Apply a small amount of engine oil to the *NEW* O-Ring to assure correct installation into the Tube Assembly.
- Install the original Fuel Filter onto the *NEW* Fuel Pump.
- Refer to the Components diagrams to review the other *NEW* parts to install.

- Apply engine oil to the *NEW* O-ring before assembly to assure correct installation into the Fuel Suction Tube.

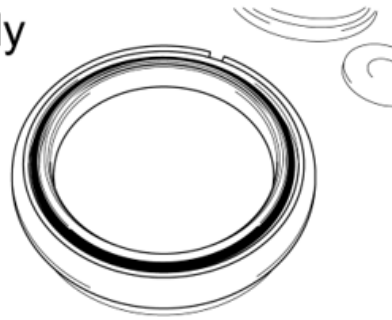
INSTALLATION TIP: PLASTIC RETAINER

Set **NEW** gasket properly

DO NOT apply
silicon grease

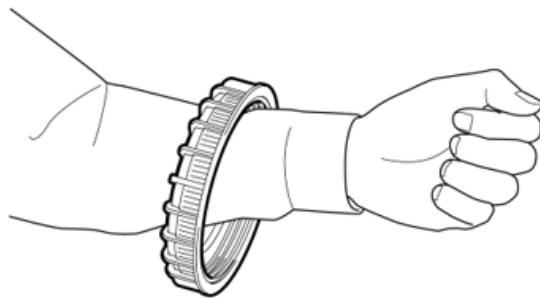
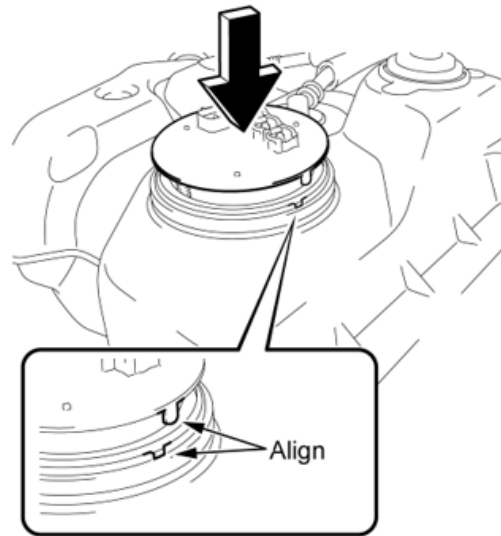
Put the retainer around the
arm so that it is not necessary
to change hands to keep
pressing down the fuel
suction tube.
(Plastic Retainer)

Keep pressing down the fuel suction
tube while installing the retainer.
