Safety Recall: Driver's Frontal Airbag Inflator (NADI-Service Part)

Certain vehicles may have had the original driver's airbag module replaced with one that was equipped with a Takata Non-Azide Driver's airbag Inflator (NADI) that may contain an aluminum seal that could allow moisture to enter into the inflator. If the propellant in the inflator absorbs a large amount of moisture, the airbag may deploy slowly. If the propellant degrades due to drying or other factors, excessive internal pressure may be generated in the inflator during deployment, which may cause the inflator container to rupture.

Inspect the driver's airbag module and inflator. If you find an affected inflator, replace the driver's airbag inflator and use the V-SMART tool to document the installation. Then, return the original, undeployed inflator as directed.

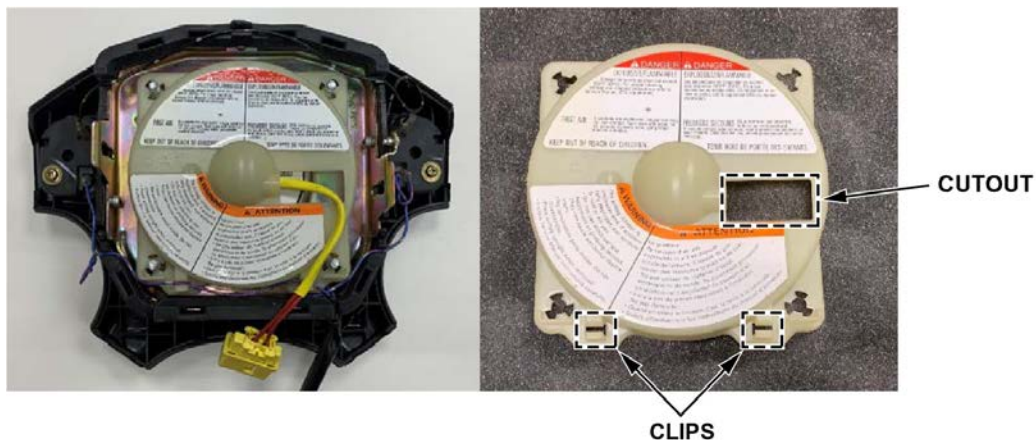
- **Inflator cover Type 1** has a cutout on the right side of the cover, and two clips at the bottom of the cover that holds the horn wire.

- If the inflator cover is **Type 1** or **2**, go to step 8.
- If the inflator cover is **Type 3**, this campaign does not apply. Go to step 23 to complete the V-SMART procedure and install the airbag module.

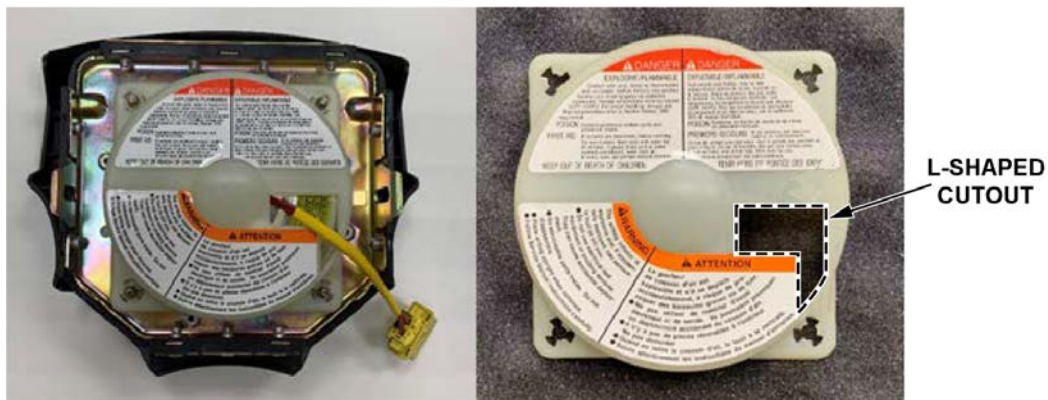
- **Inflator cover Type 2** has an L-shaped cutout at the right side of the cover.

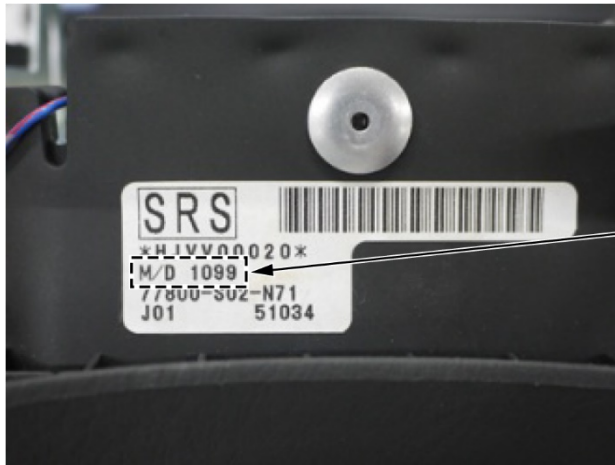
Check the last two
M/D numbers.

11. Check the **M/D** number on the airbag module serial number label.

- If the last two numbers **are 95, 96, 97, 98, or 99**, go to step 12.
- If the label is missing, or is unreadable, go to step 12.

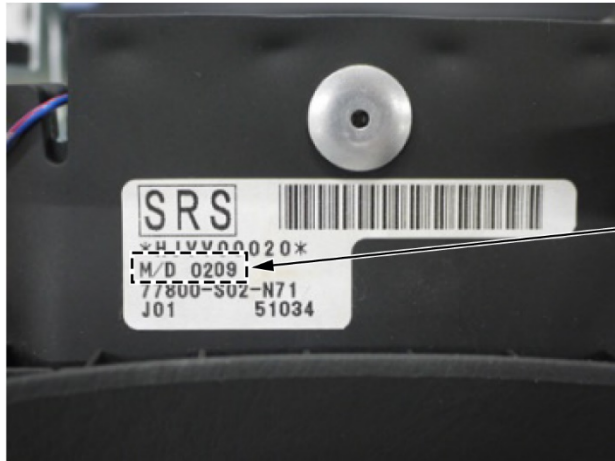
Check the last two
M/D numbers.

- If the last two numbers **are not 95, 96, 97, 98, or 99**, this campaign does not apply. Go to step 23 to complete the V-SMART procedure and install the airbag module.
