## 1. VEHICLE INSPECTION PROCEDURE

2016 Model Year Mazda CX-5 vehicles, equipped with LED Daytime Running Light (DRL)

## 2. REPAIR PROCEDURE

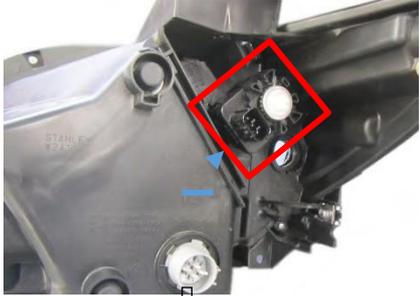
AFS	Front image	Back image
Yes (Equipped)

AFS: Adaptive Front Lighting system which enhances the range of visibility when the headlights are turned on by pointing the optical axis of the headlights in the direction in which the vehicle is advancing according to the steering operation. The swivel actuator constantly detects the headlight swivel angle from the hall sensor built into the actuator and inputs the swivel angle to the AFS control module via LIN communication.

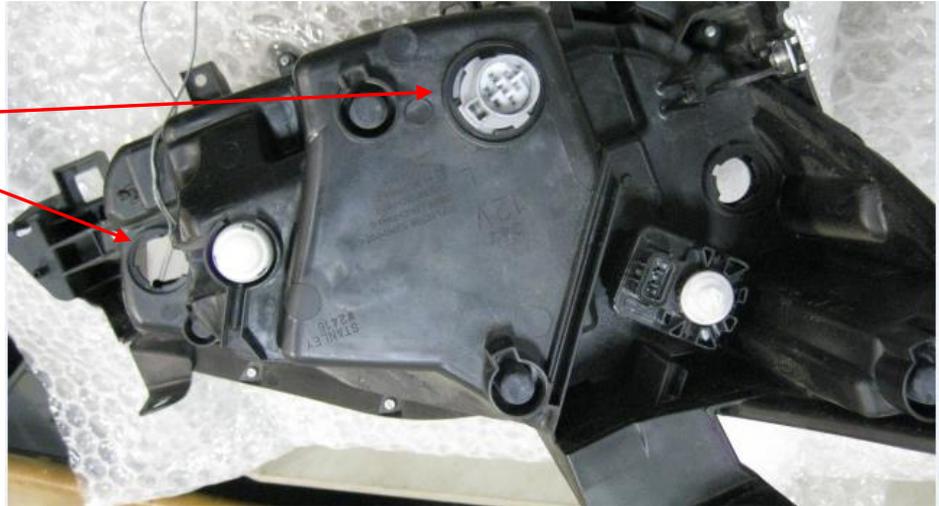
Connector of headlight.

A: Connector A

B: Connector B

**Caution:** Be careful not to damage the headlight lens (scratch etc...) or deform the terminal.

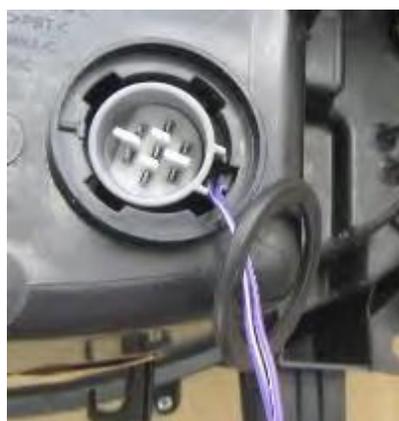
3. Install the gasket with new one (black one). Thread the new gasket onto the spare wire or string.

- Push the O ring gasket into the four hooks at the bottom of the connector.

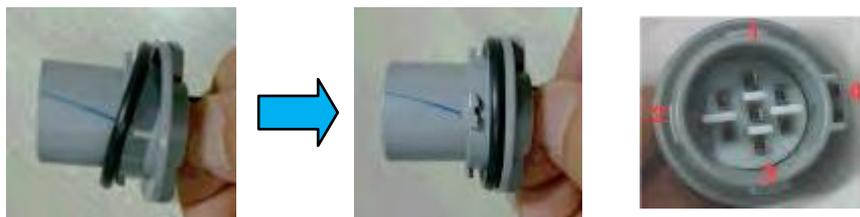
①	OK: Gasket has seated.
②	NG: Gasket is not seated on the hook.

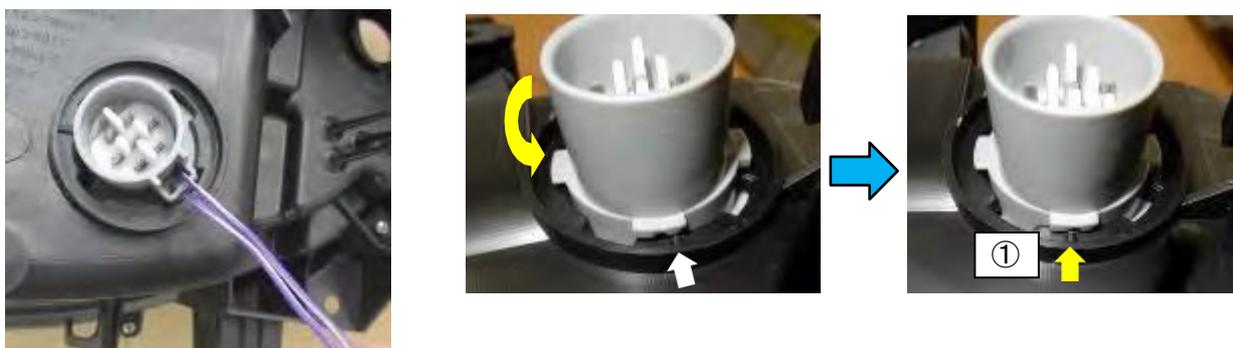
4. Pull the wire and remove from connector. Lock the connector shown the image below.

①	OK: Fits on rib protrusion.
---	-----------------------------

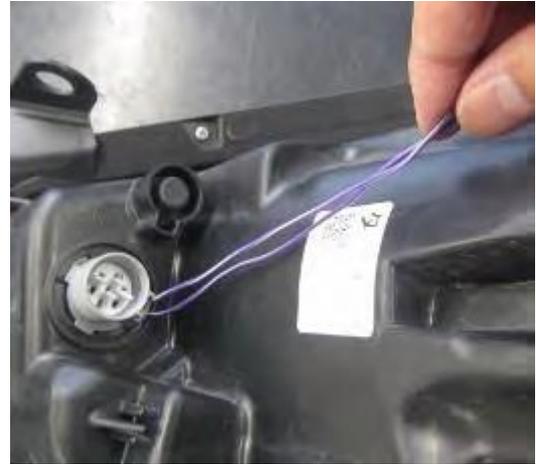
5. Unlock and make a gap between housing and connector.

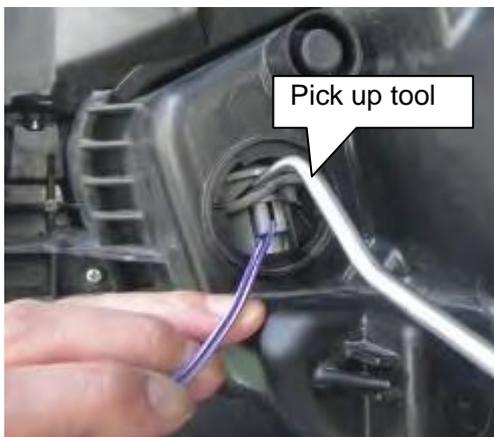
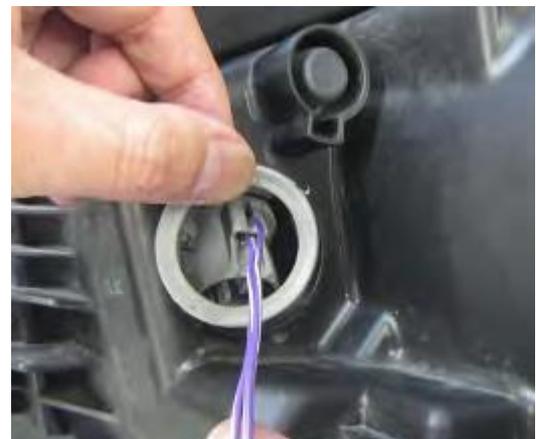
6. Use a pick tool, pull the gasket toward the outside.

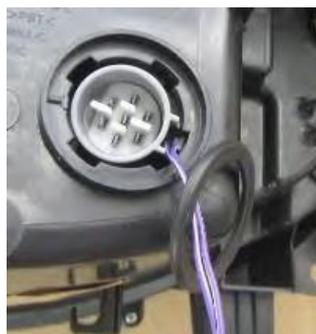
7. Install the gasket with new one (black one). Thread the new gasket onto the spare wire or string.

8. Push the O ring gasket into the four hooks at the bottom of the connector.

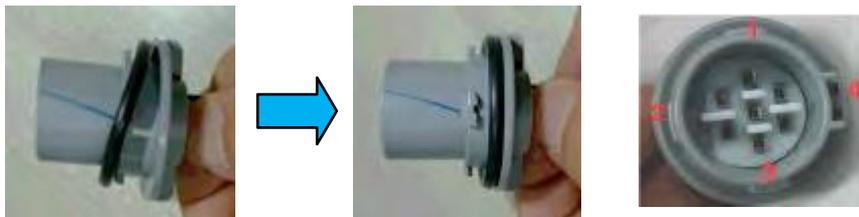
①	OK: Gasket has seated.
②	NG: Gasket comes out from the hook.

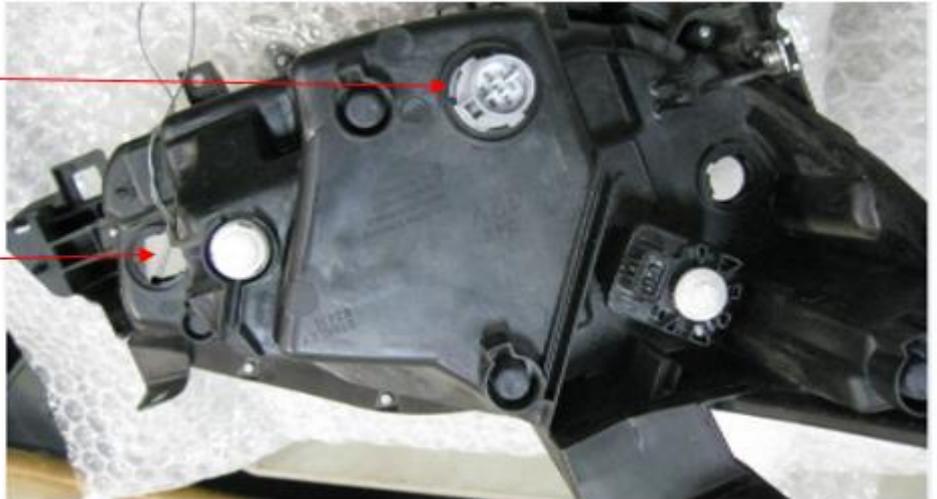
Connector of headlight.

Note: Gas absorption sheet installation is only through Connector B as shown the picture below.

A. Not necessary to unlock the connector for gas absorption sheet only for O ring replacement.

B. Connector is unlocked and dropped down inside the headlamp in order to install the gas absorption sheet.

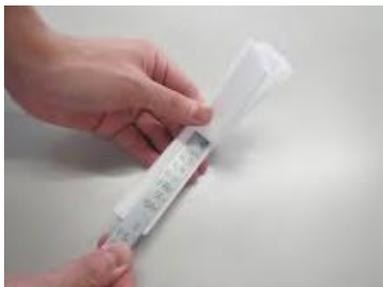
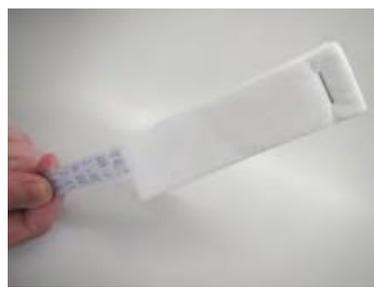
1. Prepare a gas absorption sheet and use your finger, or tweezer, short ruler to install.
2. **Peel off the adhesive tape back of gas absorption sheet.**  
**Caution:** Do not break the ply formation of the gas absorption sheet.

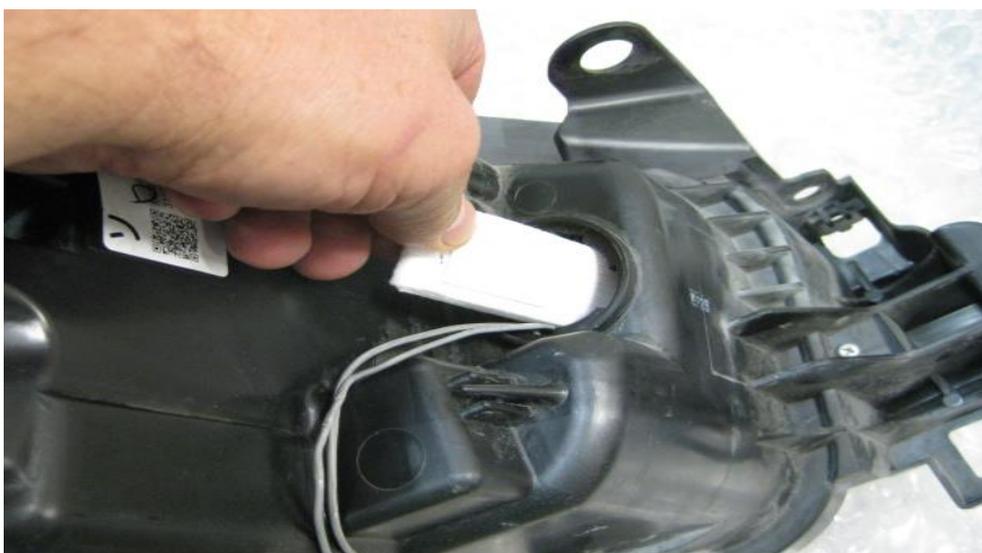
3. Install gas absorption sheet (**2 pieces per one side**) inside the connector hole.

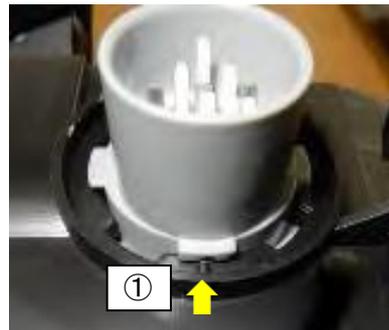
4. Re-install connector B.
5. Make sure all connector is locked. (There is marked where the lock position at yellow circle.)

① OK: Fits on rib protrusion.
