1. VEHICLE INSPECTION PROCEDURE

2016 Model Year Mazda CX-5 vehicles, equipped with LED Daytime Running Light (DRL)

Model	Subject VIN range	Subject production date range
2016 CX-5	JM3 KE**** G0 600017 – 751326	From November 3, 2014 through December 7, 2015

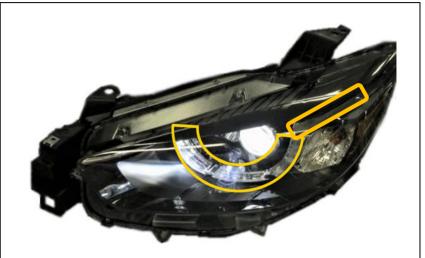
OK - DRL is illuminated.

Not OK – DRL is not illuminated or only partially illuminated. (Low beam functions normally)

- If both Daytime Running Lamp (DRL) does not light up or the DRL is flickering, replace the both headlight assemblies and complete the repair.
- If either Daytime Running Lamp (DRL) does not light up or the DRL is flickering, replace the affected headlight assembly and go to the next step, B. (Inspect working headlight production date)
- If both Daytime Running Lamp (DRL) light up, and are not flickering, go to next step B.
 (Inspect working headlight production date)

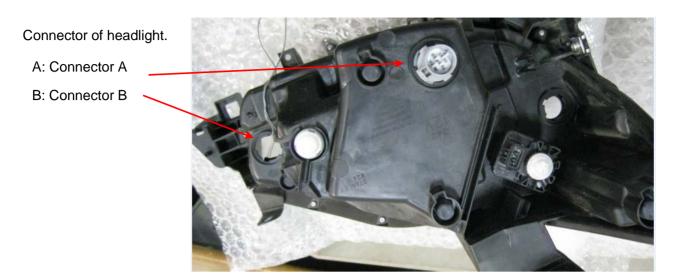
Caution: Be careful not to damage the headlight lens (scratch etc...) or deform the terminal.

In order to easily reference locking/unlocking the connector, ①Make sure it is fully locked position (fully turned left and stopped position) then ②Mark before removing.

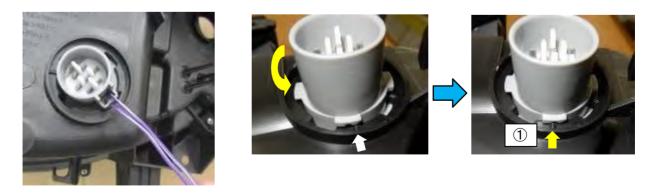
4. Pull the wire and remove from connector. Lock the connector shown the image below.

① OK: Fits on rib protrusion.

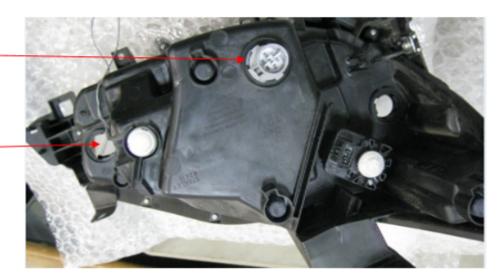
Connector of headlight.

Note: Gas absorption sheet installation is only through Connector B as shown the picture below.

A. Not necessary to unlock the connector for gas absorption sheet only for O ring replacement.

B. Connector is unlocked and dropped down inside the headlamp in order to install the gas absorption sheet.

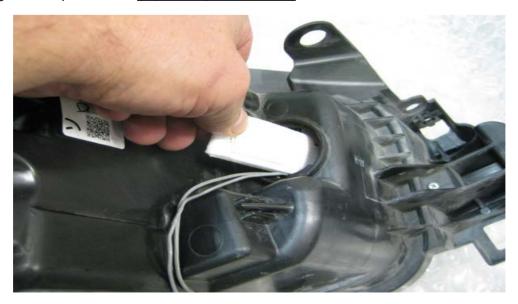
3. Install gas absorption sheet (2 pieces per one side) inside the connector hole.

- 4. Re-install connector B.
- 5. Make sure all connector is locked. (There is marked where the lock position at yellow circle.)
