## SAFETY RECALL 20LA02

### CERTAIN ENGINE BLOCKS CAN CAUSE ENGINE FAILURE LEADING TO ENGINE FIRE RISK

#### CERTAIN 2020 ES 300h

Update 8/18/2021: Instructions added for engine short block replacement in the case engine assembly is not available, and Tech Certification updated.

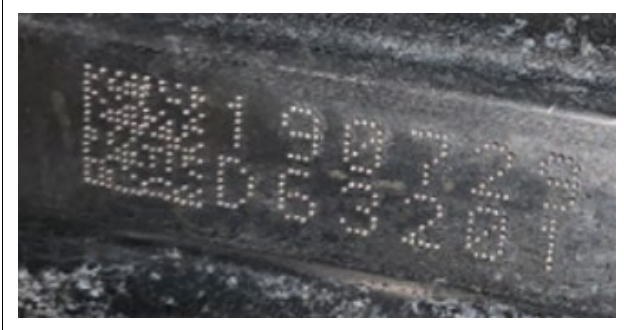
### 3. TAKE A PHOTO OF THE BLOCK ID No.

- a. Use a digital camera to take a photo of the Block ID No. Be sure to place the camera as straight and level as possible to the surface of the stamping.

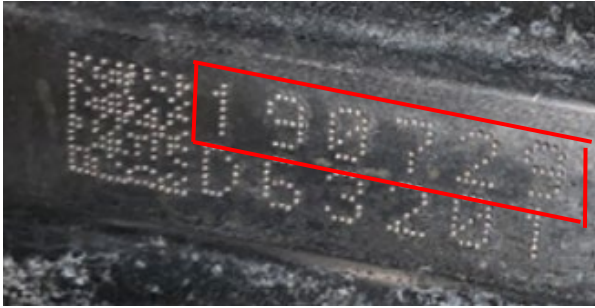
a. Enter the top row of the Block ID No. (6 digits) when prompted.

**NOTE: All 6 digits are NUMBERS.**

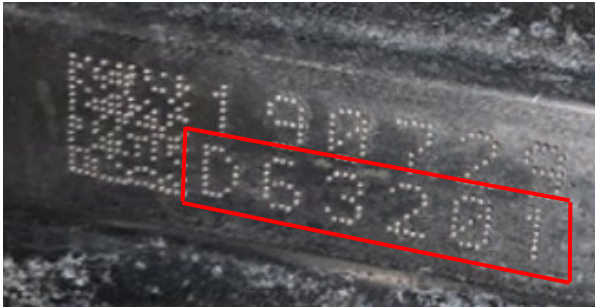
b. Enter the bottom row of the Block ID No. (6 digits) when prompted.

**NOTE: The first digit is a LETTER, the remaining digits are NUMBERS.**

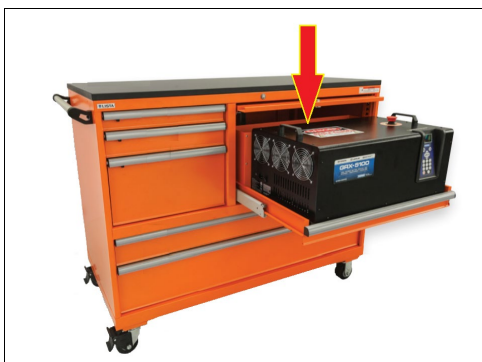
**1. CHECK HIGH VOLTAGE SERVICE GLOVES**

- a. Obtain the proper size (M, L, XL) High Voltage Service Gloves with from drawer #6 of the TOYOTA HEV WORKSTATION. Slide the drawer (release in the lower right) out to access the gloves located behind the HV Battery Charger.

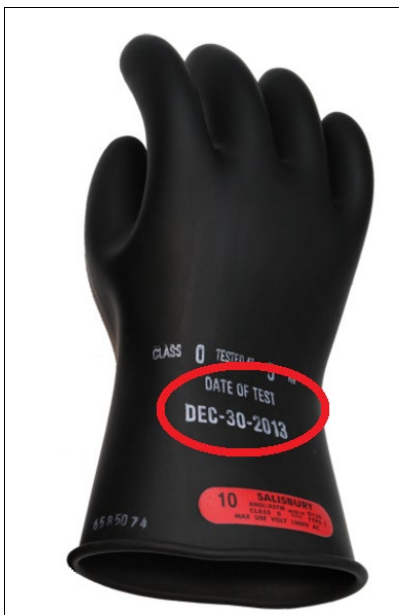
- b. Remove the leather outer protective glove (left and right) to expose the rubber High Voltage Service Gloves.
- c. Check the Date of Test stamped on the gloves. This indicates the date of the gloves most recent **Certified electrical inspection**. If the date on the gloves is more than 6 months ago, do not use these gloves. They will either need to be replaced or sent to a Certified Testing Facility for recertification to comply with [OSHA standard 1910.137](#). An internet search for [High Voltage Glove Testing](#) should assist in finding a company to recertify your gloves. For replacement gloves, contact Bosch/OTC at 1-800-933-8335:

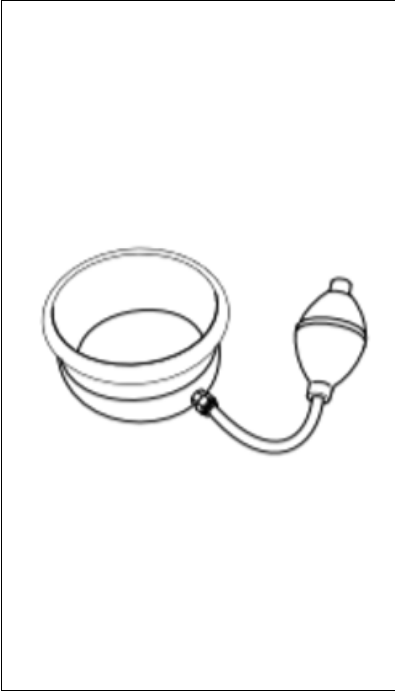
d. Before each daily use and immediately after any incident that may have caused damage, the gloves must be physically inspected. Using the Glove Inflator found in drawer #2 of the TOYOTA HEV WORKSTATION, inflate each glove and inspect for:

- Air leaks
- Holes, tears, punctures or cuts
- Ozone cutting or ozone checking
- Embedded foreign objects, texture changes, including swelling, softening, hardening, or becoming sticky or inelastic
- Any other defect that damages the insulating properties.

**Gloves with any of the above defects shall be removed from service or returned for testing.**

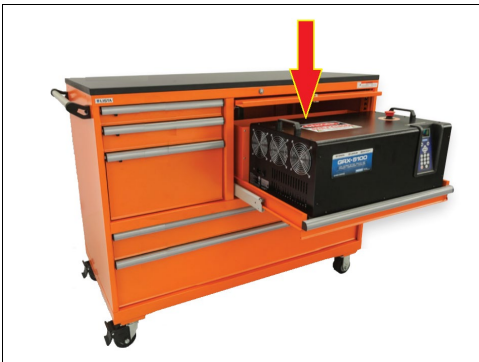
1. **CHECK HIGH VOLTAGE SERVICE GLOVES**
  - a. Obtain the proper size (M, L, XL) High Voltage Service Gloves with from drawer #6 of the TOYOTA HEV WORKSTATION. Slide the drawer (release in the lower right) out to access the gloves located behind the HV Battery Charger.

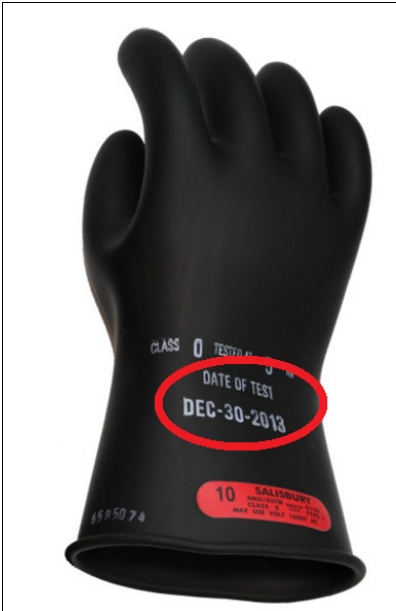
- b. Remove the leather outer protective glove (left and right) to expose the rubber High Voltage Service Gloves.
- c. Check the Date of Test stamped on the gloves. This indicates the date of the gloves most recent **Certified electrical inspection**. If the date on the gloves is more than 6 months ago, do not use these gloves. They will either need to be replaced or sent to a Certified Testing Facility for recertification to comply with [OSHA standard 1910.137](#). An internet search for [High Voltage Glove Testing](#) should assist in finding a company to recertify your gloves. For replacement gloves, contact Bosch/OTC at 1-800-933-8335:

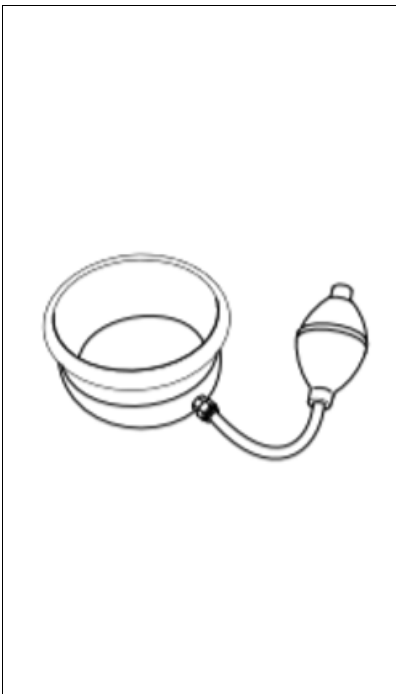
- d. Before each daily use and immediately after any incident that may have caused damage, the gloves must be physically inspected. Using the Glove Inflator found in drawer #2 of the TOYOTA HEV WORKSTATION, inflate each glove and inspect for:
  - Air leaks
  - Holes, tears, punctures or cuts
  - Ozone cutting or ozone checking
  - Embedded foreign objects, texture changes, including swelling, softening, hardening, or becoming sticky or inelastic
  - Any other defect that damages the insulating properties.

**Gloves with any of the above defects shall be removed from service or returned for testing.**
