SIB 65 09 20

RECALL CAMPAIGN 20V-243: HEAD AIR BAG (LEFT-SIDE)

2020-05-14

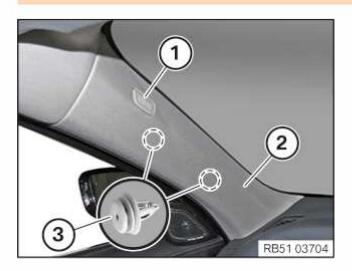
- Unclip cover panel (1) and unscrew the bolt below it.
- Detach A-pillar trim panel (2) from the clips (3) and remove upward.

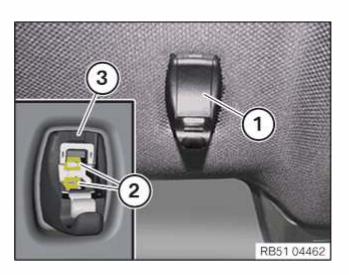
### ► Remove the counter support for the sun visor

- Pull out the cover (1).
- Push the clamps (2) together and pull the counter support (3) out of the headlining.

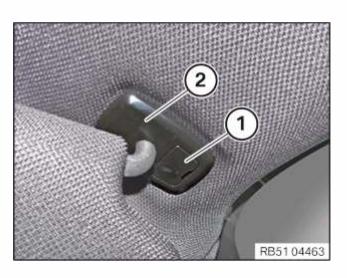
#### ► Remove sun visor

- Pull out the cover (1).
- Detach the sun visor (2) from the counter support.
- Disengage the sun visor (2) in front downward and guide it out of the headlining to the rear.
- Unlock associated plug connection and disconnect.

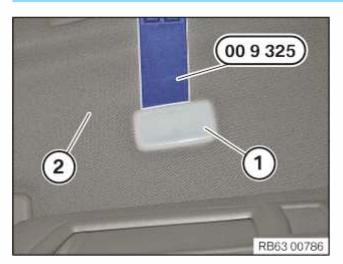
Lever out the vanity mirror light (1) using special tool 0 496 569 (00 9 325) from the headlining (2).

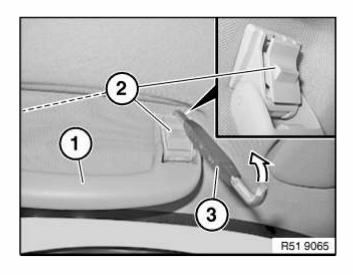
#### ► Removing the grab handle

- Expand the grab handle (1) towards the bottom.
- Disengage and remove the locking insert (2) with an angle screwdriver (3) as shown.

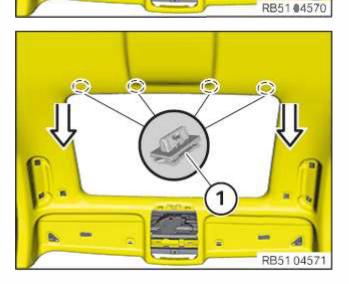
- Slide headlining towards the front and feed out from the clips (1).
- Place the headlining in the vehicle.

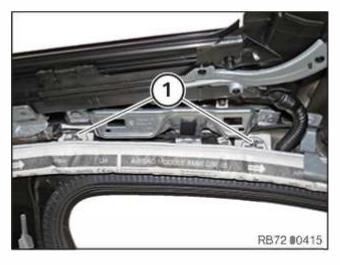
Unlock and detach the clamps (1) with the special tool 2 230 142.

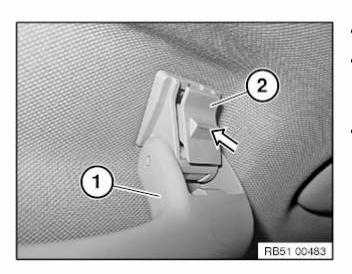
#### ► Installing the grab handle

- Insert the grab handle (1) into body.
- Correctly clamp in the grab handle (1), as otherwise the locking inserts (2) on the grab handle (1) cannot correctly engage.
- Engage the locking inserts (2) on both sides of the grab handle (1).

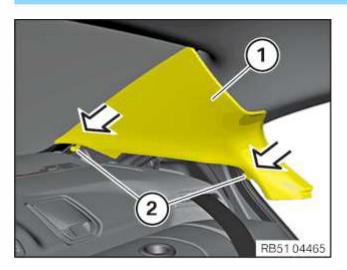
• Feed the C-pillar trim panel (1) with the guides (2) in arrow direction into the rear deck.

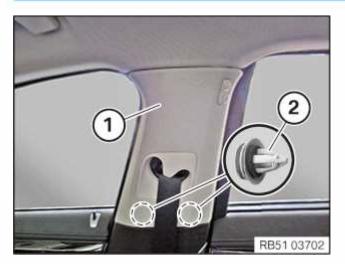
- Attach the B-pillar trim panel (1) and guide in the safety belt.
- Guide in the B-pillar trim panel (1) at the top at the roofliner and clip into the clips (2).
- Check the front and rear of the B-pillar trim panel
  (1) for the correct fit at the edge protection.

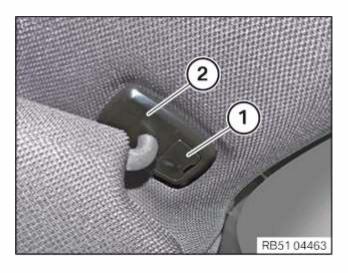
#### ▶ Install the sun visor

- Connect the sun visor (2) with the corresponding connector.
- Guide the sun visor (2) into the headlining.
- Use cover (1).
- Attach the sun visor (2) on the counter support.

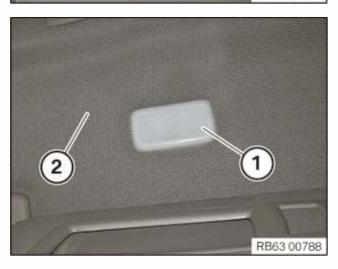
Position the vanity mirror light (1) in the headlining (2).

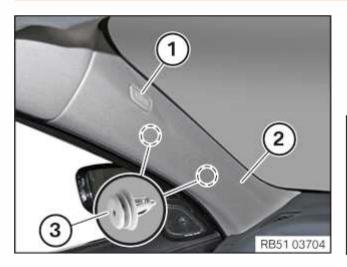
- Insert the A-pillar trim panels (2) and clip into the clips (3).
- Tighten down screw.
