TITLE: ENGINE BACKFIRE

RECALL

2019 & 2020 NINJA® ZX™-10R, 10RR, 10R ABS, & 10R ABS, & 10R KRT EDITION, ABS KRT EDITION ENGINE BACKFIRE

IMPORTANT SAFETY RECALL NHTSA RECALL NO. 20V-307

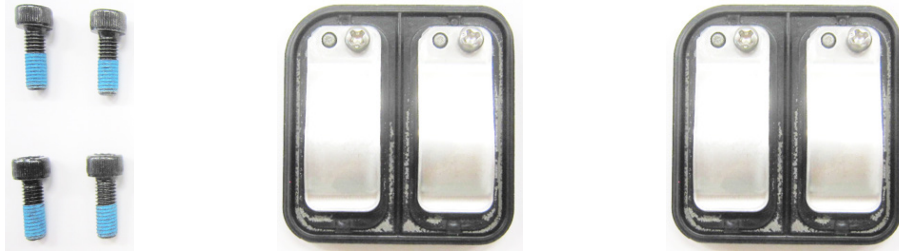
Kit, Reed Valve, MC20-02 P/N 99999-0766		
Ref	Contents	Qty
1	Bolt	4
2	Valve	2

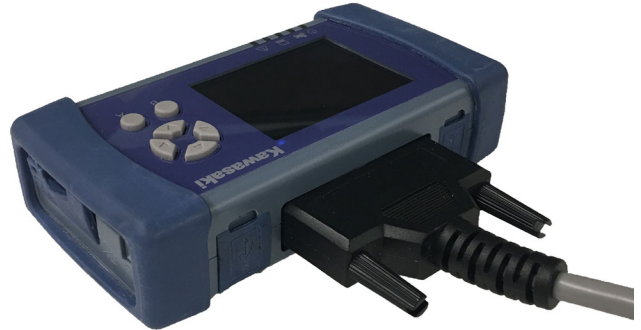
- Connect cable **57001-1843** to the K-VCI device.

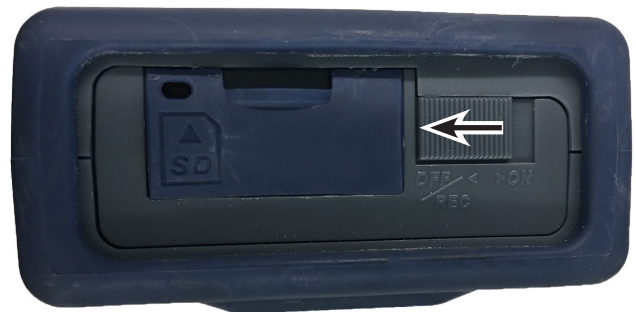
- Confirm the **power switch** on the K-VCI device to the **OFF** position.

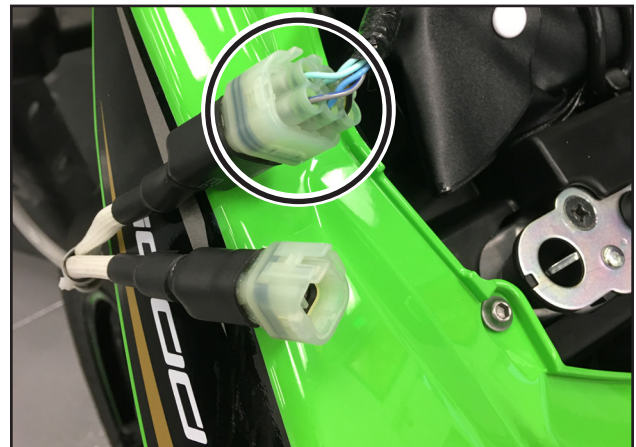
- Connect K-VCI device to vehicle's white, **six pin coupler**, using cable **57001-1843**.

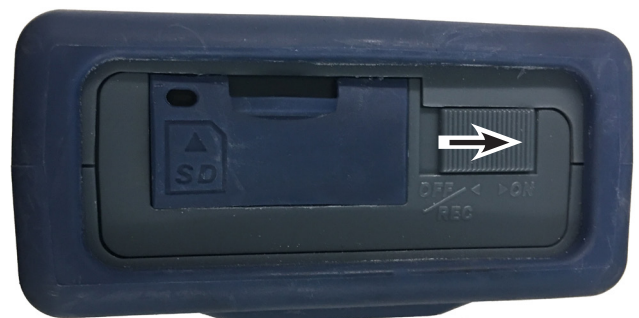
- Slide the **power switch** on the K-VCI device to the **ON** position.

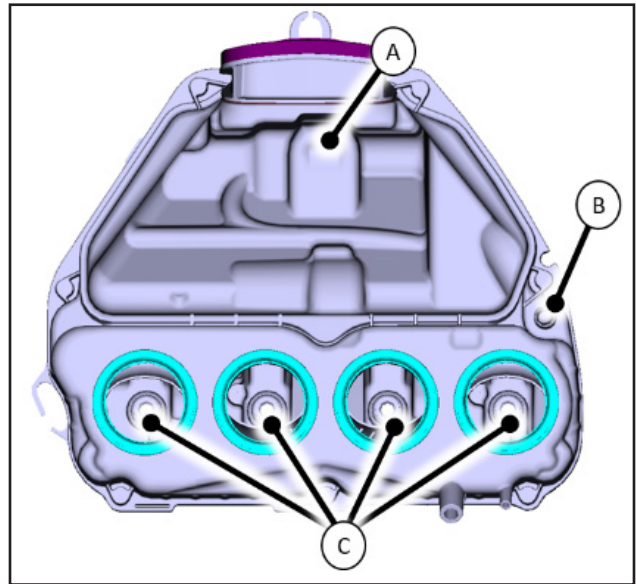
- Visually inspect the following for damage:
 - Front side of Air Cleaner Housing [A]
 - installation point of air switching valve hose [B]
 - Secondary Fuel Injector [C] for any damage.

★ If any of these parts have heat or fire damage, replace them with new parts.

Description	Part No.
Air Cleaner Housing	Call Dealer Care for Authorization to Replace Parts
Pad	
Secondary Fuel Injector
