Volvo Car Customer Service

QB Instruction VCC-519373-1

Title	Front seat belt end fitting, replace	Page	1 (9)
Action	Replacement	Operation number:	97703-2 97702-2

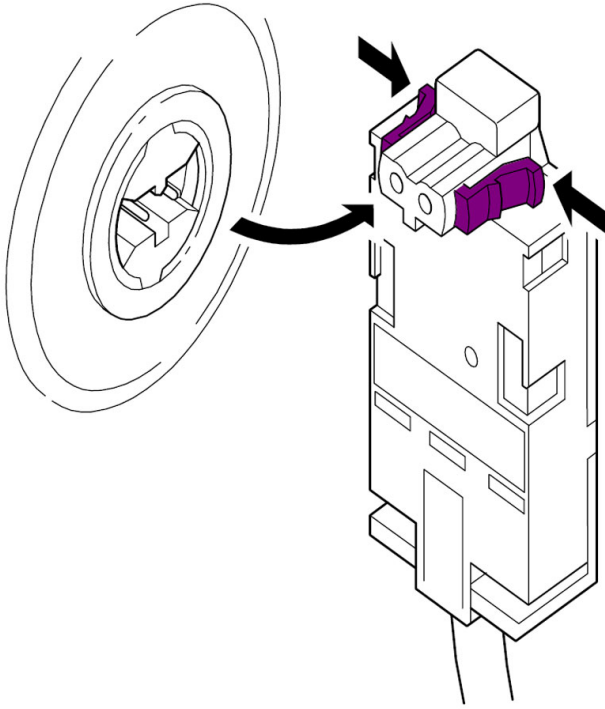
Release the connector's catch.
Disconnect the connector.

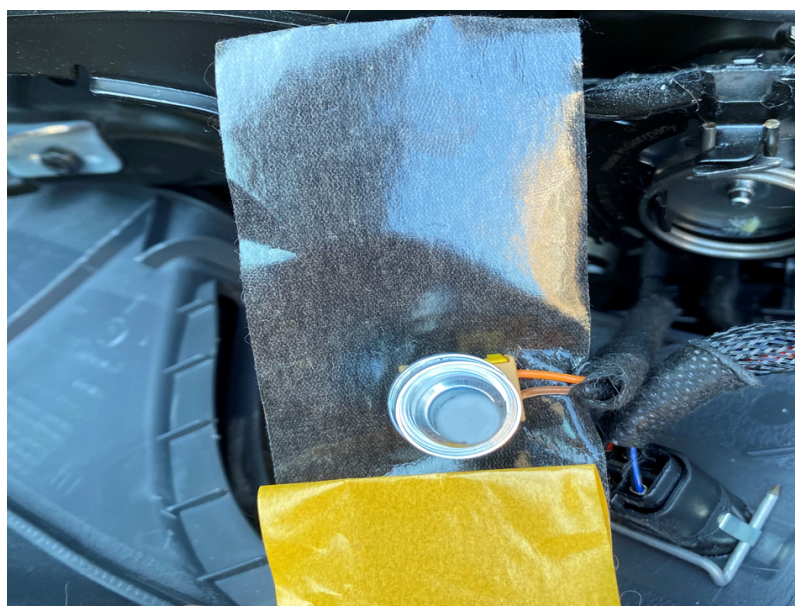
Install component/components from the repair kit.
Use tape
Application as illustrated.
