**August 7, 2020**

**Noncompliance Recall: Gauge Control Module Software Update**Supersedes 20-047, dated August 1, 2020, to revise the information highlighted in **yellow**.**AFFECTED VEHICLES**

Year	Model	Trim Level	VIN Range
2018-20	Odyssey	ALL except LX	Check the iN VIN status for eligibility
2019-20	Passport	ALL except Sport	Check the iN VIN status for eligibility
2019-21	Pilot	ALL except LX	Check the iN VIN status for eligibility

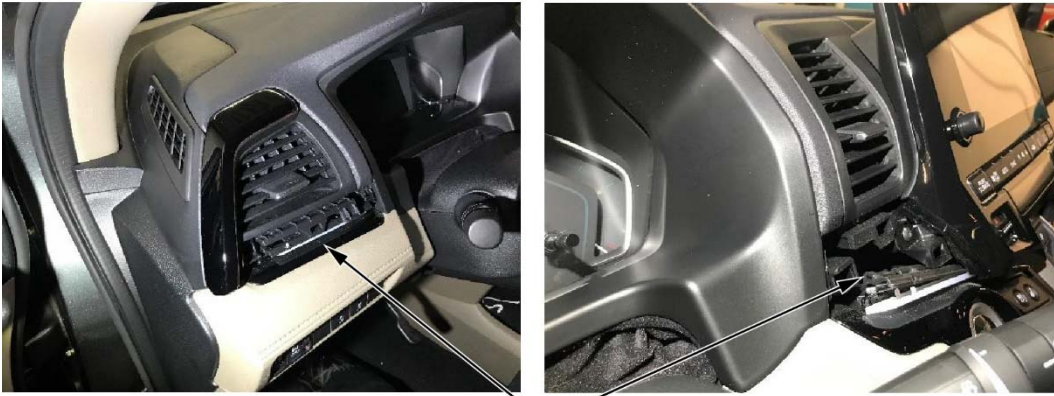
LOWER VENT COVERS

1. Remove both lower vent covers.

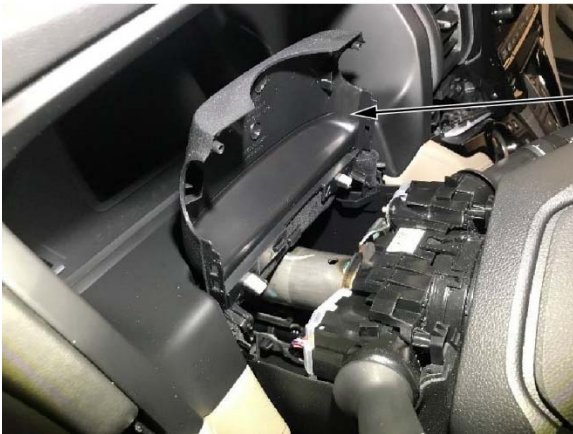
UPPER  
COLUMN  
COVER

2. Remove the upper column cover from the steering column.

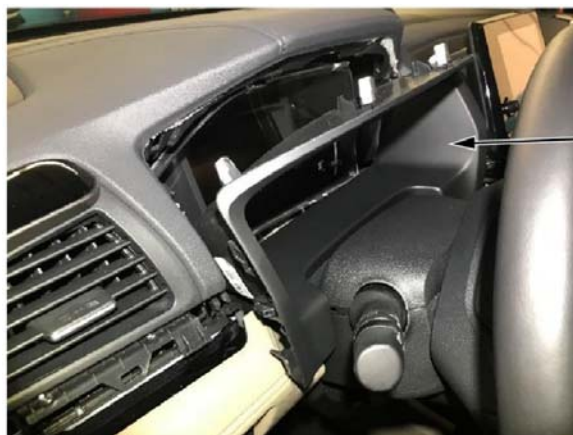
METER  
VISOR

3. Disengage the clips around the meter visor, then remove it with the upper column cover as one piece.

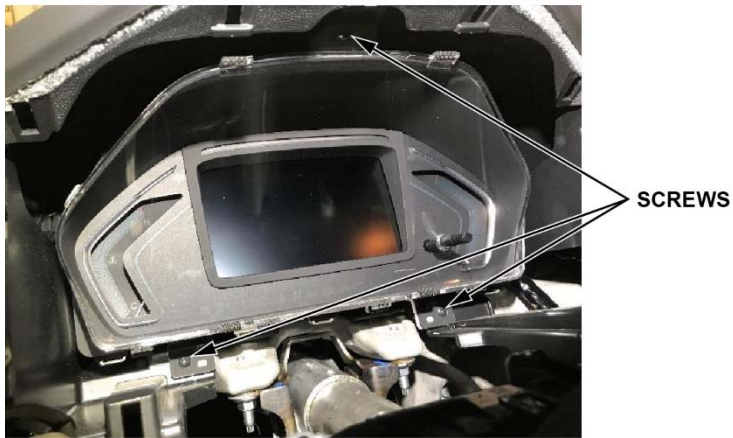
4. Remove the three screws securing the gauge control module.

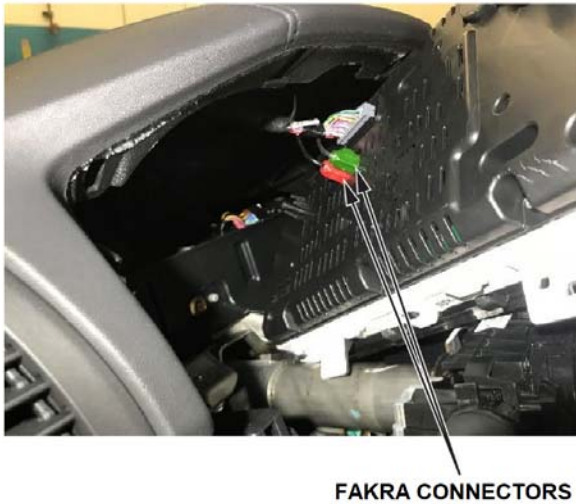
5. Turn the gauge control module to access the rear connectors, being careful not to stretch the wiring harness. Disconnect the red and green FAKRA connectors, then disconnect the remaining connectors, and remove the gauge control module from the vehicle.

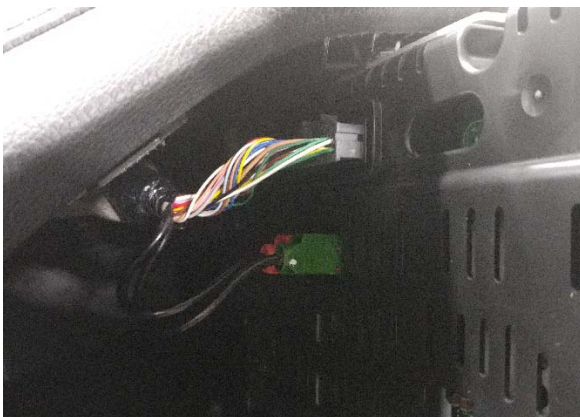
Make sure the harness is straight and not wrapped or tangled with other wires.

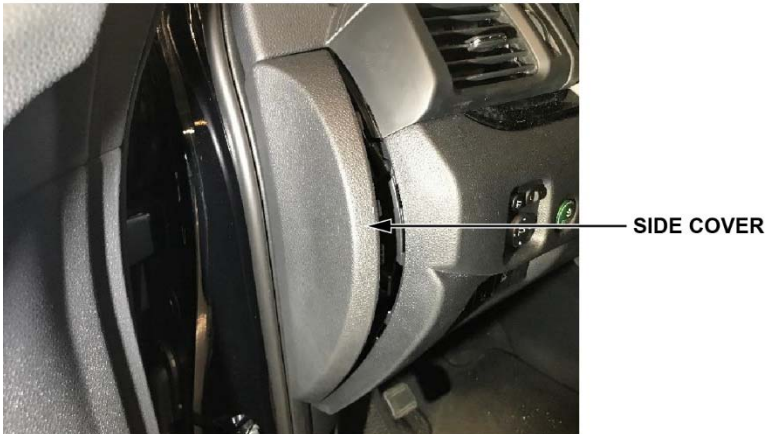
1. Remove the side cover.

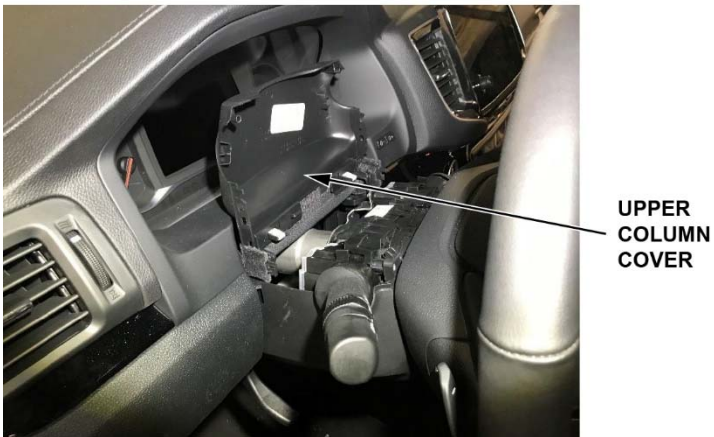
2. Remove the upper column cover from the steering column.

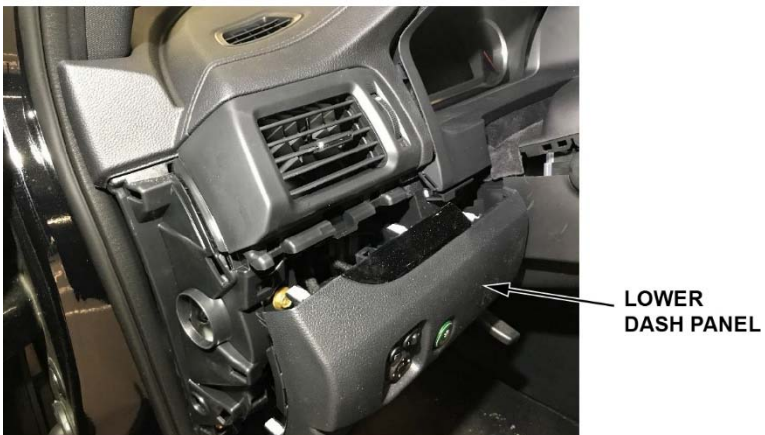
3. Remove the lower dash panel.

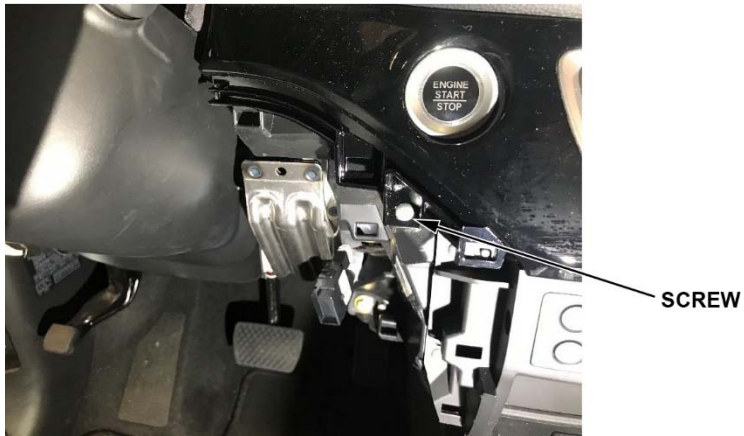
4. Remove the screw to loosen the dash panel.

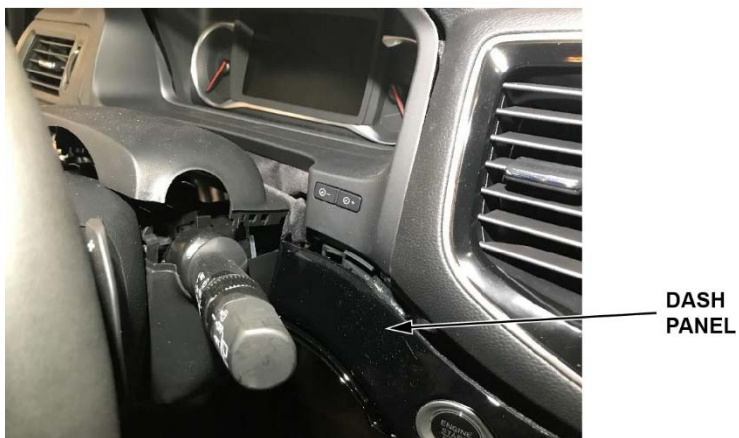
5. Pull back the dash panel as needed to allow removal of the meter visor.

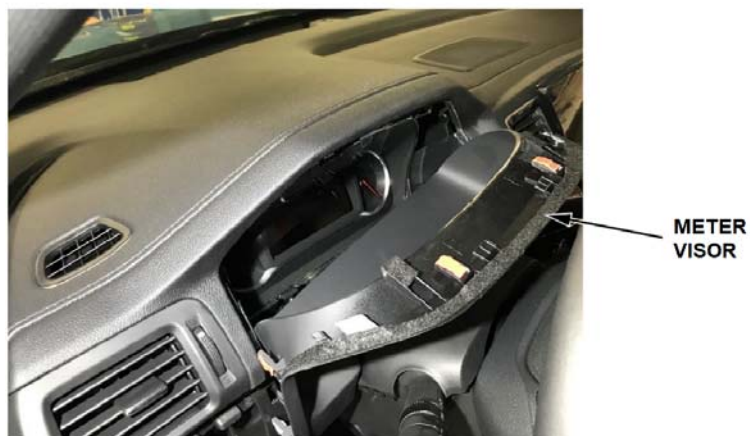
6. Disengage the clips around the meter visor, then remove it with the upper column cover as one piece.

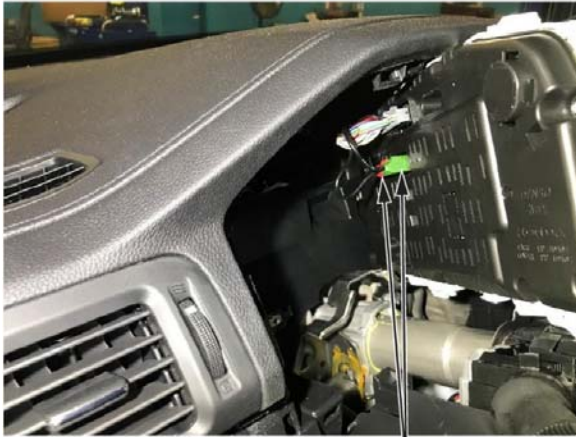
FAKRA CONNECTORS

8. Turn the gauge control module to access the rear connectors, being careful not to stretch the wiring harness. Disconnect the red and green FAKRA connectors, then disconnect the remaining connectors, and remove the gauge control module from the vehicle.

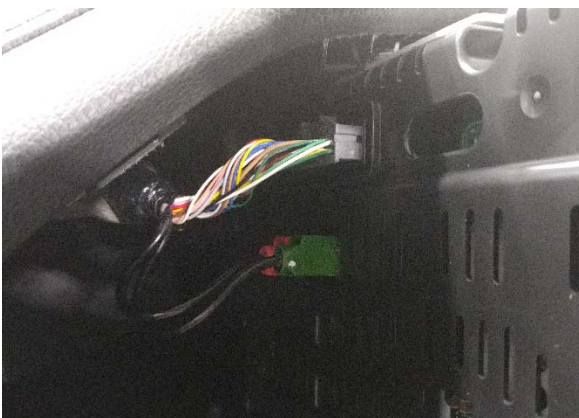
Make sure the harness is straight and not wrapped or tangled with other wires.

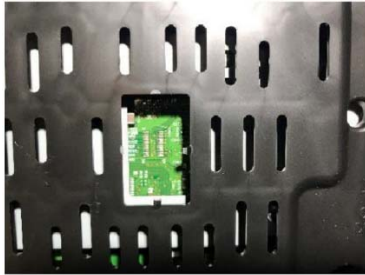
WITHOUT CONNECTOR

Some gauge control modules have a connector on the circuit board and some do not.

- *If there is no connector, go to REPAIR PROCEDURE A.*
- *If there is a connector, go to REPAIR PROCEDURE B.*

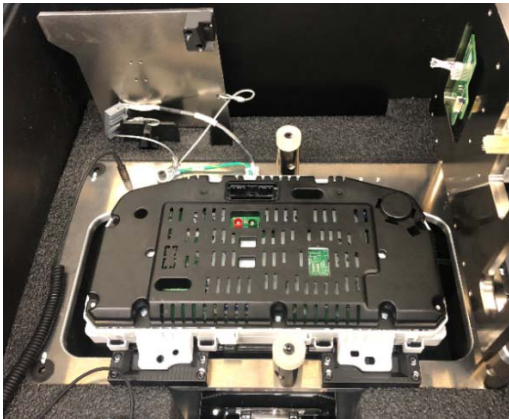
1. Write the VIN on a strip of tape, and attach it to the back of the gauge control module.
2. Load the gauge control module face down into the combimeter reflash tool, making sure it is fully seated.

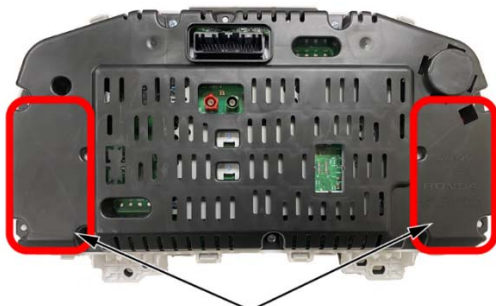
Press only in the designated areas when loading the gauge control module. Pressing on any other areas could damage the module.

Press only in designated areas.

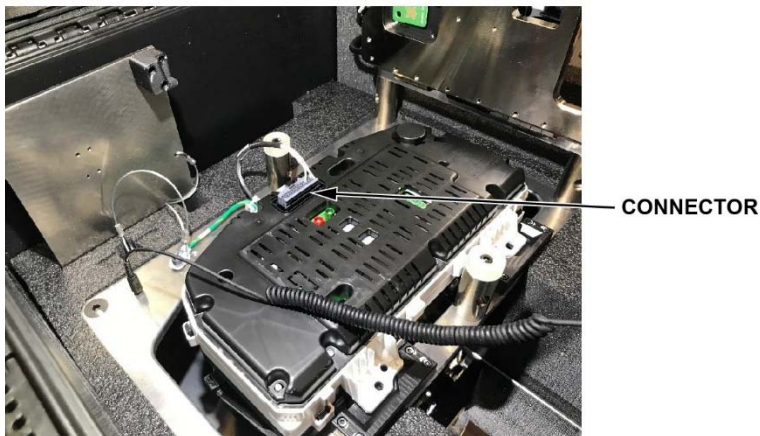
4. Connect the grey connector to the gauge control module.

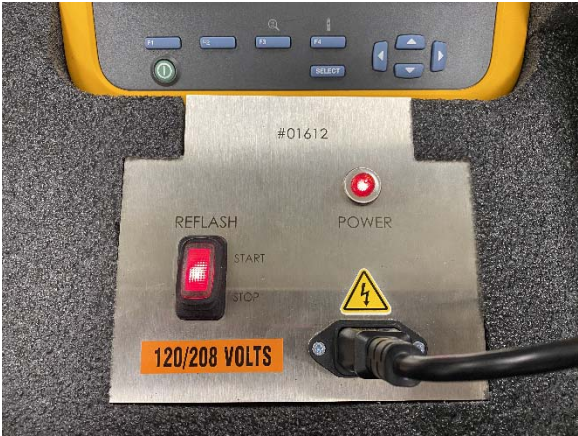
- Set the REFLASH toggle switch to START. The reflash process begins.

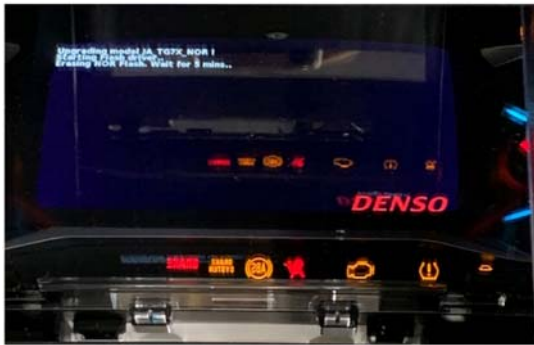
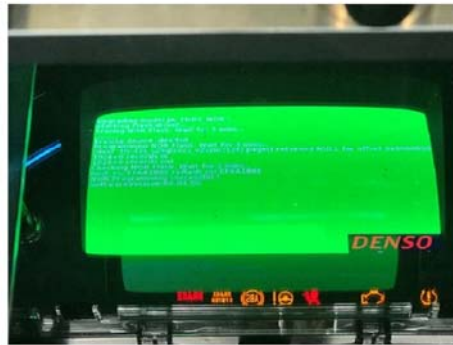
10. Check the reflash status through the inspection mirror below the gauge control module. The reflash will take about **7 to 10 minutes** to complete.

The screen will turn green once the reflash is complete.

*If the reflash fails, set the REFLASH toggle switch to STOP. Raise the pogo head with the Z-axis control knob, then start REPAIR PROCEDURE A again from step 6.*

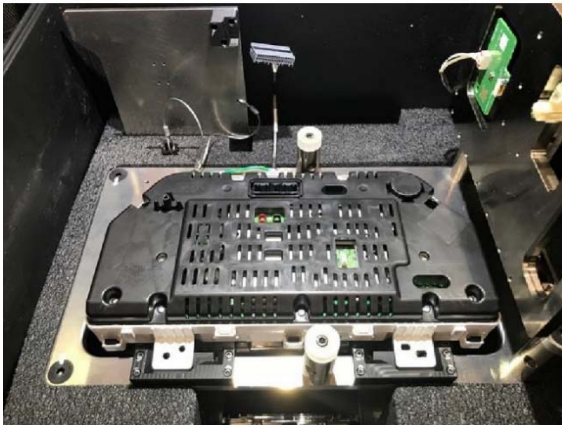
1. Write the VIN on a strip of tape, and attach it to the back of the gauge control module.
2. Load the gauge control module face down into the combimeter reflash tool, making sure the module is fully seated.

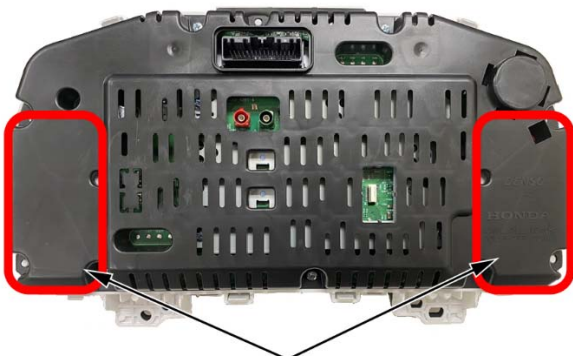
Press only in the designated areas when loading the gauge control module. Pressing on any other areas could damage the module.

Press only in designated areas.

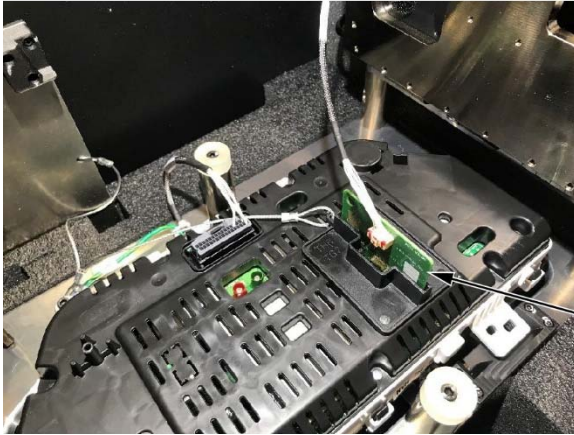
SMART  
REFLASH  
CARD

6. Insert the SMART reflash card into the alignment tool, making sure the connectors make good contact.

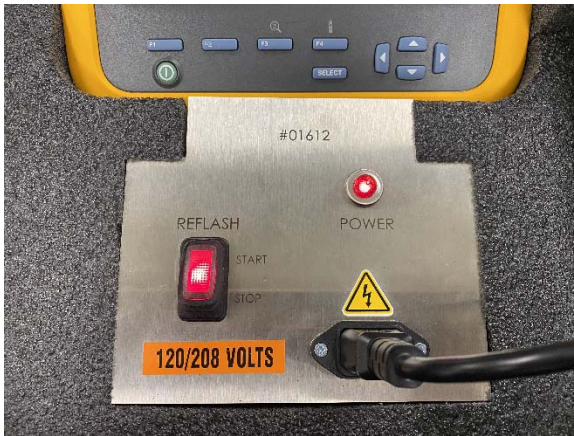
7. Set the REFLASH toggle switch to START. The reflash process begins.

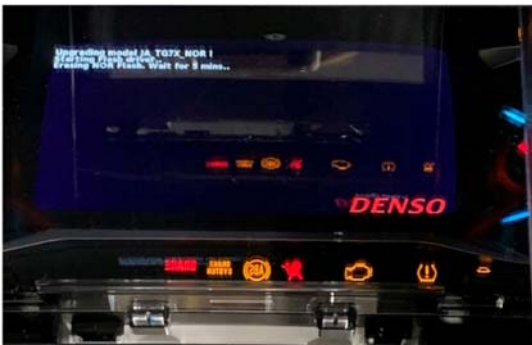
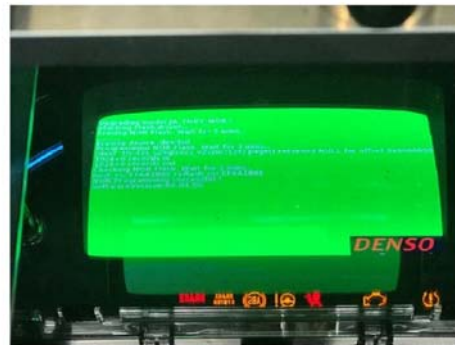
8. Check the reflash status using the inspection mirror under the gauge control module. The update will take about **7 to 10 minutes** to complete. The screen will turn green once the reflash is complete.

*If the reflash fails, set the REFLASH toggle switch to STOP and remove the SMART reflash card. Then, start REPAIR PROCEDURE B again from step 6.*
