SIB 63 05 20

RECALL 20V-516: HEADLAMP ADJUSTMENT PLUGS

E-Series	Model Description	Production Date
G29	Z4 Roadster	February 7, 2018 – June 5, 2019

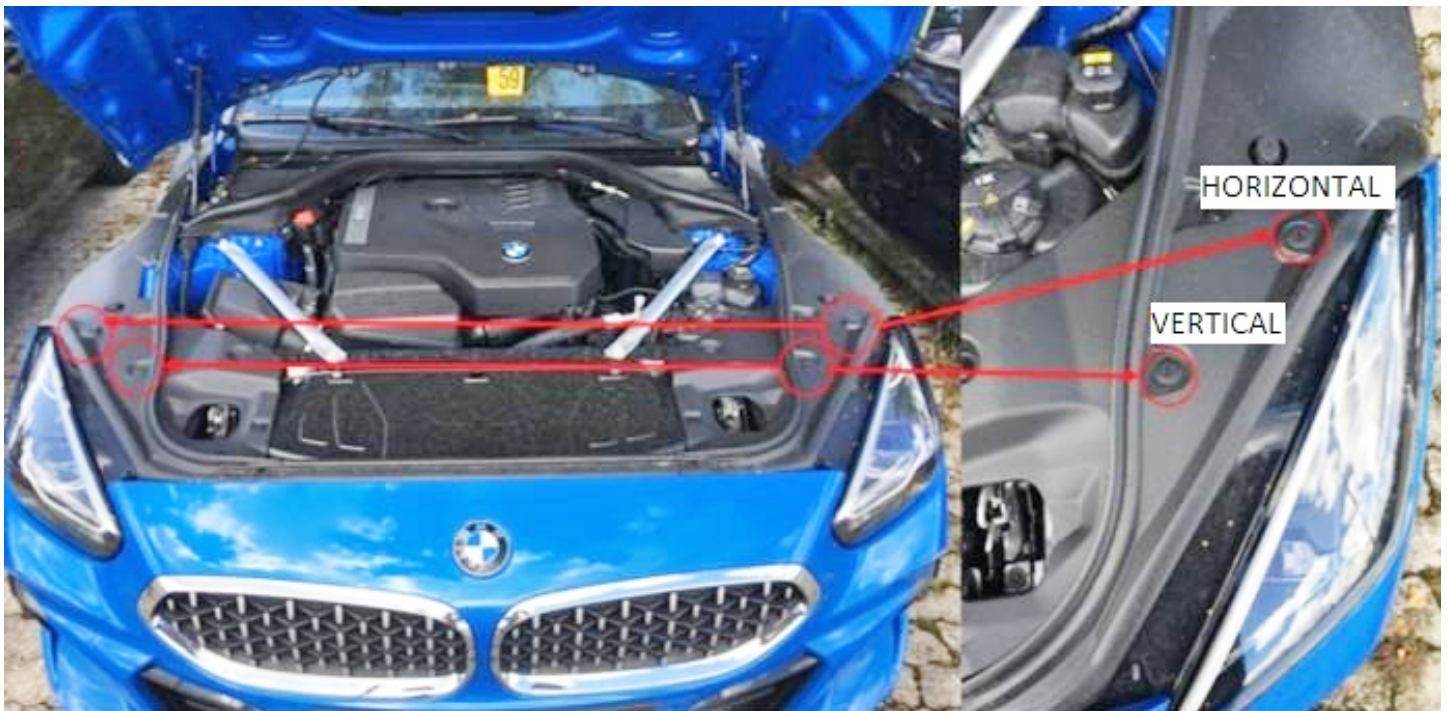
1. Refer to the photo below to familiarize yourself with which adjuster is horizontal, and which is vertical:

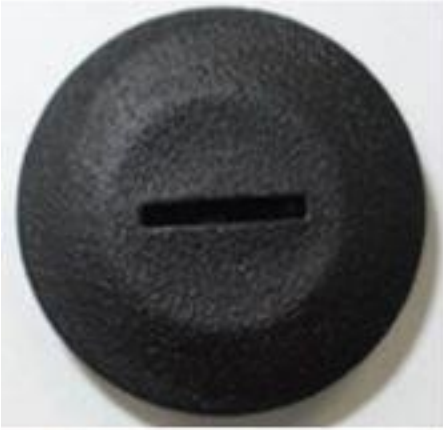
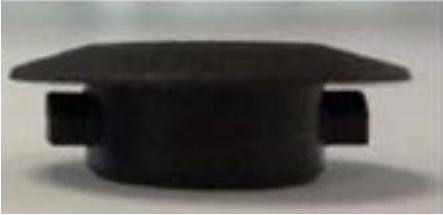
2. Inspect the **vertical** adjustment plugs first.
Do both plugs have a slot as shown below?

Yes: Continue to step 3.

No: Install plugs with slot and continue to step 3.

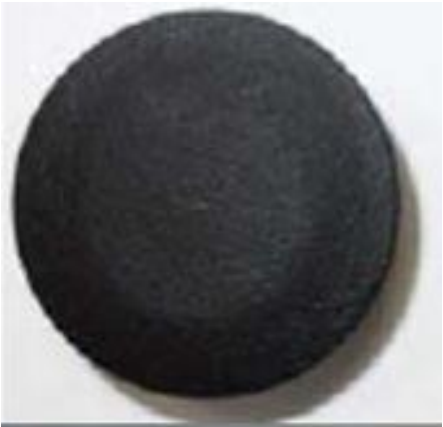
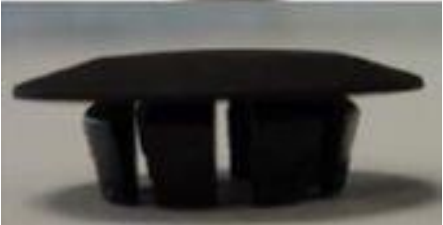
3. Inspect the **horizontal** adjustment plugs.
Are both plugs smooth without a slot as shown below?

Yes: No further correction is needed.

No: Install smooth plugs without a slot.

Note: The plugs can be swapped, and parts will **NOT ALWAYS** be required. It is possible to swap the plugs to their correct locations.
