**SIB 61 23 20**  
**RECALL 20V-601: HIGH-VOLTAGE BATTERY**

2020-11-24

BMW AG is conducting a Voluntary Safety Recall (effective September 24, 2020) on certain Model Year 2020-2021 BMW Plug-In Hybrid-Electric (PHEV) vehicles that were produced between February 22, 2020 and September 17, 2020.

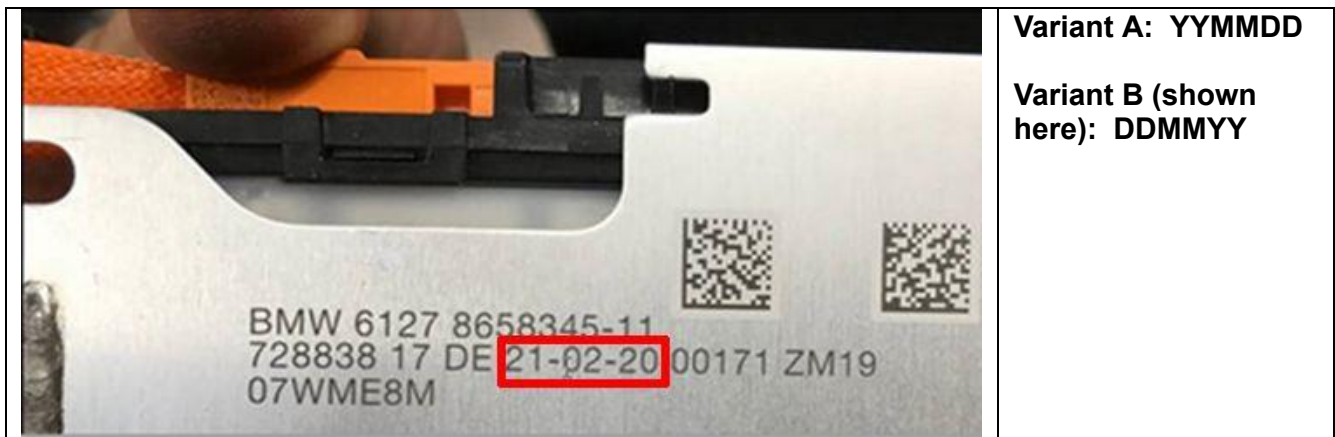
**The date in the serial number of the High-voltage module can be displayed in two different formats:**
