SIB 61 13 21

RECALL 20V-601: HIGH-VOLTAGE BATTERY RECALL

This Service Information Bulletin (Revision 4) replaces SI B61 13 21 **dated February 2022**.

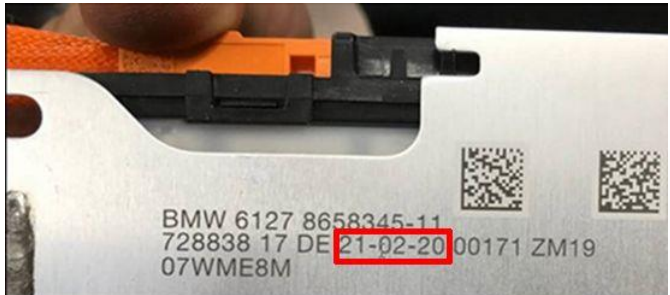
The date in the serial number of the High-voltage module can be displayed in two different formats:

<p>Variant A: YYMMDD</p> <p>Variant B (shown here): DDMMYY</p>
---	--

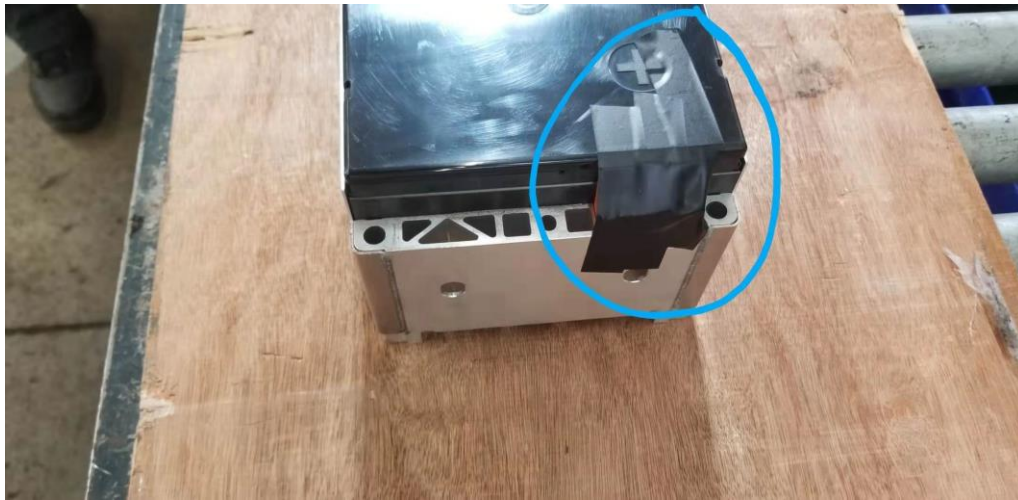
(Photo 4b. # 1 above)

- b. Ensure terminals are thoroughly covered with proprietary cover & electrically non-conductive tape to ensure no portion of terminals are exposed. **SEE PHOTO 4b. #1 & #2.**
- c. With electrically non-conductive tape, tape any cable leads that may be extending from the battery module. Attach cable to module with tie wrap/zip tie, like new module. **If the plastic cable end is intentionally "pinched", it could create a short circuit.** Then cut off the excess length of tie wrap/zip tie. **SEE PHOTOS 4c #1 - #3.**

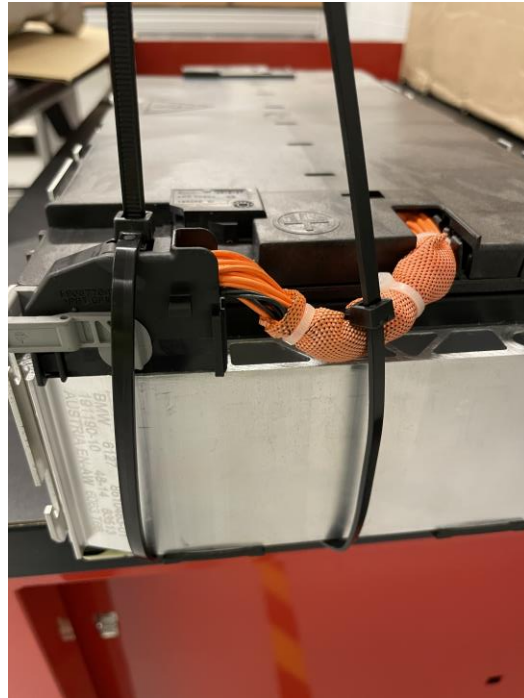
(Photo 4c. #1 above)

Section 4 continued: actual BMW module (4c. photos)

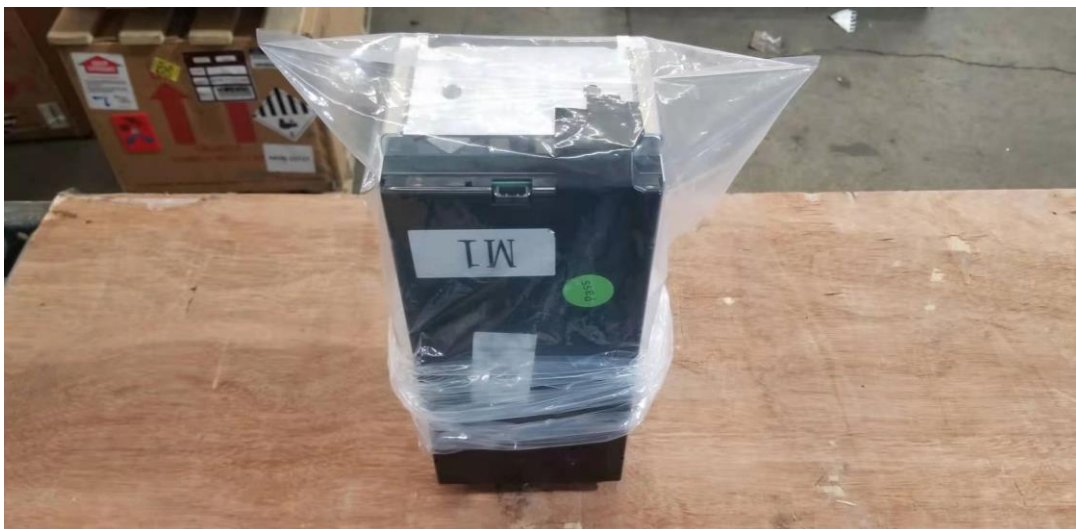
(Photo 6a. above)

- a. Lay the battery module vertically with cable lead side facing upward. Do not lay module where cable lead side is at the bottom bearing weight of module – there shouldn't be any unnecessary weight on this component that could cause damage to cable lead as mentioned in section 4.c. ***SEE PHOTO 6a. (Actual module in photos is not part of this project - only an example. Module in photos do not have a cable lead)***

Section 6: PER BAGGING/SEALING INSTRUCTIONS IN SECTION 6, WHEN POSITIONING THE MODULE VERTICALLY OR HORIZONTALLY, NEVER PLACE (1) THE CABLE LEAD SIDE OF THE MODULE, NOR (2) THE TOP SIDE (TERMINAL/PLASTIC SIDE) AT THE BOTTOM, BEARING WEIGHT OF MODULE. THIS PHOTO EXAMPLE CONTAINS A MODULE THAT DOES NOT HAVE A CABLE LEAD, SO IT WAS ABLE TO BE PLACED VERTICALLY ON BOTH SIDES. THAT IS NOT THE CASE WITH THIS PROJECT'S BATTERY MODULES.

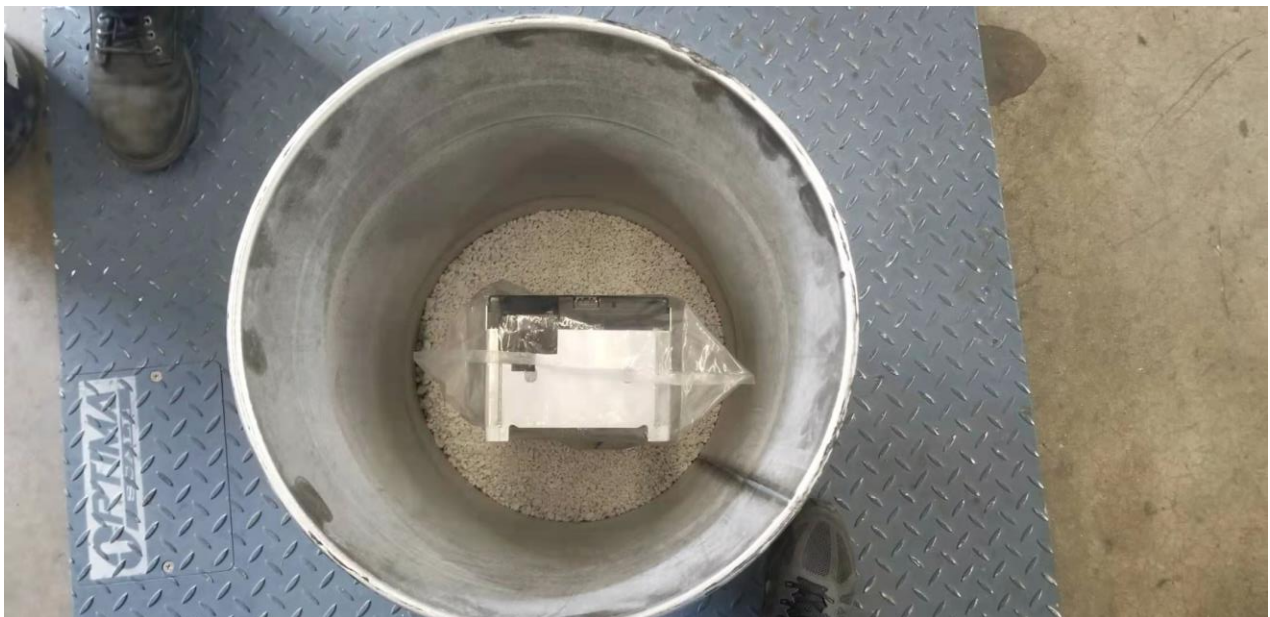
(Photo 7b. above)

- a. Remove bag of perlite from selected drum & place on the floor temporarily.
- b. Then with the cable lead end of the module facing upward, place the bagged/sealed battery module vertically at the center of the drum on the base of loose perlite material, so that cable lead end of module is on top. With the module properly centered, the space between the module & inside wall of drum should be ~ 3.5" (no closer than 3") on one axis, & ~4.5" (no closer than 4") on the other; space measurements are based off the center of the drum and the module per axis. **SEE PHOTO 7b. (module in photo does not have a cable lead).**

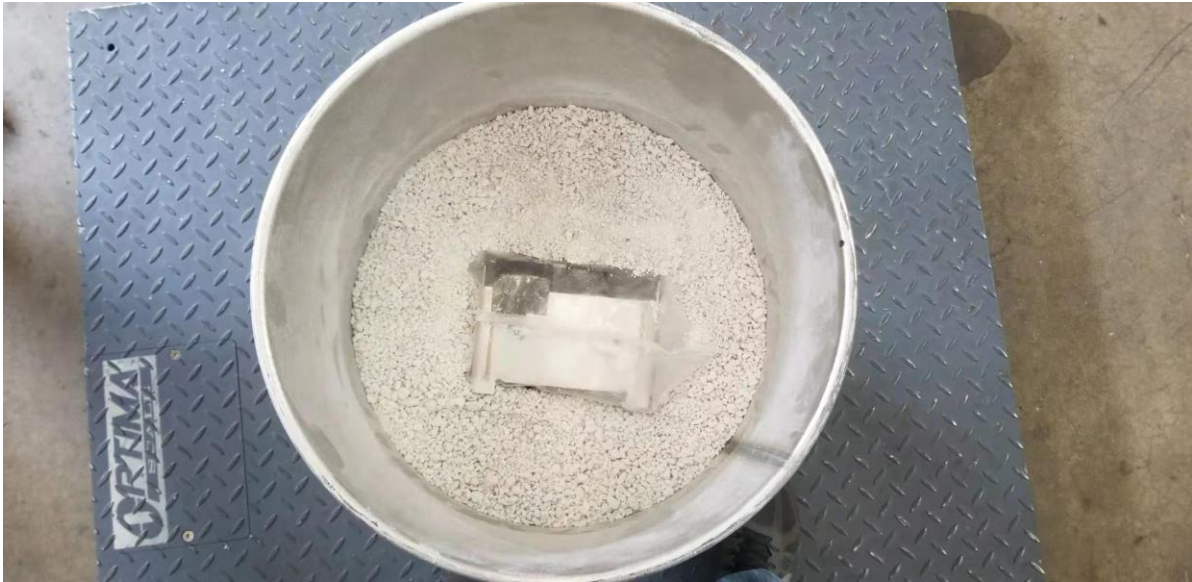
(Photo 7c. above)

- c. Open the bag of perlite & begin gently pouring the perlite material in the space around the battery module that is between the battery & the inner wall of the drum till you have reached the height of battery module. **SEE PHOTO 7c.**

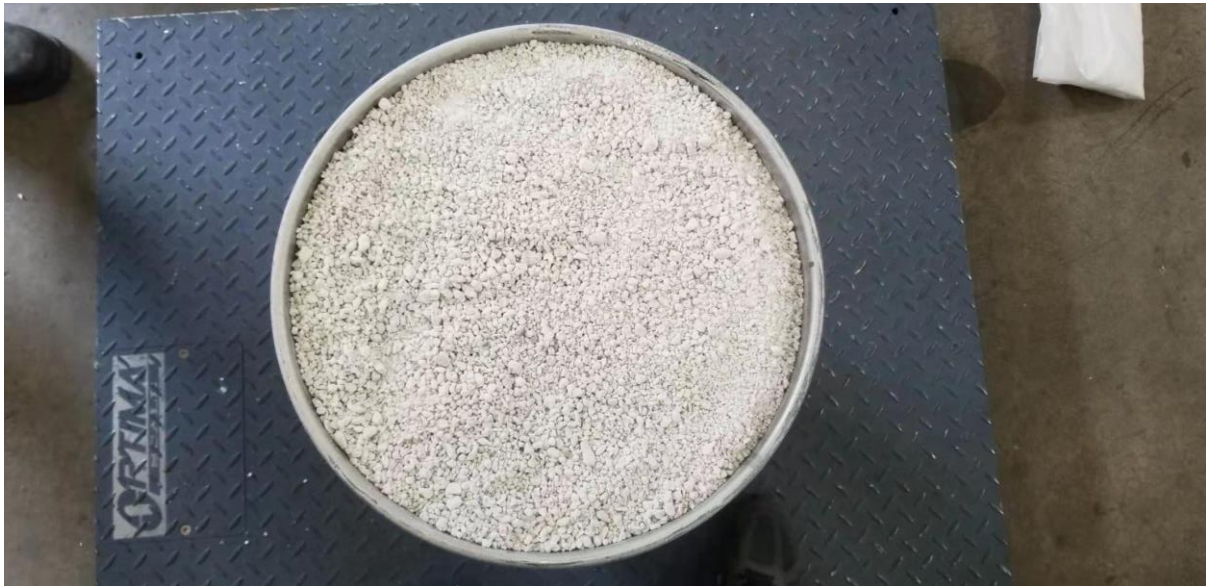
(Photo 7e. above)

- e. Then pour the balance of the perlite material onto the drum, completely filling the drum. **SEE PHOTO 7e.**
- f. Then fold the empty bag & place on top of open drum for return.

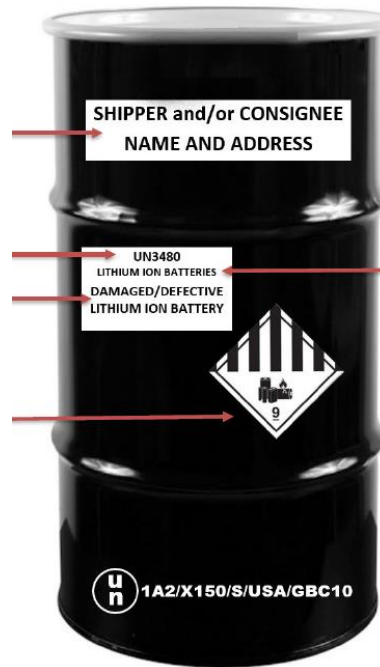
(Photo 9a. above)

- a. With drum's closure mechanism facing inward, place the below listed labels/markings on the drum, opposite side of the closure mechanism, facing outward. **SEE PHOTO 9.a**

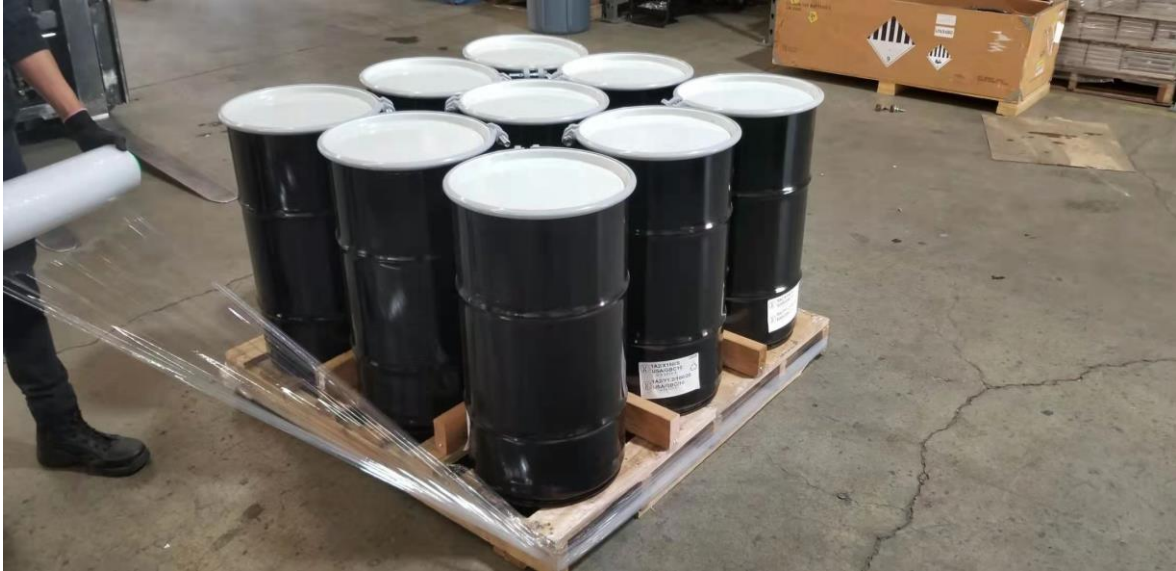
(Photo 11d. above)

Section 11 continued: photo illustration only of stretch wrapping/palletizing instructions. Per section 9, labels/markings need to be placed on each drum before stretch wrapping drums/pallet(s).

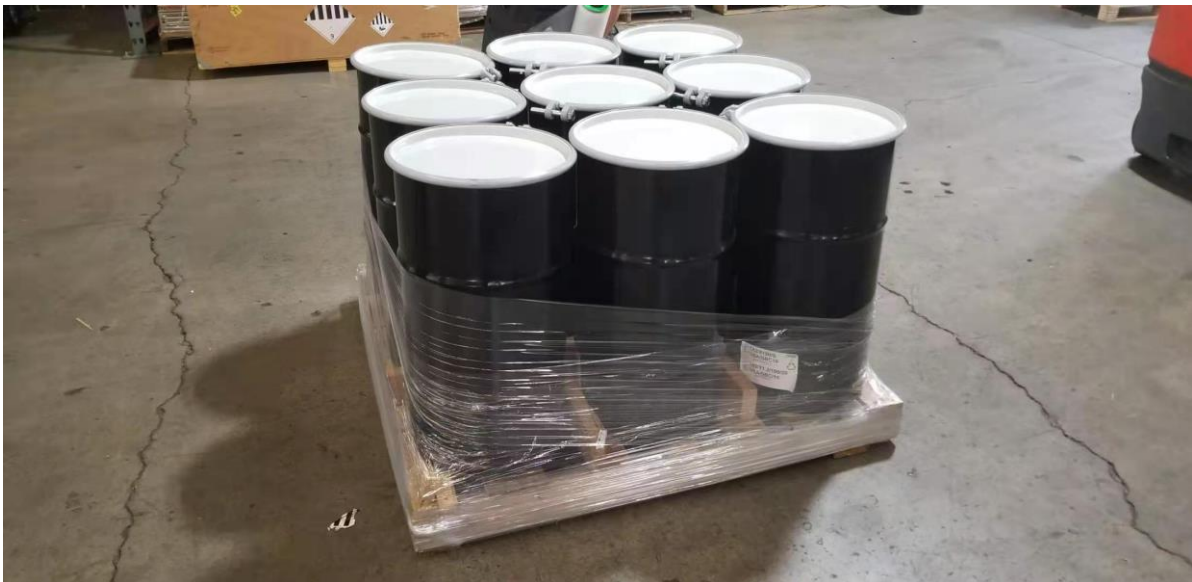
(Photo 11e. #1 above)

- f. **When stretch wrapping actual drums, pull with relative force at every turn/corner of the pallet in order to create enough tension and strength in the wrapping package. Otherwise, the stretch wrap will be loose & not strong enough for shipping.**

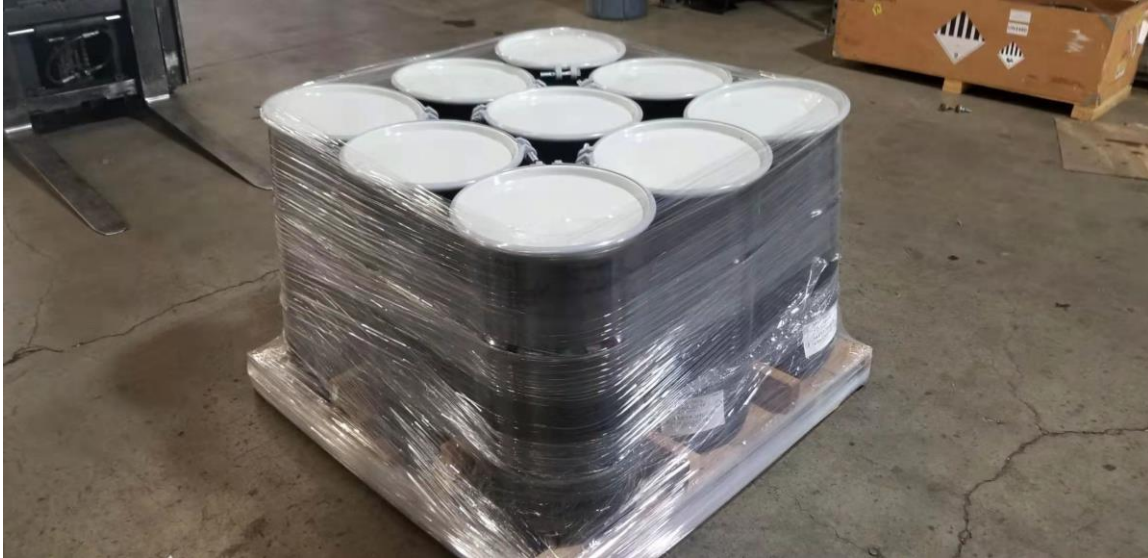
(Photo 11e. #2 above)

Section 11 continued: photo illustration of properly stretch wrapped/palletized pallet. Per section 12, additional labels and markings need to applied after this step is completed.
