SERVICE BULLETIN

FIELD CAMPAIGN SERVICE BULLETIN #: SVC2022-062

BC1000XL Wheel
and Tire Assembly
Replacement Kit
(IK00-3940)

NHTSA SAFETY RECALL NUMBER 20V-085

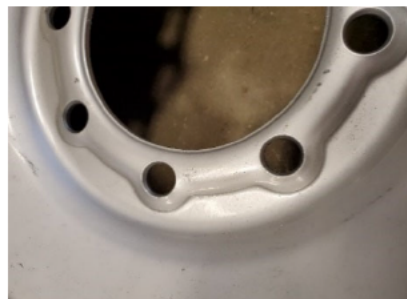
**Defective Supplier Wheel
Improper Lug Nut Seat
and Potential Cracks**
Identified by continuously raised lug nut surface

Specific wheels (steel rim) with bolt pattern 8 on 6½ inch (165 mm) circle to be used with 5/8" studs provided by a supplier [only 7000 lb (3175 kg) electric brake axle configuration]:

- have an incorrect lug nut contact area causing wheel lug nuts to loosen; and/or
- can develop possible cracks causing the tire to lose air pressure.

Destroy wheel and tires. When you remove the supplier defective steel rim/wheels, these wheels can never be used or sold for any purpose. The wheels **must** be destroyed:

- Remove the tire from the steel rim/wheel or deflate the tire.
- Torch cut the wheel(s) across the lug nut area.
- Take photo(s) of the destroyed wheel(s) and attach to campaign warranty claim.
- Discard the lug nuts so they can never be used or sold for any purpose.
- The removed used tires may be retained in your used tire inventory or disposed of. The cost of tire removal and disposal is included in the labor hours.

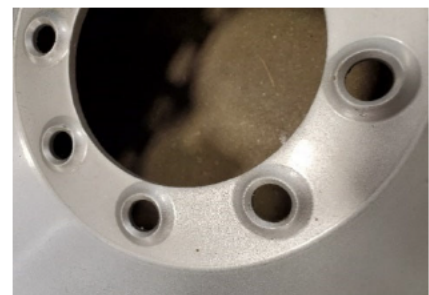
**Properly Manufactured Wheel
Correct Lug Nut Seat**
Identified by raised surface only around
lug nut location
