SERVICE BULLETIN

FIELD CAMPAIGN SERVICE BULLETIN #: SVC2022-057

**BC1500 Wheel
and Tire Assembly
Replacement Kit
(IK00-3922)**

NHTSA SAFETY RECALL NUMBER 20V-085

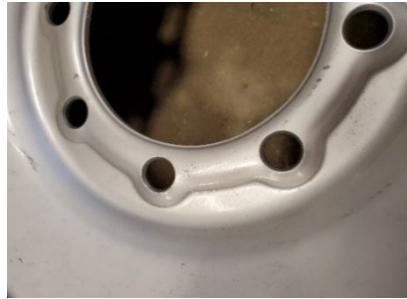
**Defective Supplier Wheel
Improper Lug Nut Seat
and Potential Cracks**
Identified by continuously raised lug nut
surface

Specific wheels (steel rim) with bolt pattern 8 on 6½ inch (165.1 mm) circle to be used with 5/8-in studs provided by a supplier:

- have an incorrect lug nut contact area causing wheel lug nuts to loosen; and/or
- can develop possible cracks causing the tire to lose air pressure.

IK00-3922 has been created to provide the necessary parts and instructions to replace the wheel and tire assembly, install a new safety sign (shown at right), install a new wheel/tire specification placard decal and provide a supplemental operator's and maintenance manual.

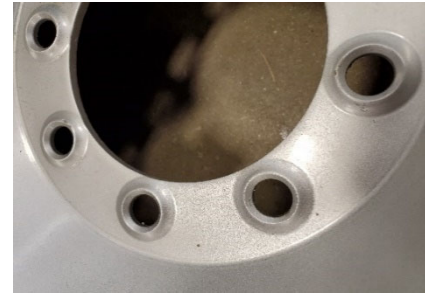
**Properly Manufactured Wheel
Correct Lug Nut Seat**
Identified by raised surface only around lug nut
location
