# SERVICE BULLETIN

FIELD CAMPAIGN SERVICE BULLETIN #: SVC2022-072

## AX19 Wheel and Tire Assembly Replacement Kit (IK00-3939)

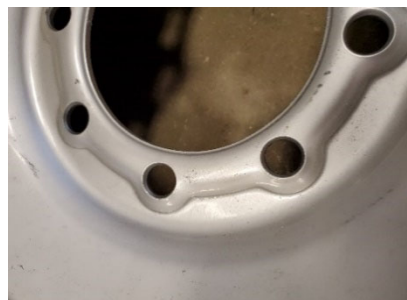
#### Defective Supplier Wheel Improper Lug Nut Seat and Potential Cracks

Identified by continuously raised lug nut surface

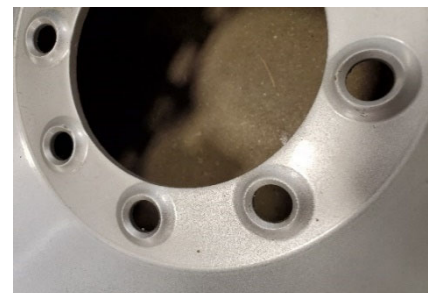
#### Properly Manufactured Wheel Correct Lug Nut Seat

Identified by raised surface only around lug nut location
