Subject: Recall R20AO, FMVSS 105 Noncompliance – Hydraulic Brake Units W/Floor Mounted Park

Brake Hand Lever Assembly

R20AO Hydraulic Brake Floor Mounted Hand Lever Setting

Models Affected: Certain MY 2007-2013 All American and MY 2006-2021 Visions

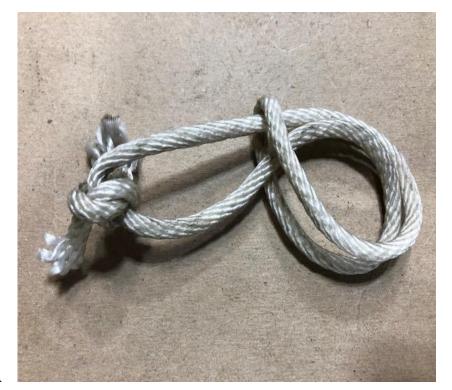
Photo A

- 1. Place the park brake handle in the released position.
- 2. Attach a 16" rope tied into a loop if your force gauge is not equipped with a loop strap. (Reference Photo A)
- 3. Slowly pull up the hand lever to the peak park brake applied location. (Reference Photo B)
- 4. Pull several times to verify the setting.
- 5. If the force setting is 90 to 95 FT lbs. No other actions are required.
