**DATE:** January 20, 2022  
**TO:** Blue Bird Owners  
**Subject:** Recall R20AP, FMVSS 105 Noncompliance – Hydraulic Brake Units with Orscheln Foot Pedal Park Brake Assembly

**IMPORTANT SAFETY RECALL NOTICE**  
**NHTSA Campaign Number: 20V-258 (School Bus)**  
**NHTSA Campaign Number: 20V-259 (Non-School Bus)**

**SUBJECT:** Recall R20AP, FMVSS 105 Noncompliance – Hydraulic Brake Units with Orscheln Foot Pedal Park Brake Assembly

## R20AP: Hydraulic Brake Units With Orscheln Foot Pedal Park Brake Assembly

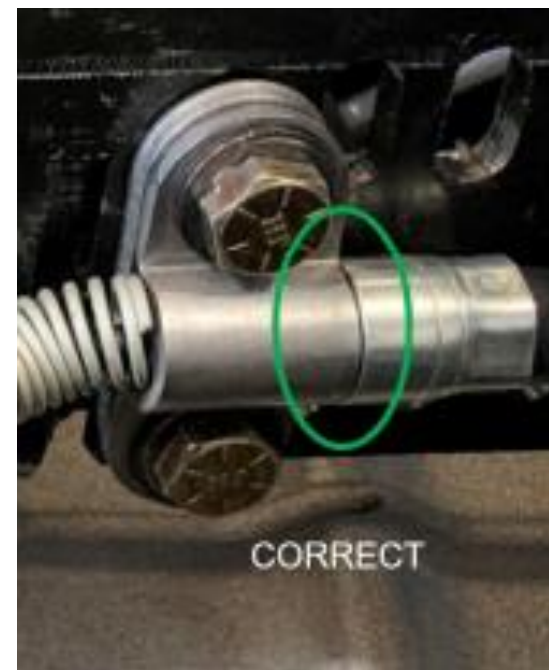
Photo 1

6. **Ensure wheels are chocked.** Release parking brake and remove cotter pin and clevis pin at bell crank to relieve cable.
7. Be sure cable saddle is set in 3<sup>rd</sup> set of holes in mounting bracket. (Detail 1)
8. Ensure the cable is tight with no gap at cable saddle. (Photo 1)
9. Check slack in cable by pulling down on cable below pedal.
  - a. Check visually and physically that the cable is seated at the pedal clevis.
10. Pull slack out of bell crank and any downstream linkage by pushing bell crank forward until you feel shoes contact drum.
11. Screw cable end yoke forward or rearward so the yoke eye aligns with hole in bell crank. (Photo 2)
  - a. Do not engage parking brake by pushing bell crank too far forward.
  - b. Only push until initial resistance is felt.
