R20AX

Subject: Recall R20AX, FMVSS 210 Noncompliance – Installation of Seats with 3-Point Belts

R20AX – FMVSS 210 Noncompliance – Instl. of Seats with 3-Point Belts

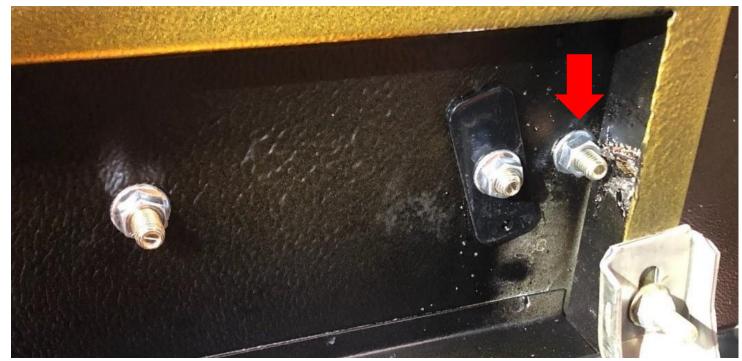
See Photo (1)

1. Inspect the Seat Fastener Installation to ensure the correct seat washers are installed. Do this by visually inspecting the underside of the seat fasteners. Each seat must have a washer installed on the rear two fasteners. No washer is required on the forward seat fastener.

Photo 1-Rear Washer Missing

- 1. Loosen the seat bolt that requires the washer addition.
- 2. Insert the notched washer (Photo 2) on to the fastener between the floor panel above the nut (Photo 3).
- 3. Torque the fastener to 26-30 ft lbs.

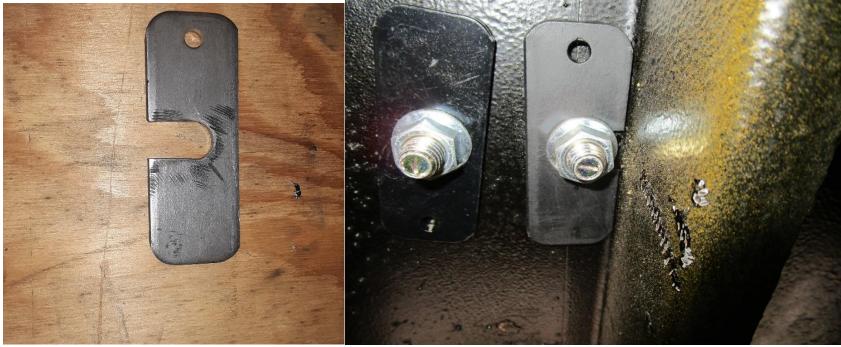
Photo 2-Notched Washer

Photo 3-Notched Washer Installed
