# F/CMVSS Noncompliance Recall

## A202304070 Label Missing Tire and Wheel Information

**Release Date:** May 2020

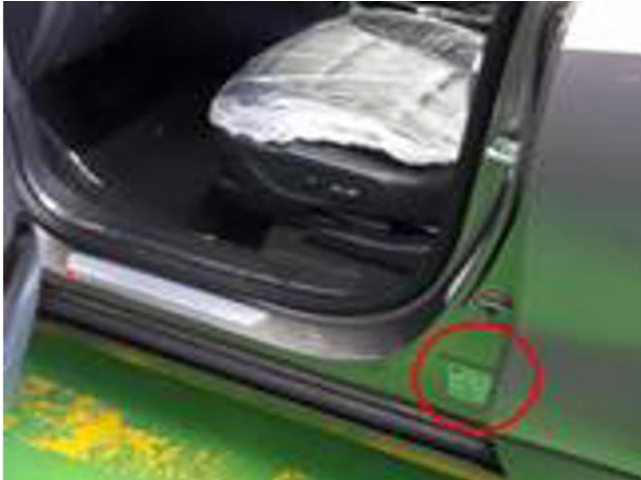
5608526

1. Open the left front door.

2. Locate the silver certification label on the lower area of the driver side center pillar. Ensure that the label surface and the area surrounding the label is clean and dry. Use a non-oil based cleaner, preferably isopropyl alcohol (rubbing alcohol) to clean the label surface and the area surrounding the label.

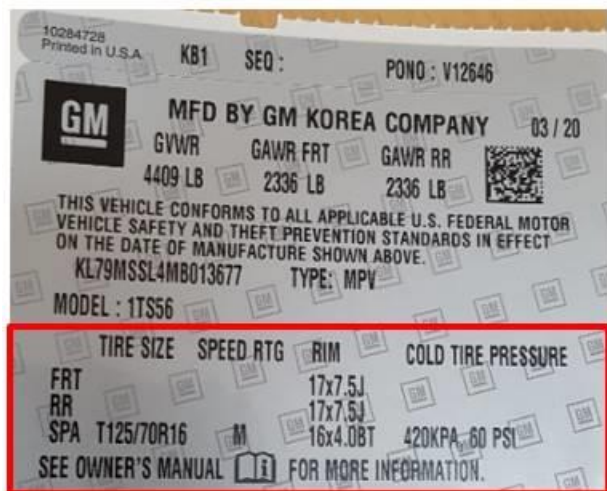
5609079

4. Apply the label in the location shown and smooth the label from the center out.
5. Close the door.
6. CALIFORNIA VEHICLES ONLY: Complete a "Proof of Correction" certificate and provide to the vehicle owner upon recall completion.

**NOTE:** The service label only contains the tire information portion of the label, not the complete label. Align the service label with the blank tire size section of the existing label.

3. Remove the backing from the new label.
